Pacific Safety of Navigation Project Risk Assessment – Tarawa, Kiribati

October 2018

As part of the Phase 2 of the project, in September 2018 SPC conducted an **AtoN risk assessment** of the Betio port area using the **Simplified IALA Risk Assessment (SIRA) tool**: this report details the risks identified, the estimated costs in case of incident, the potential risk control options suggested and their costs. Kiribati’s maritime stakeholders identified ten possible **scenarios**: four “**groundings**” in the vicinity of Betio port, two “**allisions**”, one “**foundering**”, two “**structural failure**” and one other scenario. Upon discussion with the AtoN officer, from the ten possible scenarios, **six** were **further assessed** for risk control options. For each scenario, the approximate **cost of the incident** was identified and a **risk score** was given, taking into account the probability of the incident happening and its potential impact on the country.

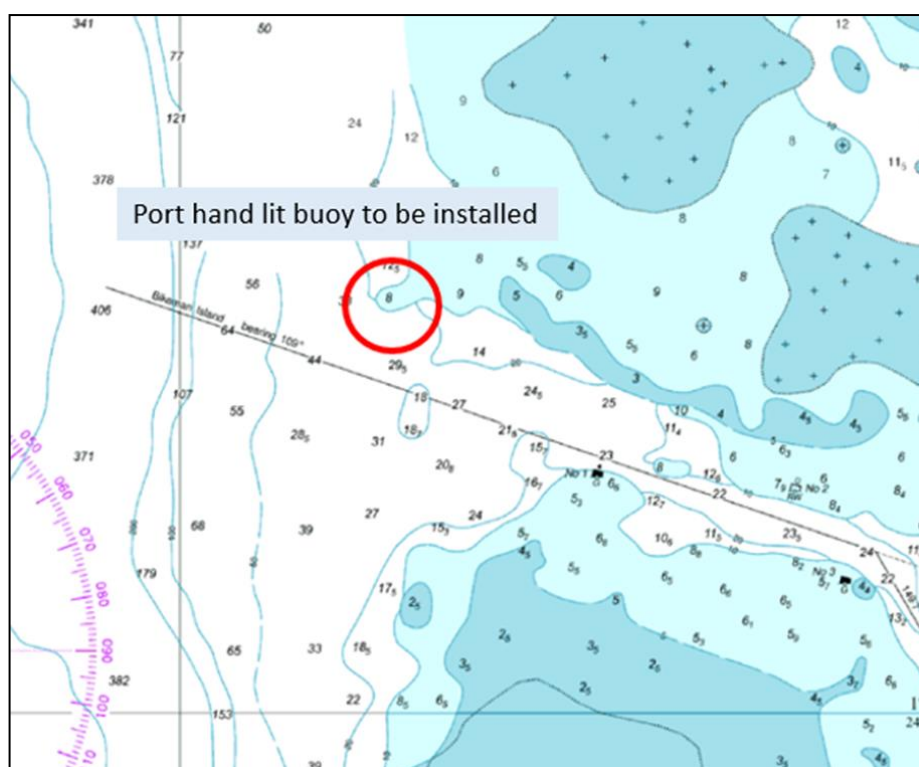
Therefore, **it is recommended that a port hand lit buoy be installed on the 8 m shoal at the entrance of the channel.**

Recommendations 1	Amount (AUD)
Install a port hand lit buoy on the 8 m shoal at the entrance of the channel.	
Cost of Buoy (including installation)	40,000.00
Annual maintenance cost	603.00 ⁶

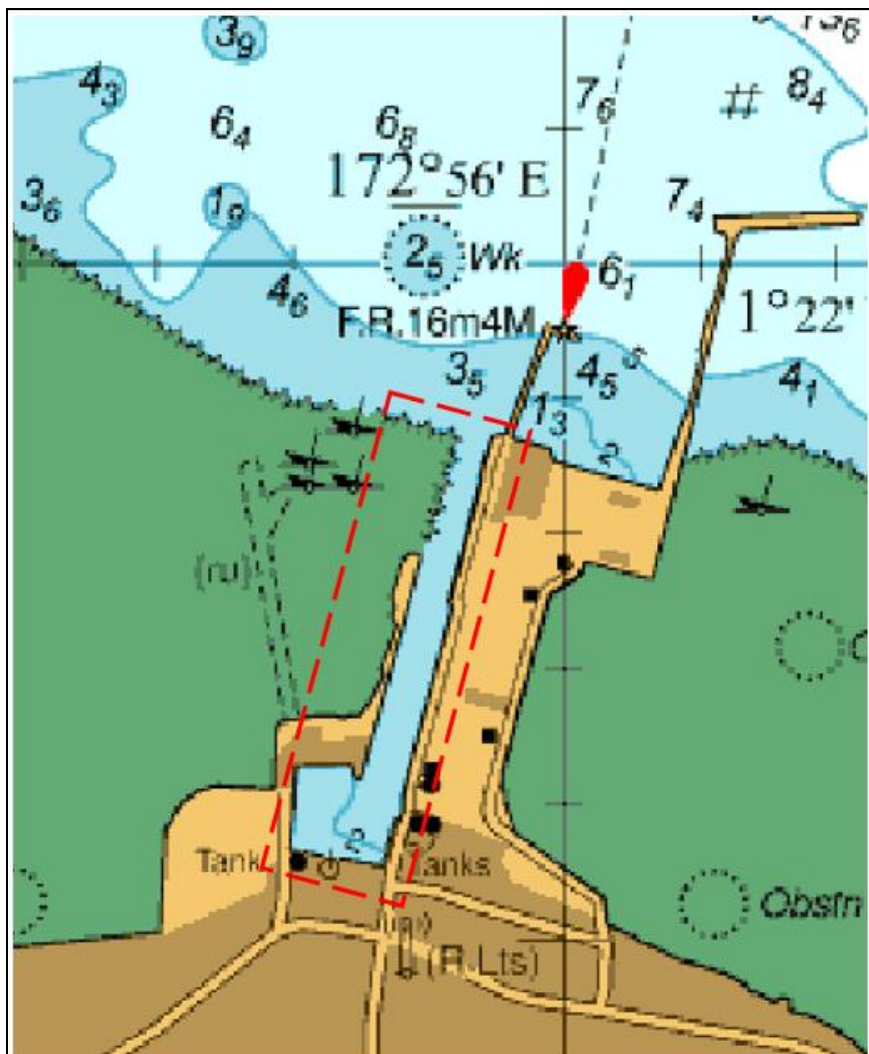
The old KPA wharf is very shallow at the entrance and the berthing area has water depths of less than 2 m as shown below. Local vessels accessing this wharf and the slipway at the end of the old KPA wharf prefer to come alongside at high tide to avoid grounding.

Therefore, it is **recommended to dredge the entire length of the channel to 4 m** so that all domestic ships can access this wharf at all times. This will help prevent ships' grounding, engine damage and thus will help reduce ship downtime.

Recommendations 2	Amount (AUD)
Dredging of the channel and berthing area	
Cost of dredging	150,000.00
Annual maintenance cost (no maintenance dredging required for the first 5 years)	none

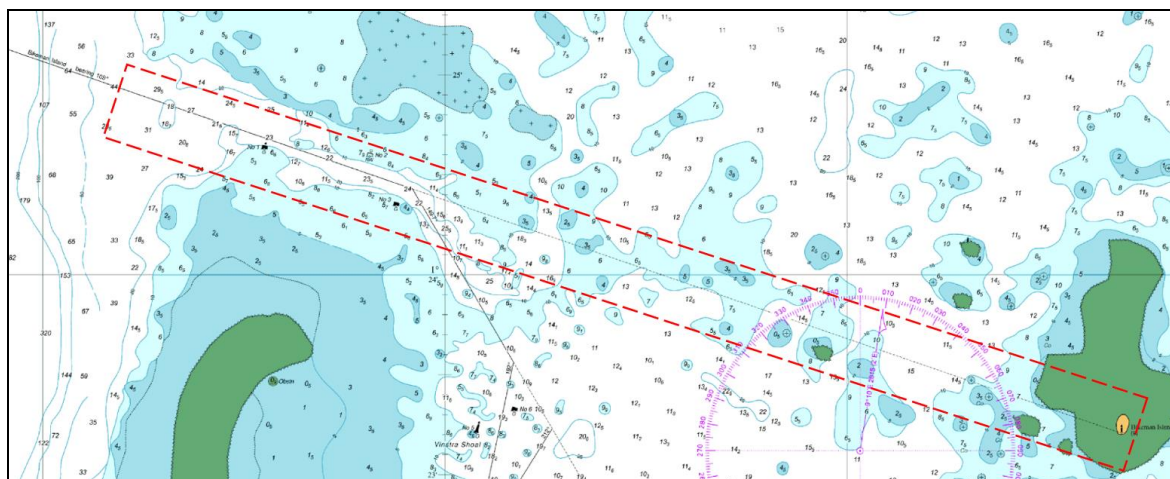
The transit light at Bikeman Island is destroyed, thus foreign vessels cannot access the Betio port at night. The destroyed leading light can cause vessels to ground while on route to the port at night.

Therefore, **it is recommended to re-install the leading light on Bikeman Island**. This will enable all vessels to come into port at all times and will significantly reduce the risk of vessels running aground.

Recommendations	Amount (AUD)
Approximate cost of light	20,000.00
Annual maintenance cost	603.00 ⁷

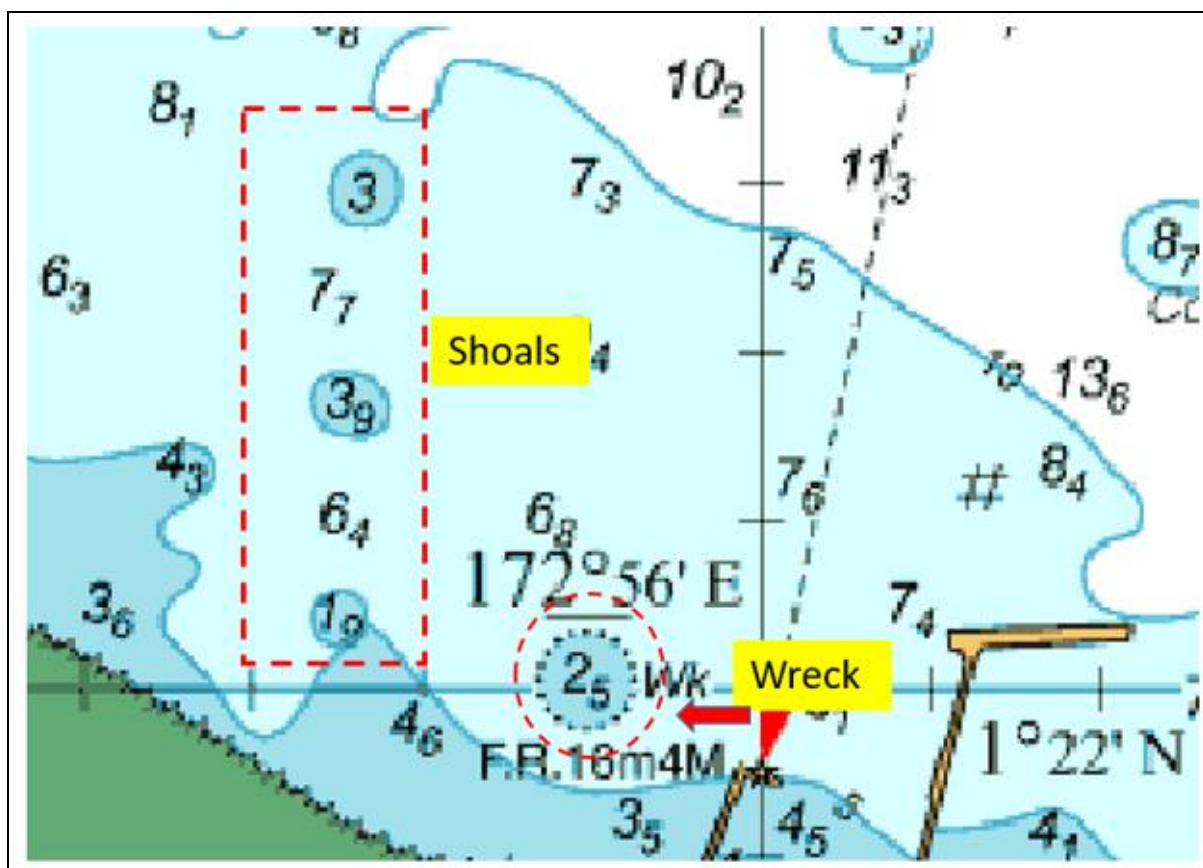
Therefore, **it is recommended that a wreck marking buoy be installed near the wreck** to warn the mariners of the danger.

Recommendation 4	Amount (AUD)
Install a wreck marking buoy	
Cost of buoy (including installation)	40,000.00
Annual maintenance cost	603.00 ⁸

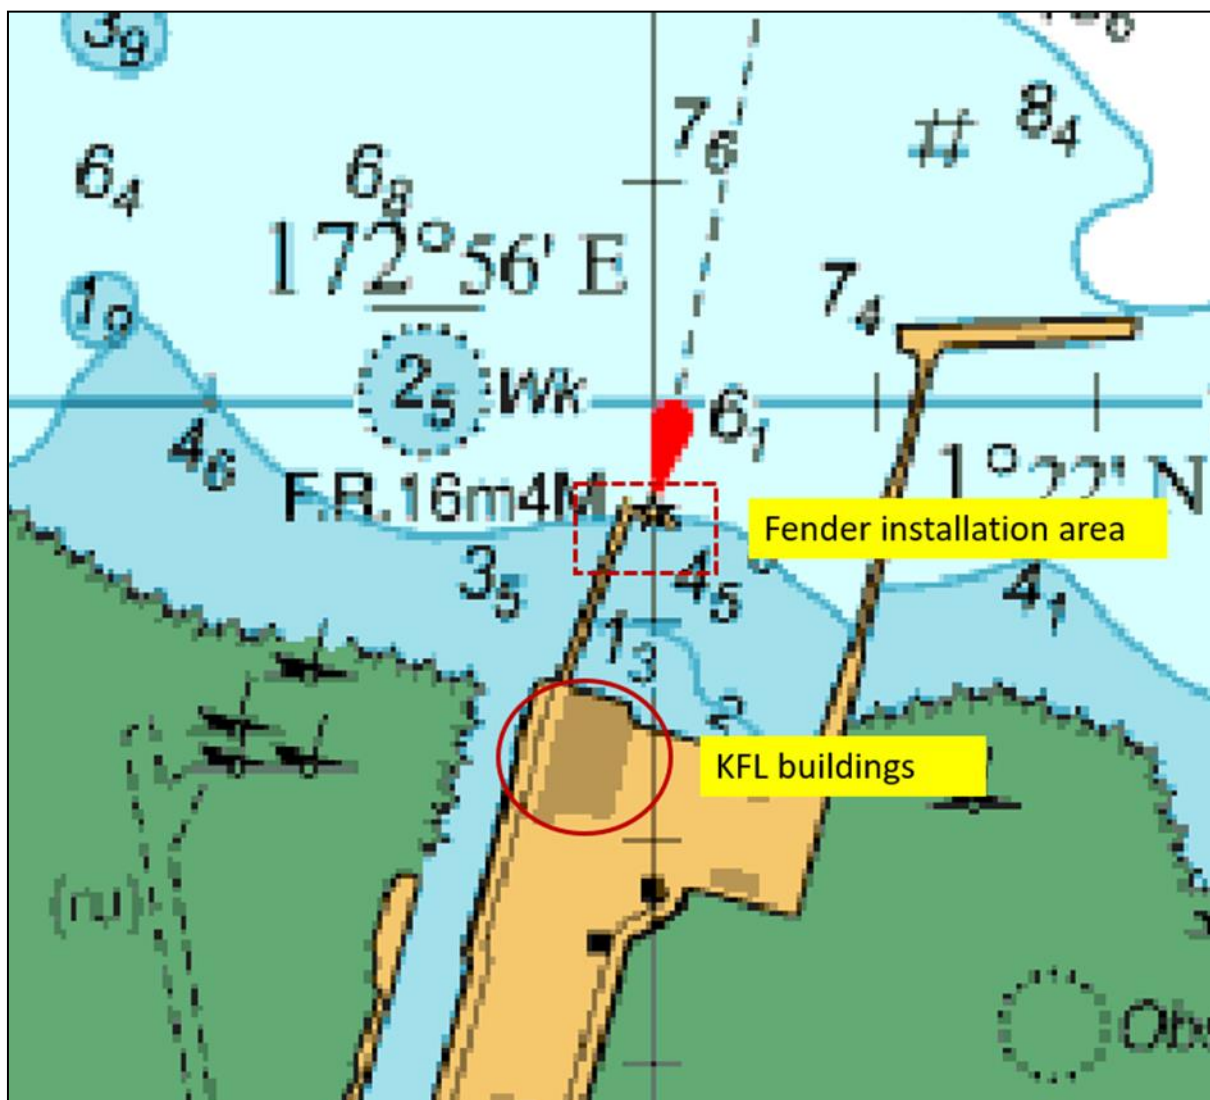
There have been occasions when ships have allided with the domestic wharf. This have been noticed during bad weather conditions when ships anchored close to the wharf drag anchor and allide with the domestic wharf. It has also been noticed that when ships try to come alongside the domestic wharf during bad weather conditions, they allide with it. Another contributing factor for this scenario is the intensity of the background lights from the Kiribati Fish Limited (KFL) building which affect the night vision when coming alongside the wharf.

Therefore, it is **recommended to install fenders on the domestic wharf and to reduce the intensity and direction of the background lights from the KFL buildings**. These measures will definitely reduce the risk to as low as reasonably practicable.

Recommendations	Amount (AUD)
Cost of fenders and installation	100,000.00
Cost to reduce direction/intensity of KFL lights	none
Annual maintenance cost(estimated at 1% of total cost)	1,000.00

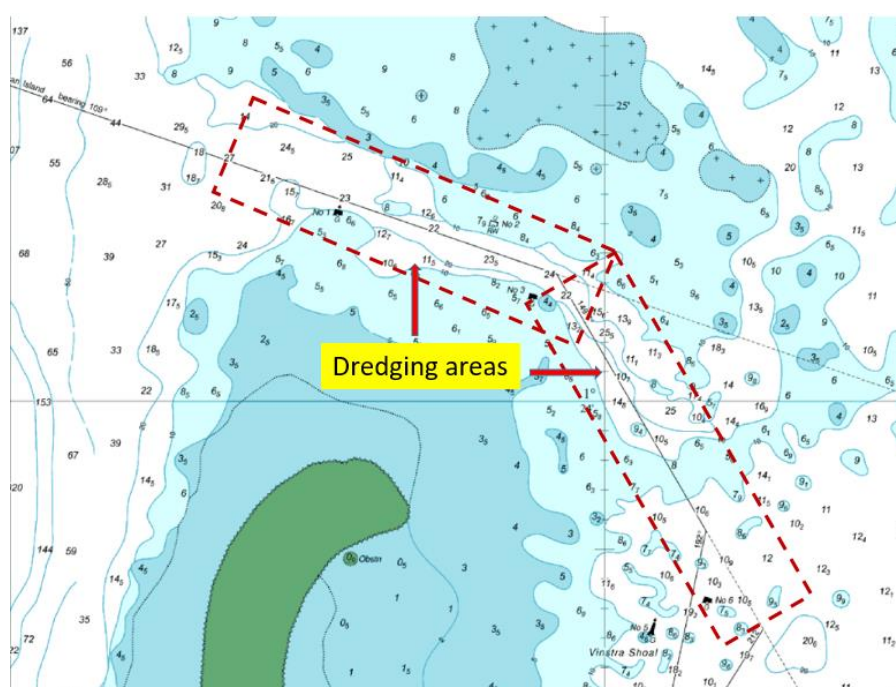
No. 2 port lateral mark has been laid in shoal water about 100 metres north of the channel. Because pilotage is compulsory, this was not seen as an immediate problem, however there is a real risk that the master of a vessel might consider it safe to pass close to this buoy believing it to mark the edge of the channel⁹.

Therefore, it is recommended that the No. 2 port lateral mark should be repositioned so that it marks properly the edge of the approach channel into Betio Port. Considerations should also be given to the option of dredging and enlarging the channel into Betio Port.

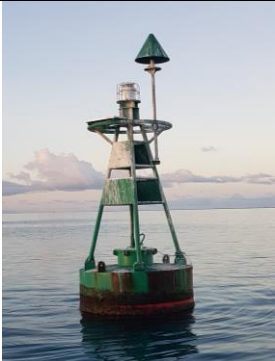
Number on Buoy Feature Name: Description: Light Characteristics: Position (WGS84): Comments:	3 Starboard hand mark Buoy, single green cone pointing upwards FL G(3s) 01°24.349N 172°55.819E needs urgent maintenance	 
Number on Buoy Feature Name: Description: Light Characteristics: Position (WGS84): Comments:	5 Starboard hand mark Buoy, single green cone pointing upwards FL G(3s) 01°23.203N 172°56.138E needs urgent maintenance	 
Number on Buoy Feature Name: Description: Light Characteristics: Position (WGS84): Comments:	7 Starboard hand mark Buoy, single green cone pointing upwards FL G(3s) 01°22.411N 172°56.065E needs urgent maintenance
