# IGC 5 TASK GROUP REPORT

## BUILDING CONDITIONING OF LIGHTHOUSES, ACCOMMODATION, OUTBUILDINGS AND ASSOCIATED STRUCTURES

2009

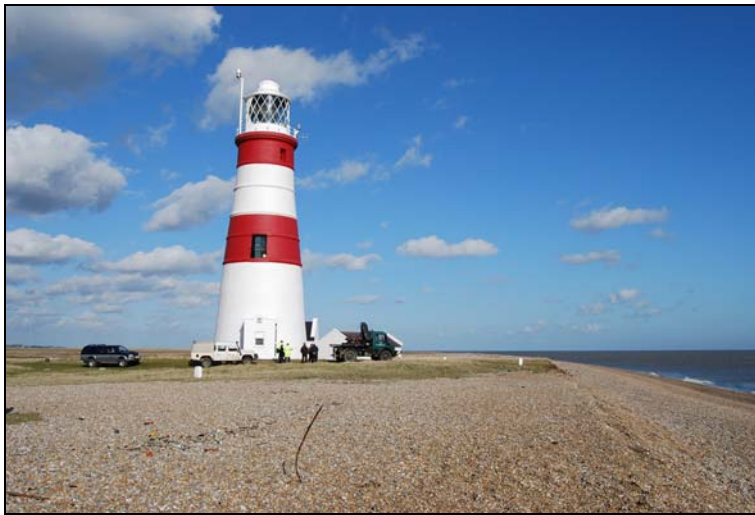
*Figure 6: Orfordness Lighthouse located on a shingle spit which is undergoing significant coastal erosion that will eventually jeopardise the structural stability of the tower*

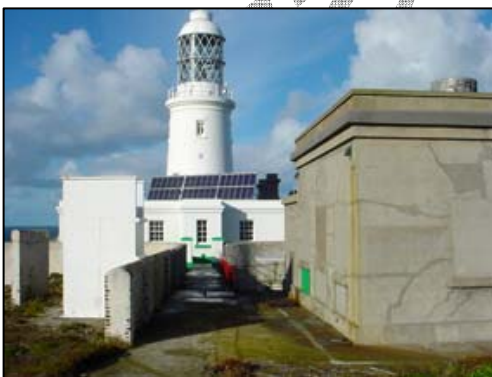
*Figure 7: An example of different categories of condition with the operational lighthouse painted while the non-operational redundant engine room in the foreground is left unpainted (Round Island – TH site 31 in Figure 8).*

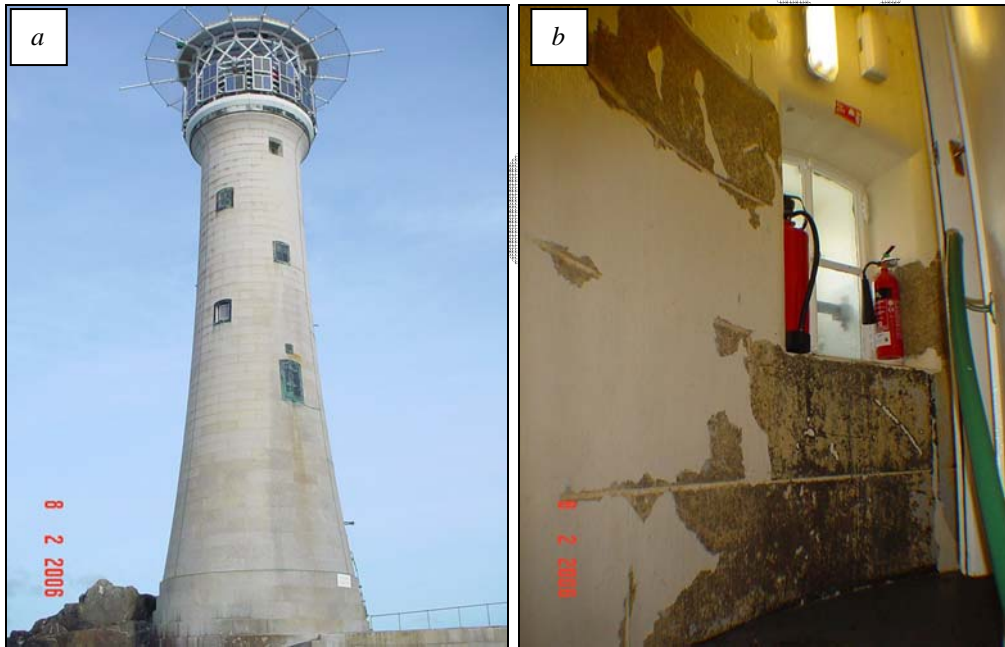
Figures 15: (a) Exterior of Hanois lighthouse and, (b) interior of the tower showing deterioration of painted surfaces

- Installation of a 'Premaberg' ventilator within the lower bronze window but fitted in such a way as to be reversible within the context of the historic integrity of the window frame.
- Opening of a disused vent in the gallery with fitting of a stainless steel revolving cowl to increase the draw of air up through the tower.
- Removal of all paint film on the walls of the staircase.
- Possible introduction of solar fans with the panel positioned in the staircase window and the fan fitted as required within the stairwell.
- With the exception of the engine room, all doors within the tower are to be kept open when personnel are not on station.

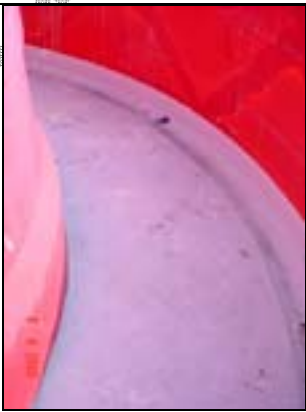
Blocked drains and gallery flooding

Regular monitoring of gallery drains is necessary to avoid blockage by debris and dead birds especially when the gallery is surrounded by a solid parapet. Existing drainage holes may need to be enlarged and/or new ones added to ensure the rapid and efficient removal of water.
Blocked gully in asphalt roof which can cause flooding of the roof and moisture ingress through flashings

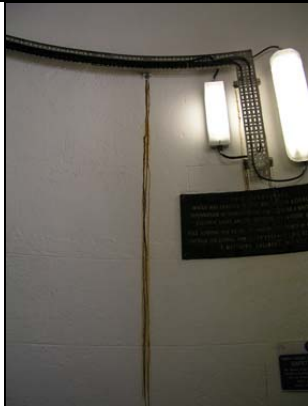
Repair defective lantern glazing. If the soffit plate is badly affected it may be removed if the building does not have listed status. However, if it is listed then the soffit plate may need to be replaced.
Corrosion of fixings behind a new stainless-steel tray with associated staining of adjacent painted surface

Where possible corrosion resistant stainless steel fixings should be used when attaching components to solid masonry walls especially external walls that may contain moisture. This should prevent corrosion and the problems associated with surface staining. When such corrosion staining does occur, all ferrous fixings such as old electrical fixings, nails, screws and exhaust manifolds should be removed and replaced, where necessary with corrosion-resistant equivalents.

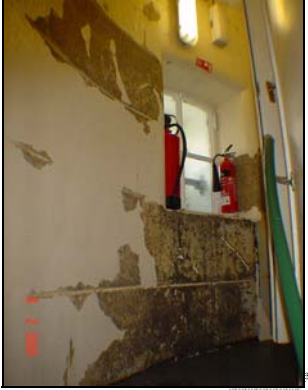
Staining of stonework associated with corrosion of embedded ironwork is the first sign of deterioration of ironwork which will eventually result in fracturing of adjacent stonework due to corrosion-related expansion of ironwork.
<b>Moisture Ingress &amp; Deterioration of Internal Surfaces</b>		
Flaking, peeling and loss of paint associated with moisture in masonry materials and excess surface condensation

If the building is not used for accommodation paint removal should be considered. This will allow affected masonry to 'breathe' and facilitate drying. Checks of the building exterior should be made for any defects that might facilitate moisture penetration. The situation may also be improved by increasing ventilation. If the building is required for accommodation then thought must be given to introducing or increasing the duration and extent of heating along with improved ventilation.

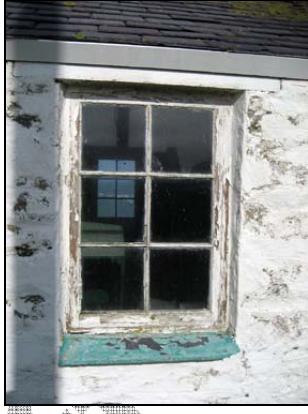
Description of Issue	Photo	Recommended Intervention
Salt-rich moisture penetration around window with breakdown of granite stonework and loss of painted surface	 	The problem was exacerbated in this instance by the presence of a disused duct cut into the external granite by the window casing. This allowed moisture penetration and saturation of the internal granite block. The duct should be sealed using a mix of granite dust and hydraulic lime mortar with excess salt and loose surface granite debris brushed off and removed. In extreme cases it may be necessary to 'dress back' and reface the affected portion of internal stonework in order to prevent further deterioration.
<b>Woodwork / Joinery</b>		
Rotting of window joinery due to breakdown of protective paint cover

Regular application of paint will prevent initiation of wood rot and eventual penetration of moisture.
Weathered external paintwork on joinery elements	 	Opening of joints in woodwork, if neglected, will eventually allow moisture penetration and possible initiation of rot.
