# Building Conditioning of Lighthouses, Accommodation, Outbuildings and Associated Structures

IGC5 TASK GROUP REPORT  
2009

# **IGC 5 TASK GROUP REPORT**

## **BUILDING CONDITIONING OF LIGHTHOUSES, ACCOMMODATION, OUTBUILDINGS AND ASSOCIATED STRUCTURES**

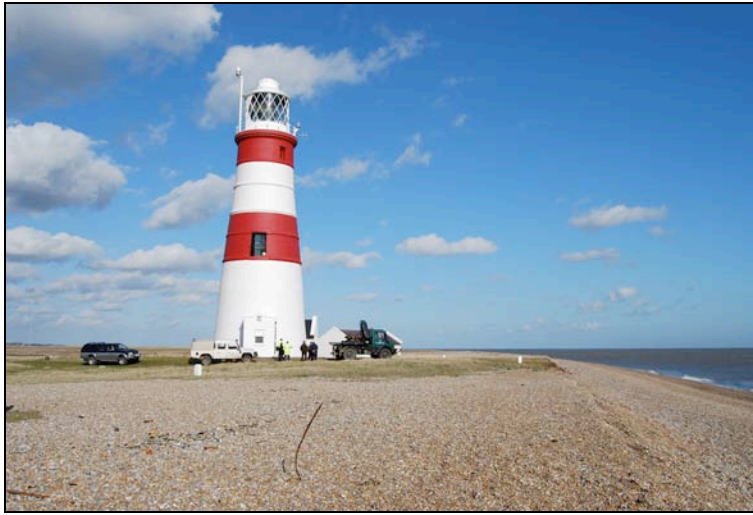
*Figure 7: Orfordness Lighthouse located on a shingle spit which is undergoing significant coastal erosion that will eventually jeopardise the structural stability of the tower.*

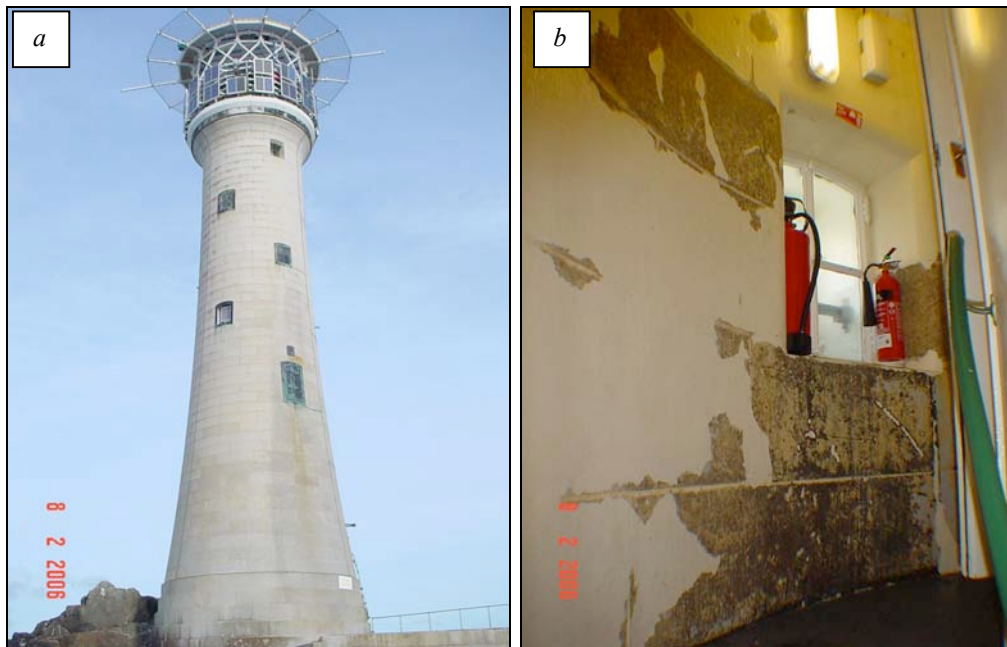
Figures 16: (a) Exterior of Hanois lighthouse and, (b) interior of the tower showing deterioration of painted surfaces.

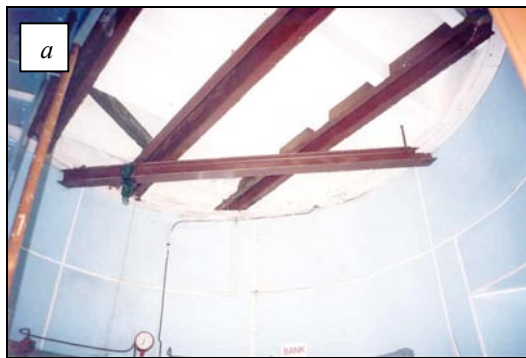
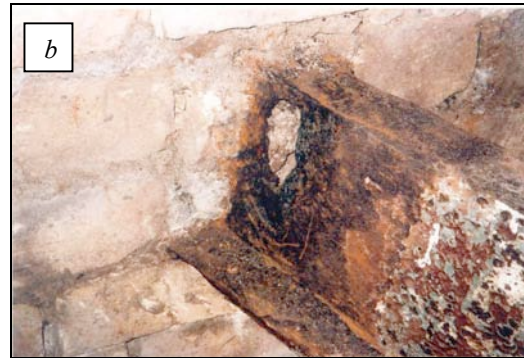
Figure 19: (a) View of ‘Wearite’ dry-lining and steel beams and timber floor joists; (b) severely corroded steel beam end behind the ‘Wearite’.

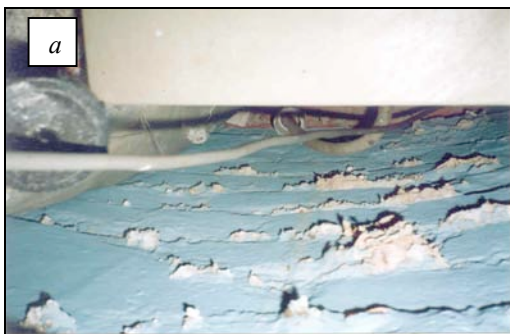
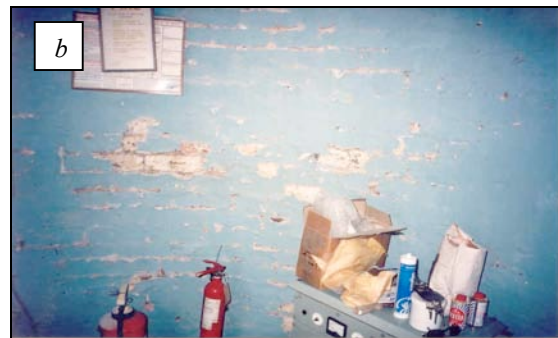
Figure 22: (a) Well-developed salt efflorescence associated with mortar lines on internal walls illustrating the effect of long-term salt-rich moisture ingress and chemical interaction with components of the mortar to form complex sulphate salts; (b) salt efflorescence has contributed to deterioration of painted surface of internal walls.

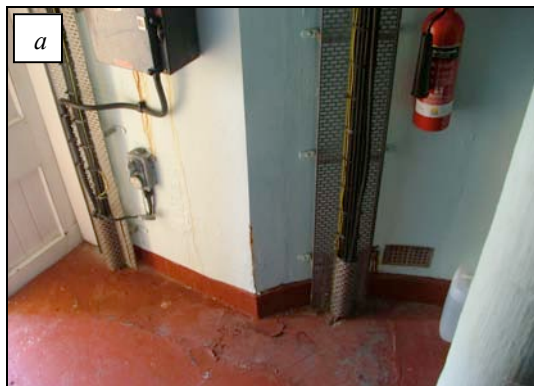
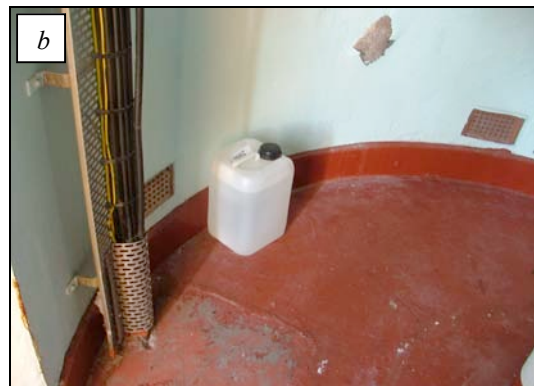
Figure 28: (a) Image showing corroded corner beading, flaking floor paint and corrosion related staining on walls; (b) example of flaking paint and bossed plaster.

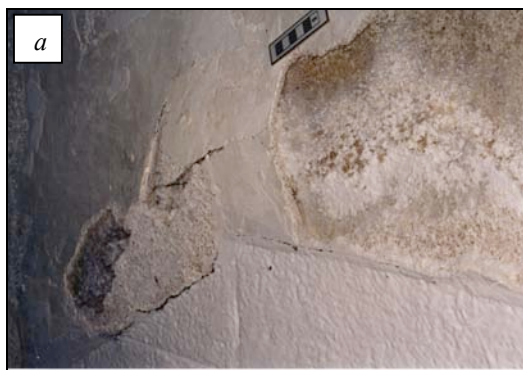
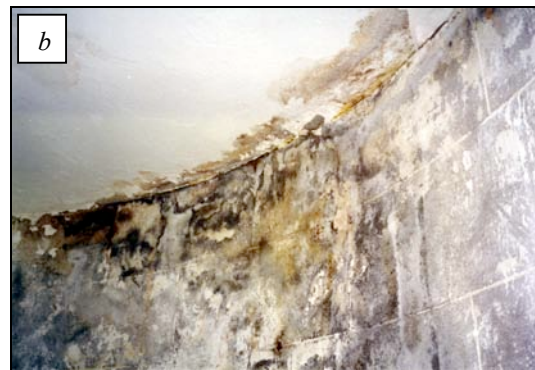
Figure 31: (a) Deterioration and breakdown of render associated with well-developed sulphate salt efflorescence; (b) staining of walls in the upper section of St. Peter's Tower caused by a combination of mould growth and corrosion from the service room above associated with moisture ingress from historic flooding of the lantern gallery.

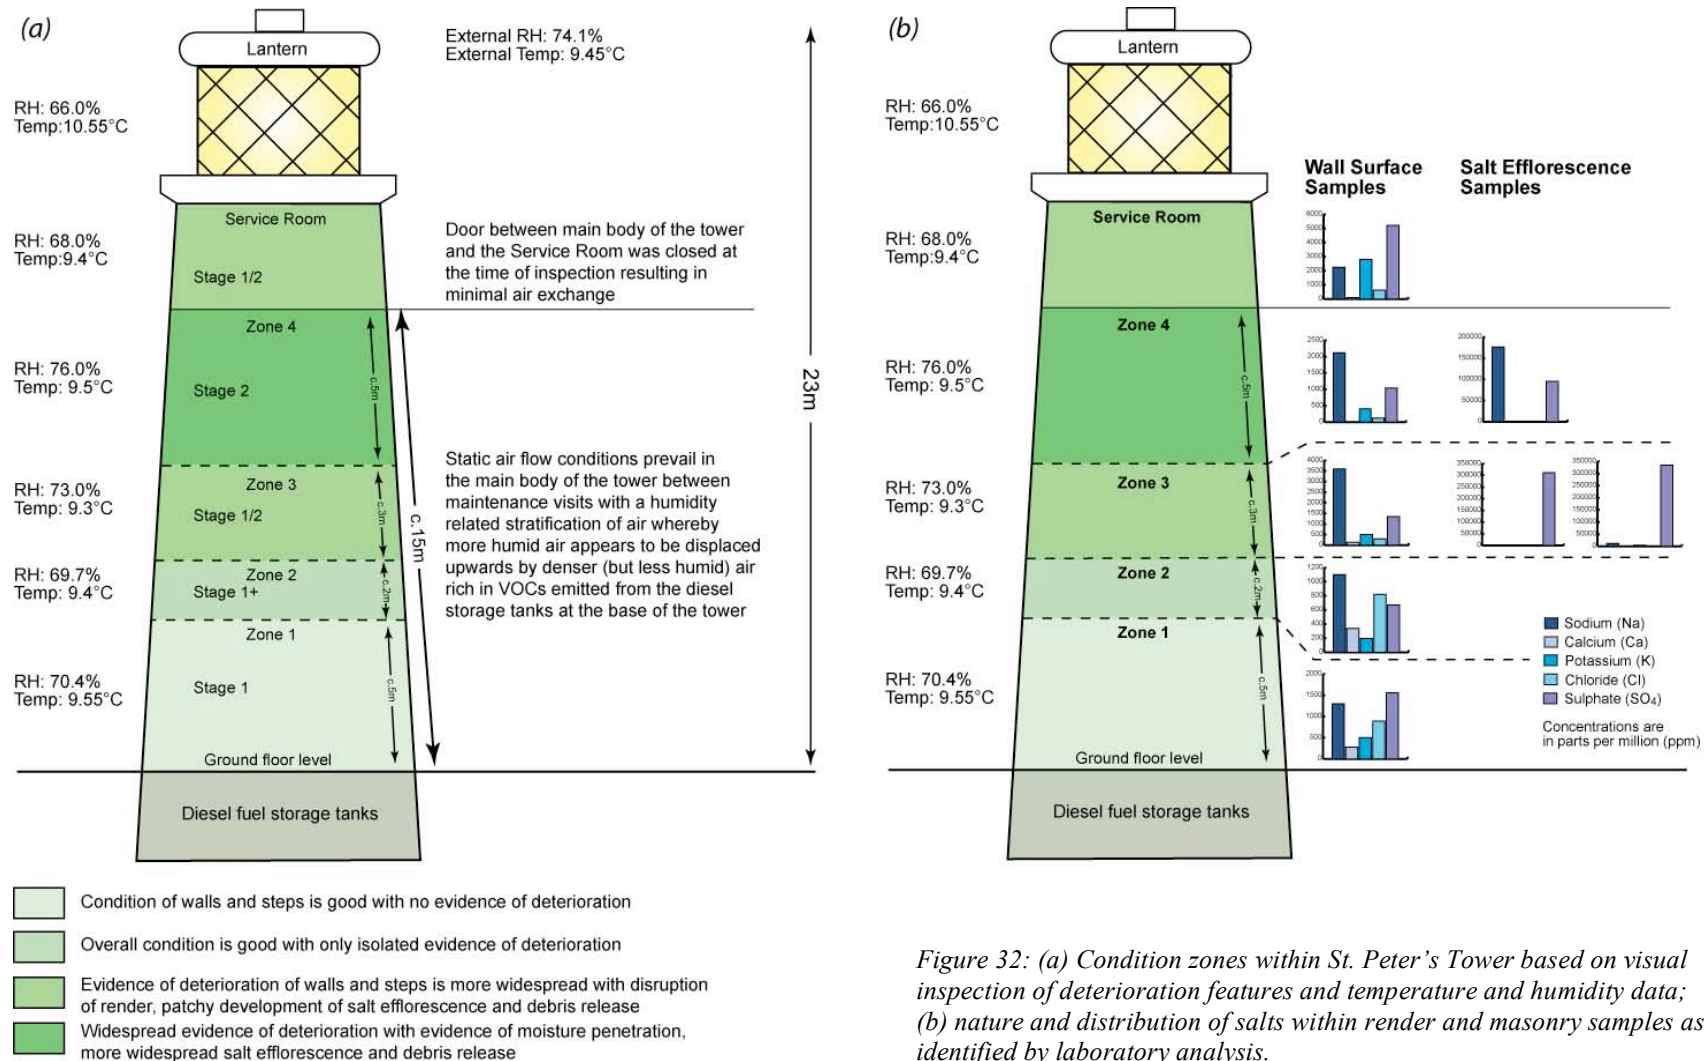
Figure 32: (a) Condition zones within St. Peter's Tower based on visual inspection of deterioration features and temperature and humidity data; (b) nature and distribution of salts within render and masonry samples as identified by laboratory analysis.

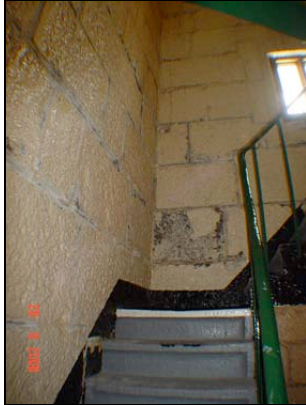
Moisture and salts preferentially drawn in through block joints and mortar resulting in emulsification (saponification) of alkyd (oil-based) paint. Check external wall surface for evidence of defects that may have aided moisture ingress and repair if present (e.g. defective external paint and/or degraded mortar). If the problem is widespread, paint should be removed to allow masonry to 'breathe' and release moisture.
Delamination of painted lining paper from a ceiling primarily caused by moisture ingress and poor internal ventilation

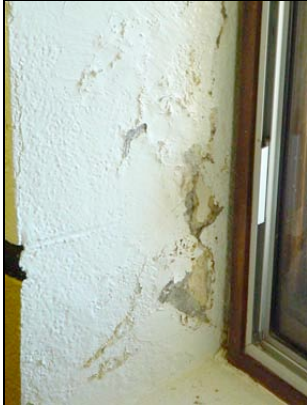
Water and salt ingress around window joinery resulting in destabilisation of painted surface associated with salt crystallisation. Identify and repair site or area of moisture ingress. Remove paint and loose material from affected area to facilitate drying. The area may need to be left unpainted for some time to allow the affected surface to stabilise.

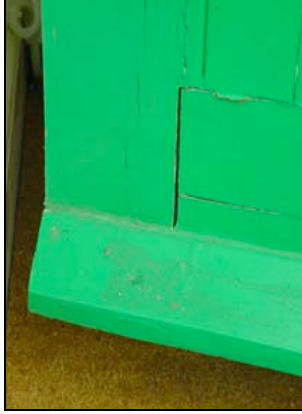
Opening of joints in woodwork, if neglected, will eventually allow moisture penetration and possible initiation of rot.
