Evaluation of  
Extreme Ice Forces  
on a Lighthouse  
in the Bothnian Bay

A study of the Björnklack  
overloading event in April 1985

VBB Project M7334

Final Report Jan. 15th, 1987

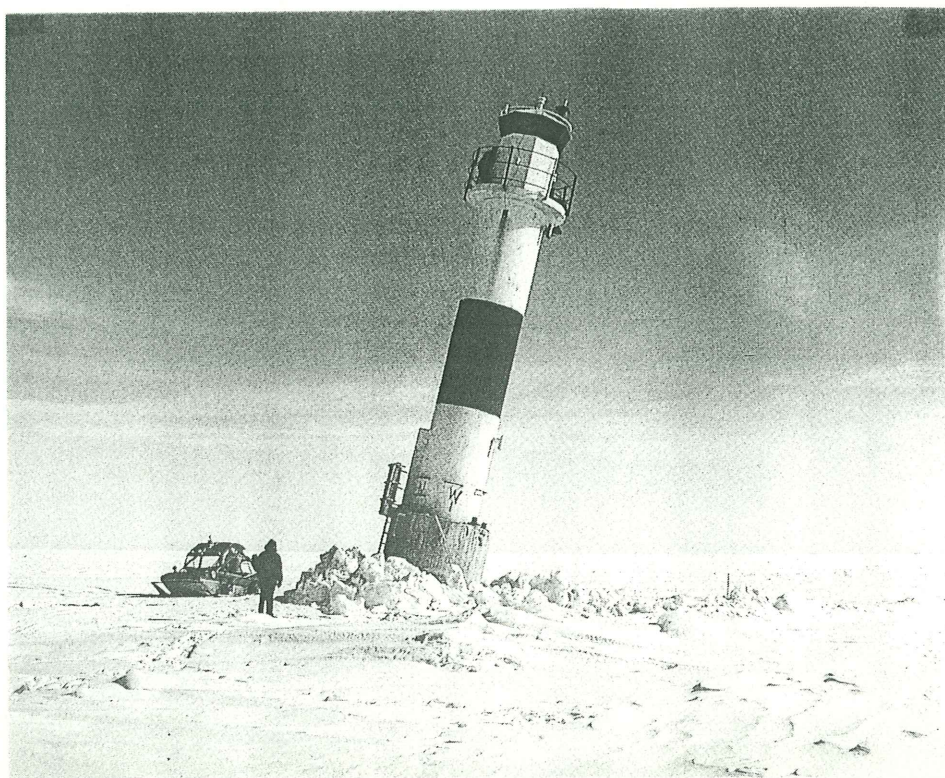
Figure 3.1 The frozen situation a few days after the overloading event

After 14 years without any damage the BJÖRNKLACK lighthouse became overloaded on the 4th of April 1985, when a large ice floe was pressed by wind drag and currents against the structure. After the ice floe, released from the surrounding continuous ice cover by a broken ice channel and two crossing cracks, had been somewhat indented by the lightpier, the ice thrust became too strong and the lighthouse was moved from its bed to a sloping part of the adjacent sea bed, where it came to rest in an inclined position as shown in Figure 3.1.

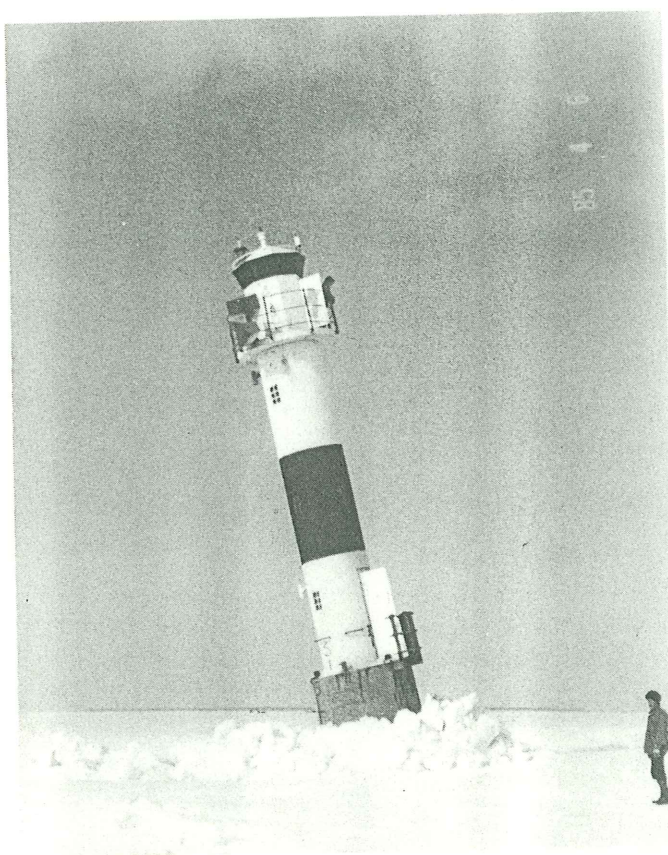
Figure 4.1 View from E, April 6th 1985

A few days after the overloading event the lighthouse and the surrounding ice cover were inspected by personnel from the Administration of Shipping as well as from the University of Luleå. The inclination of the lighthouse as well as the thickness of the ice cover at various points were measured and photographs were taken, Figures 4.1-4.3. On the 10th of April the university staff went out and collected ice cores for laboratory investigations.

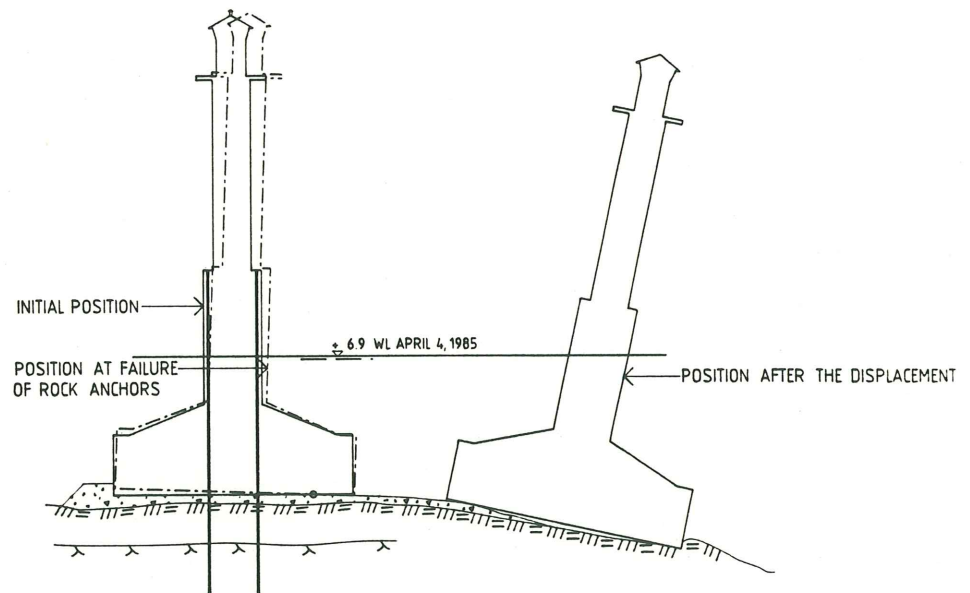
Figure 5.1 Reconstruction of the overloading event

- The lighthouse structure had been displaced about 17 m. All the rock anchors had ruptured at approximately the same level not far from the top of the cement grouted stone bed. No other damage was detected on the structure which had obviously slid southwards, first on the bed and then on the sloping sea bed, see Figure 5.1. The southernmost part of the stone bed had yielded. The structure had ploughed up some soil from the sea bed before it had come to rest with an inclination of  $12^\circ$  from vertical.

- The lateral displacement of the lighthouse has been preceded by an overturning movement, which is the primary cause of the failure of the rock anchors. (Figure 5.1)
- Before the tendon failure and probably when the major part of the base slab had been lifted off from the bed, the bearing capacity of the bed below the highly compressed southernmost part of the structure was exceeded. The failure of the bed had the character of a minor settlement combined with a lateral displacement of the order of 0,1 m in the ice force direction. (Figure 5.1)
- As a consequence of this motion the anchor force increased corresponding to the reduction of the distance to the centroid of the vertical pressure on the bed. At the same time the lateral displacement introduced bending stresses in the strands due to the angular rotation at the lower face of the base slab. (Figure 5.3)

The level arm between the centre of the lighthouse and the centroid of the ground pressure is estimated to be 5.0 m  $\pm 5$  per cent (see Figure 5.1).

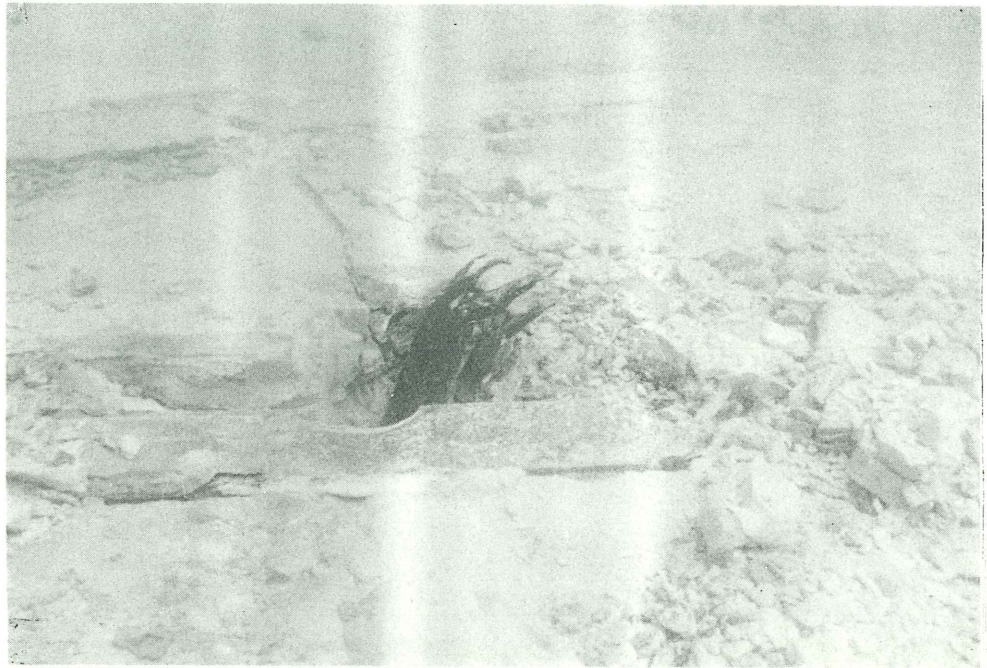
Figure 5.2 Part of grouted stone bed with protruding ends of a ruptured rock anchor tendon

-All the strands protrude between 10 and 15 cm from the top of the grouted stone bed (see Figure 5.2).

- The strands have been bent southwards corresponding to a lateral displacement of about 10 cm. The bending radii below the surface of the bed are relatively large since the strands have indented the bed, but smaller bending radii were observed at the ruptured ends of the strands (see Figure 5.3).
- The strands were not affected by corrosion.
- The ruptured ends of plastic sheaths around the strands have been extended before the rupture and displaced southwards. (The elongated ends of the sheaths, which can be seen in Figure 5.2, should not be mistaken for strands.)

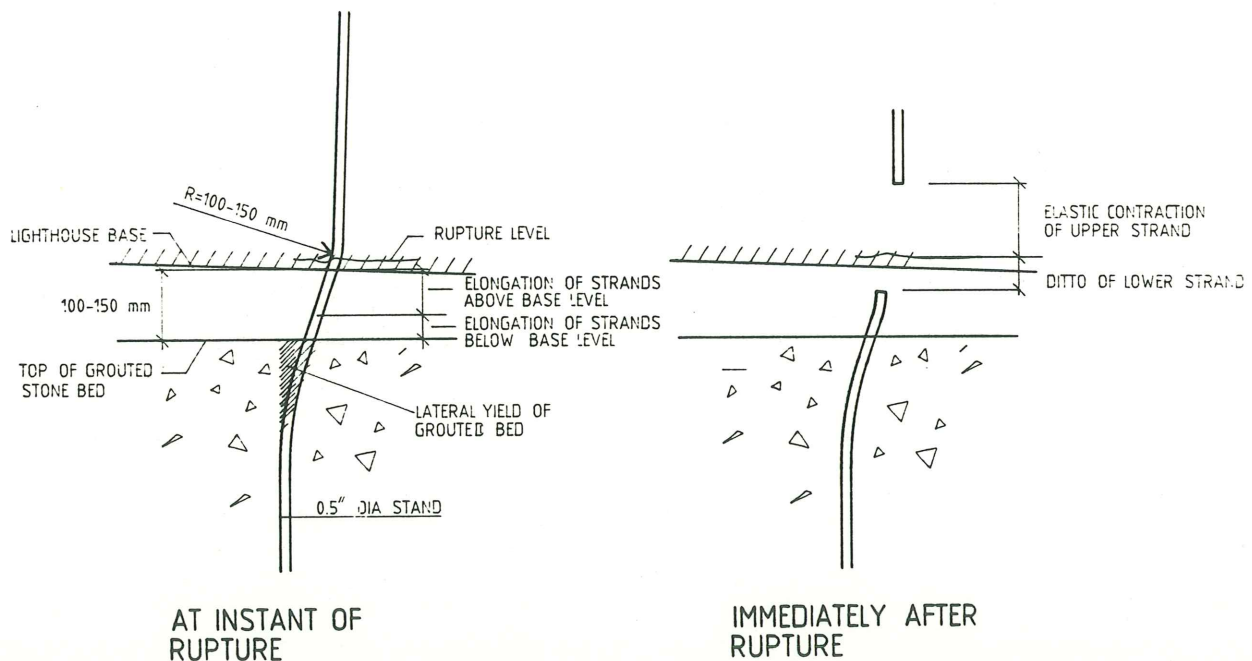
Figure 5.3 Failure mode of rock anchor strands

- After the first rupture due to the ultimate strain level being exceeded by the order of 6 per cent by combined tension and bending, the rest of the strands have failed one by one due to progressing overloading after taking over the load from previously ruptured strands.

- The ends of the ruptured strands, protruding 0.10-0.15 m from the bed, indicate that the strands were stressed along their whole lengths somewhat over the elastic limit before failure (see Figure 5.3).

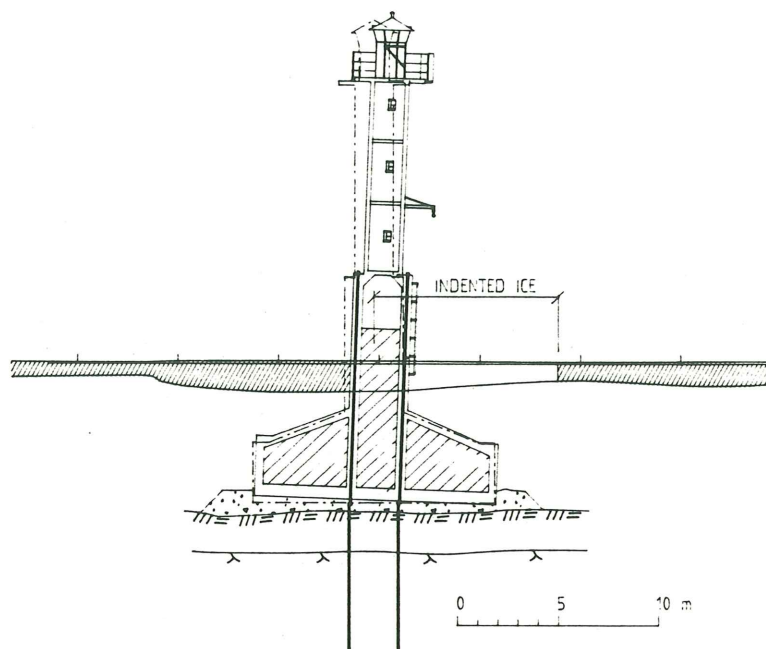
Figure 6.1 Ice profile along the centre line of indentation at the instant of anchor failure

It is obvious that the ice was crushed along the path of indentation. The almost linear increase of the ice thickness until the point of structural failure indicates that the structural failure load corresponds very closely to the limit force for crushing of the ice sheet.

As indicated by the ice cores, the ice cover had a composite structure. The upper part consisted mainly of five or more layers with a nearly uniform thickness of about 60 mm. The layers seemed to be bonded tightly together. The lower part consisted of homogeneous columnar ice. Apparently the layering of the ice had been caused by repeated rafting at an early stage, maybe initiated by the lighthouse when obstructing the drifting ice.

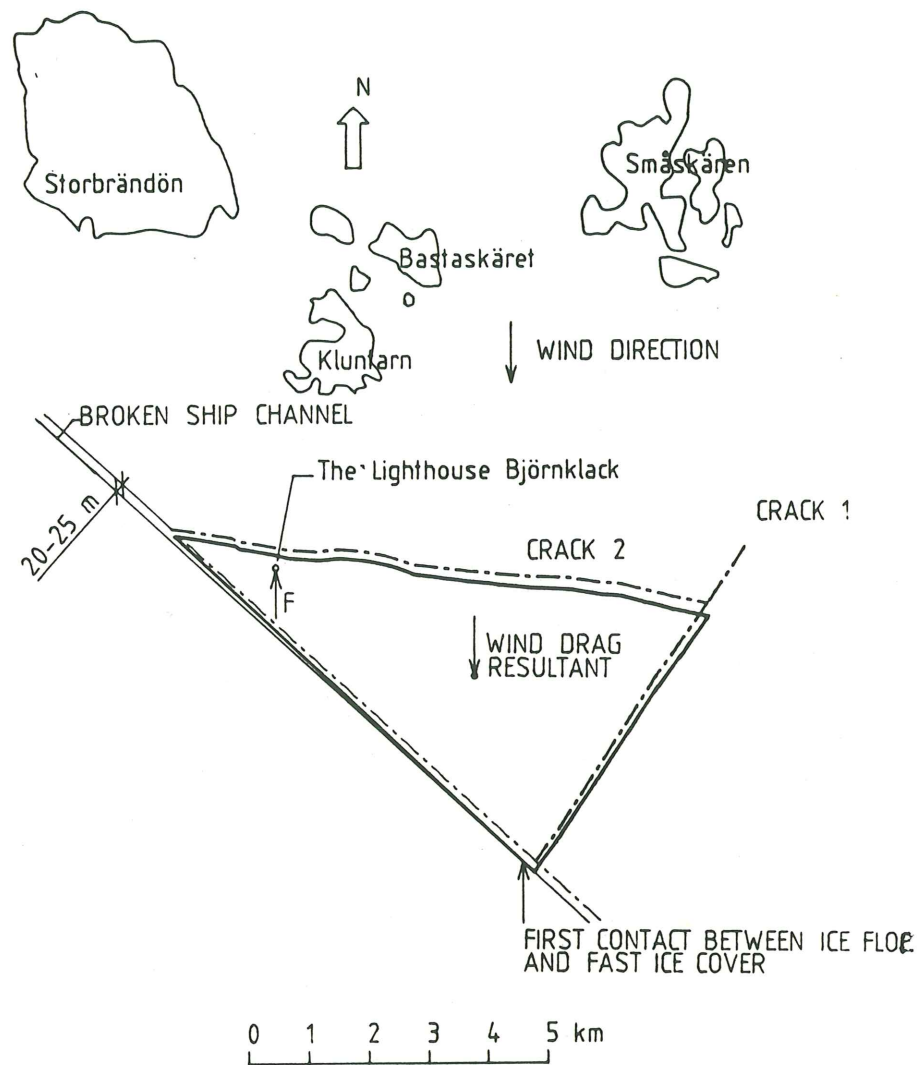
Figure 7.1 Ice situation at the BJÖRNKLACK site at the instant of overloading. (Channel width and ice floe displacements enlarged)

The large triangular ice floe illustrated in Figure 7.1 and further described in Appendix 1 had a surface area of 20 km<sup>2</sup>. According to observations crack No. 1 initially opened. After the development of crack No. 2 the strong wind forced the ice floe southwards. The movement was first restricted only by the lighthouse, inertia and possibly water drag. There was probably a rotation of the ice floe before its south-east corner was stopped at the southern edge of the ice channel. Since the lighthouse indented the ice about 6 m, it was probably free to rotate at least at the moment when the lighthouse was overloaded.

The geometry of the ice floe and the support conditions are roughly sketched in Figure 7.1. If, tentatively, the drag coefficient  $C_d$  is derived from Eq. (5) on the basis of these geometrical assumptions, the value  $C_d=0,019$  is obtained.
