# Aids to Navigation Risk Assessment in the Pacific; Kiritimati, Kiribati

This study is the risk assessment as part of the technical support for Kiribati which is the pilot country of the project. The risk assessment process is a structured approach to plan, manage and review the AtoN service effectively. Given the low quality and quantity input for the tools for the Pacific region, the IALA simplified version of risk assessment tool was tested to maximize the effect while the other IALA tools couldn't be used, and give a chance to raise the awareness of the safety of navigation.

An AtoN risk assessment workshop for Kiritimati Island was held on 13 Feb, 2017. The workshop was attended by 12 participants, representing the users, authorities, and stakeholders. It was a meaningful event to be aware and discover the potential risks, and to evaluate them by various perspectives.

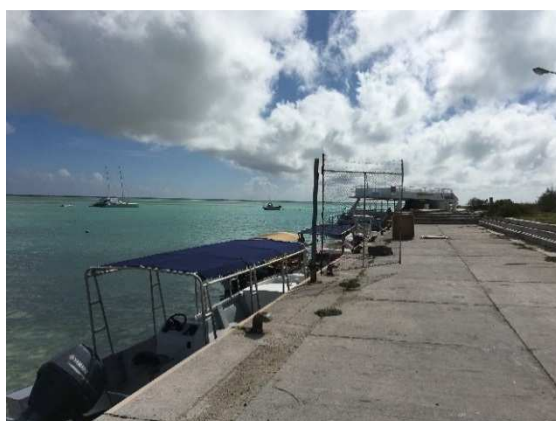
Approach to the port of London is very shallow because of the siltation which hasn't been scientifically measured yet.

Figure 6 Port of London

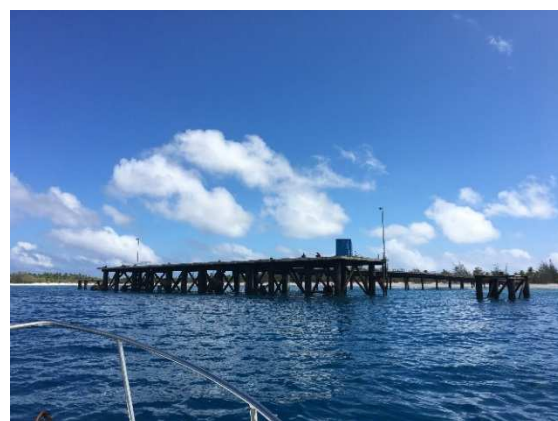
The Kiribati Port Authority (KPA) jetty is placed outer island on the 10m contour depth line. Container vessels (typical capacity 519 TEU) visit the port every 2-3 months.

Figure 7 KPA jetty

Pilot is on board, but still the severe high waves and swells make it difficult to come alongside the jetty. The probability and impact are moderate and they could be reduced by proper AtoN.

The definition of Allision is striking of a vessel against a fixed man-made object. The main jetty of KPA is placed on the outer island and exposed to swell and big waves from the ocean. Under this geographical circumstance, its structure itself present a continuous hazard for the vessels navigating across and approaching. In 2000, there was an unreported about 10m high swell incurred onto the jetty, and it swept away the upper structure and containers on the top of the jetty.

This kind of natural disaster cannot be prepared for before the structure is moved into the lagoon, but at least, beacons to mark the end of object could be installed to be recognized at night time.

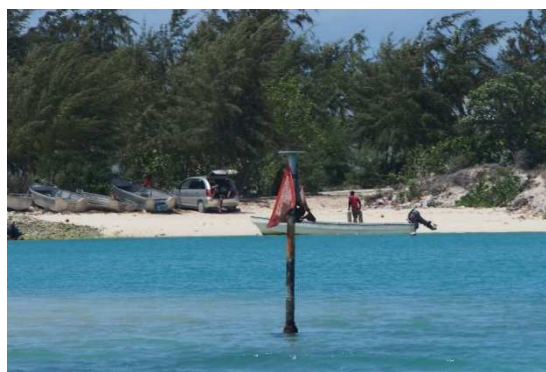
Figure 9 Non-IALA compliant beacon

The only AtoN charted on the islands is the Kiritimati Atoll (M8536 in ADLL Volume M), but the light has been temporarily discontinued for the moment. Two beacons in front of the London ports are installed but not properly maintained. One buoy is installed to mark the locations of the wrecks.

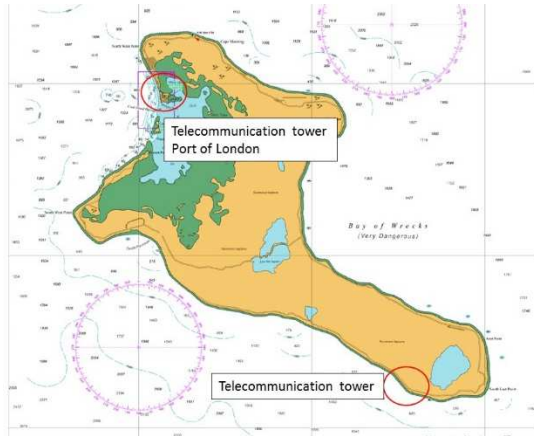
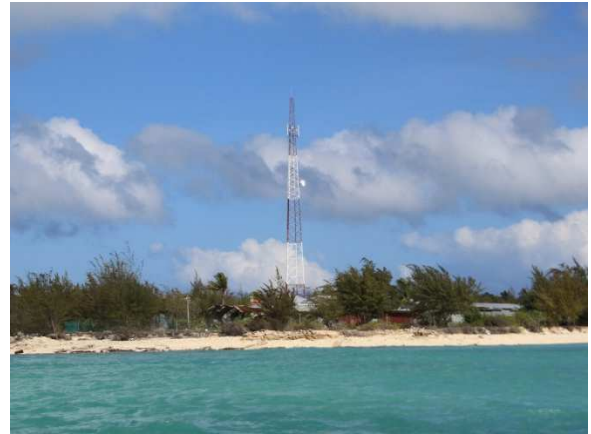
It was also presented that due to the low-lying terrain and lack of shore lights on the islands, local fishermen lost sight of land at night if they were more than 2 NM offshore. Landfall lights were considered necessary in at least two locations. One could be on the top of the telecommunication tower in London, and the other one on another tower in the south.

Figure 10 Telecommunication tower

Figure 11 Landfall lights potential locations

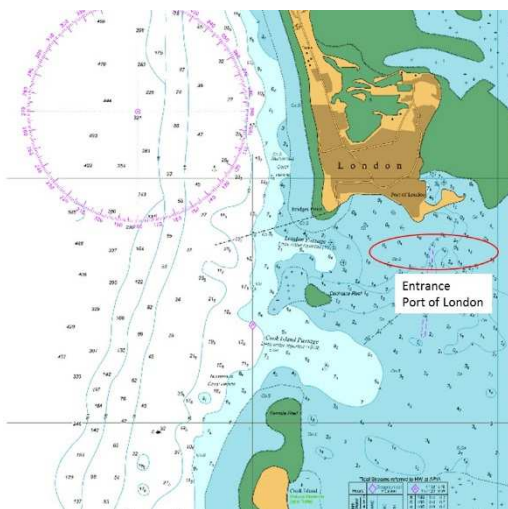
The main entrance to the London port was marked with six buoys, which were lost in bad weather about 10 years ago. There is a need to re-mark the locations for the yacht and small vessels. And, it was agreed that the wave breaking point on the south end of the north passage should be marked with a beacon. And, the KPA jetty could be marked with a beacon for the cargo and container ships approaching to the facility.

Figure 12 Entrance to the port London

Moreover, AIS Base station could help the Marine Division and KPA to get the necessary information to compile the situation. It is suggested that this could be improved significantly by the installation of VHF AIS Base Stations.

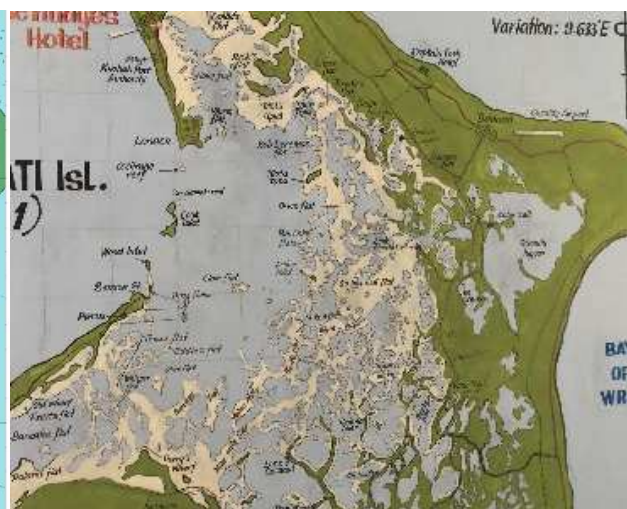
The anglers move to many flats to fish and the vessels rely on their local knowledge, the numerous flats should be marked with simple type of beacons. At least, 10 locations were identified from the anglers map.

Figure 13 Locations of the flats
