Evaluation of  
Extreme Ice Forces  
on a Lighthouse  
in the Bothnian Bay

A study of the Björnklack  
overloading event in April 1985

VBB Project M7334

Final Report Jan. 15th, 1987

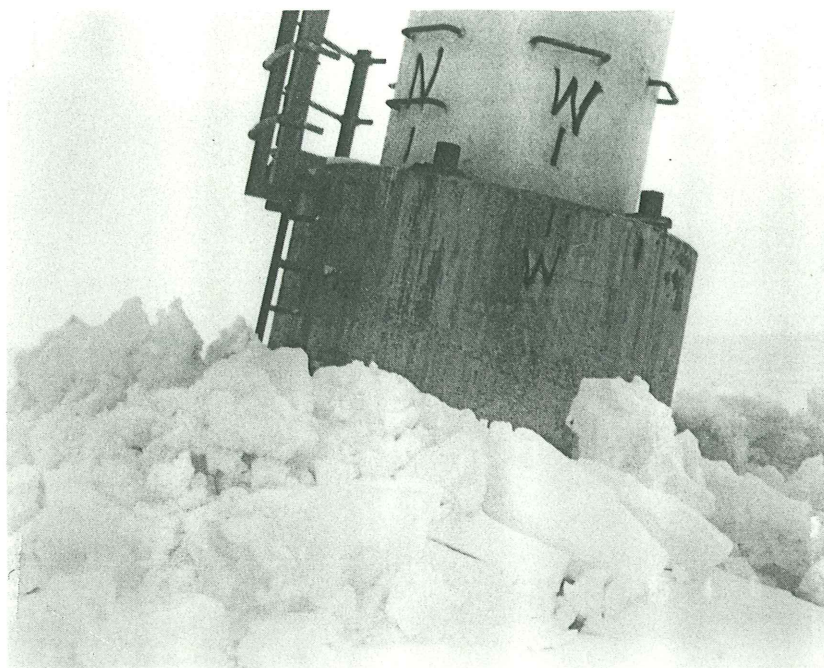
Figure 4.2 View from NW, April 6th 1985
