Evaluation of Extreme Ice Forces on a Lighthouse in the Bothnian Bay

A study of the Björnklack
overloading event in April 1985

VBB Project M7334

Final Report Jan. 15th, 1987

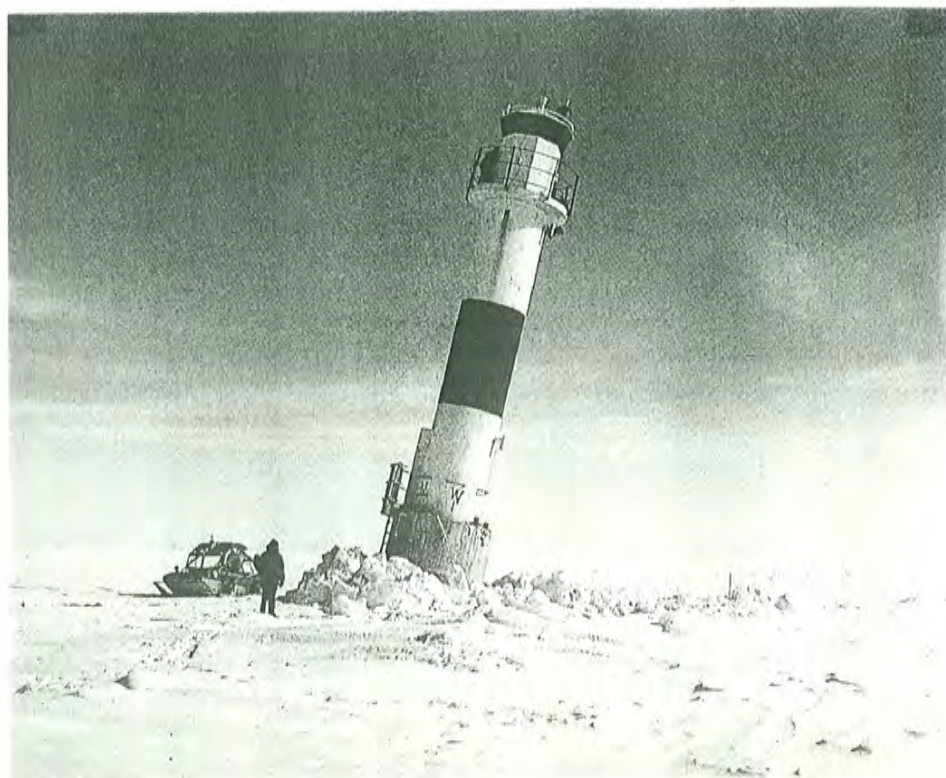
Figure 3.1 The frozen situation a few days after the overloading event

After 14 years without any damage the BJÖRNKLACK lighthouse became overloaded on the 4th of April 1985, when a large ice floe was pressed by wind drag and currents against the structure. After the ice floe, released from the surrounding continuous ice cover by a broken ice channel and two crossing cracks, had been somewhat indented by the lightpier, the ice thrust became too strong and the lighthouse was moved from its bed to a sloping part of the adjacent sea bed, where it came to rest in an inclined position as shown in Figure 3.1.

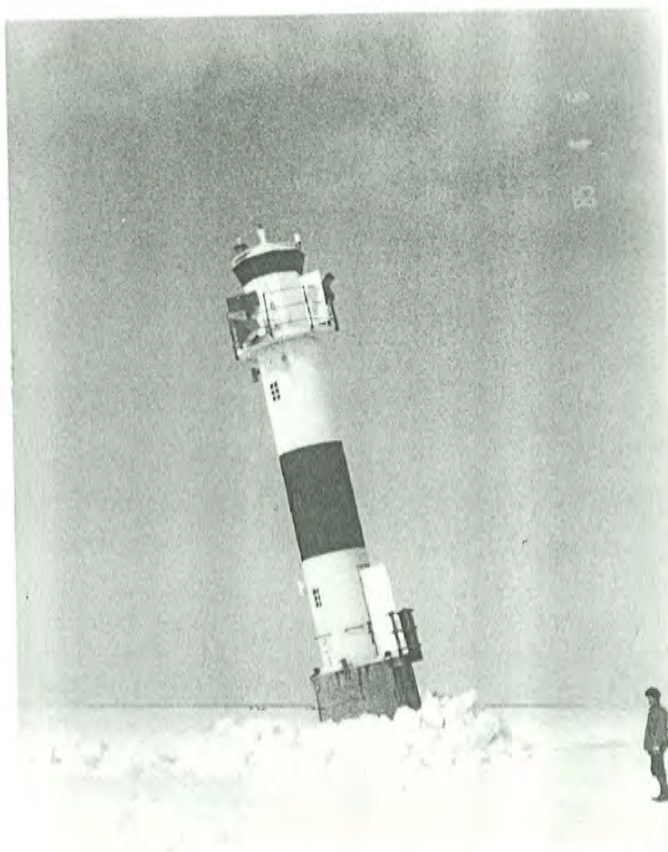
Figure 4.1 View from E, April 6th 1985

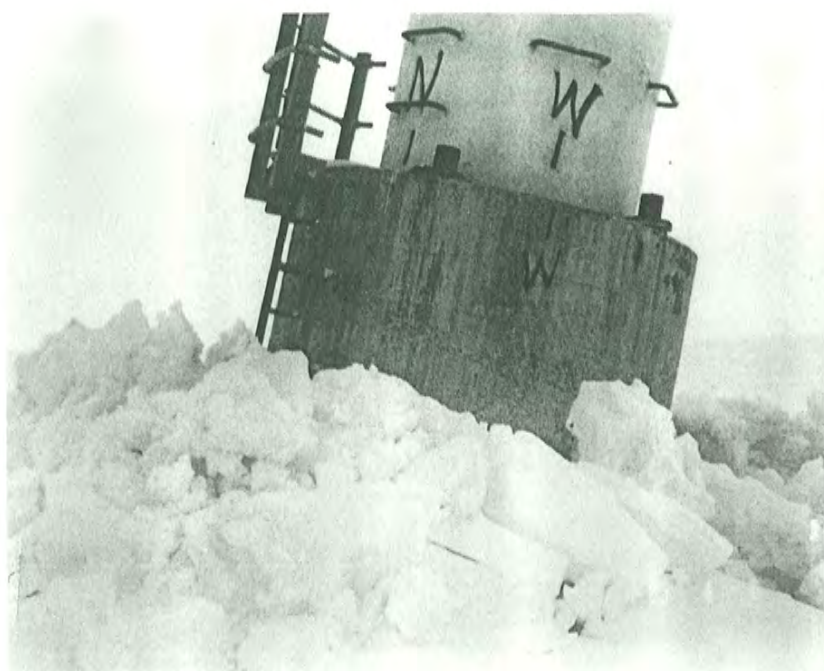
Figure 4.2 View from NW, April 6th 1985

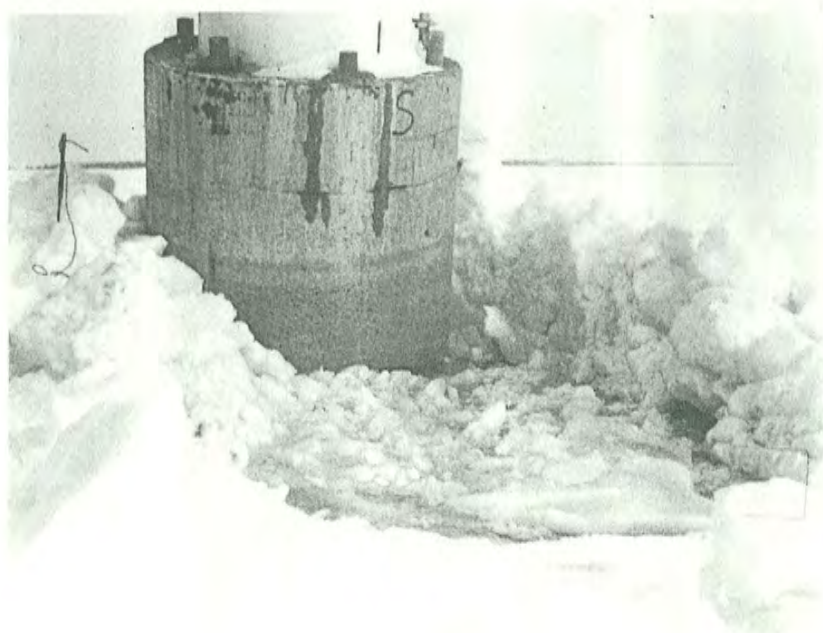
Figure 4.3 View from SW, April 6th 1985

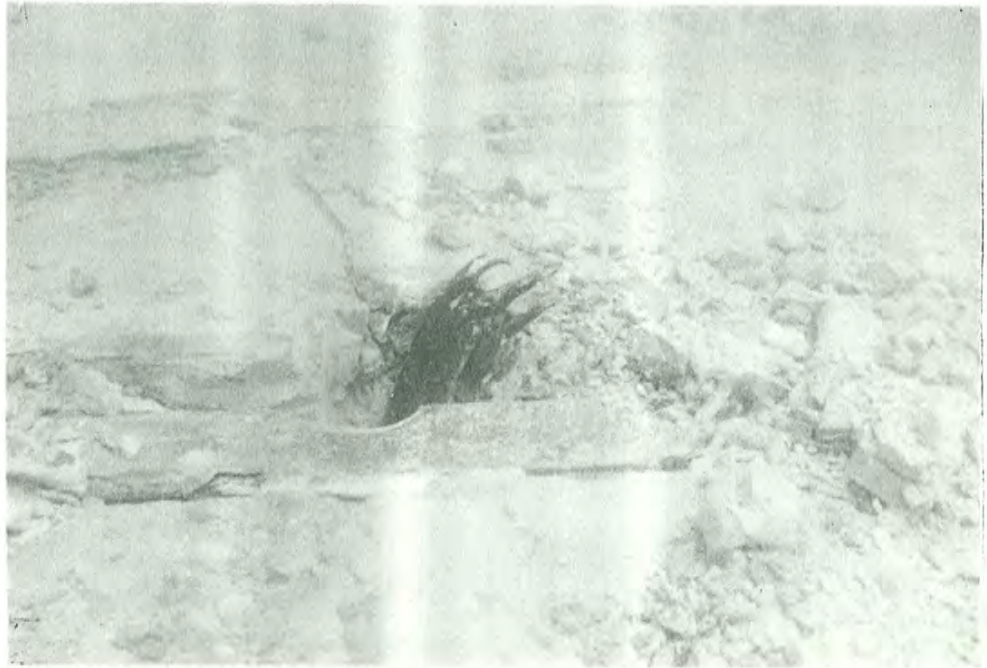
-All the strands protrude between 10 and 15 cm from the top of the grouted stone bed (see Figure 5.2).

Figure 5.2 Part of grouted stone bed with protruding ends of a ruptured rock anchor tendon

- The strands have been bent southwards corresponding to a lateral displacement of about 10 cm. The bending radii below the surface of the bed are relatively large since the strands have indented the bed, but smaller bending radii were observed at the ruptured ends of the strands (see Figure 5.3).
- The strands were not affected by corrosion.
- The ruptured ends of plastic sheaths around the strands have been extended before the rupture and displaced southwards. (The elongated ends of the sheaths, which can be seen in Figure 5.2, should not be mistaken for strands.)
