# IGC 5 TASK GROUP REPORT

## BUILDING CONDITIONING OF LIGHTHOUSES, ACCOMMODATION, OUTBUILDINGS AND ASSOCIATED STRUCTURES

2009

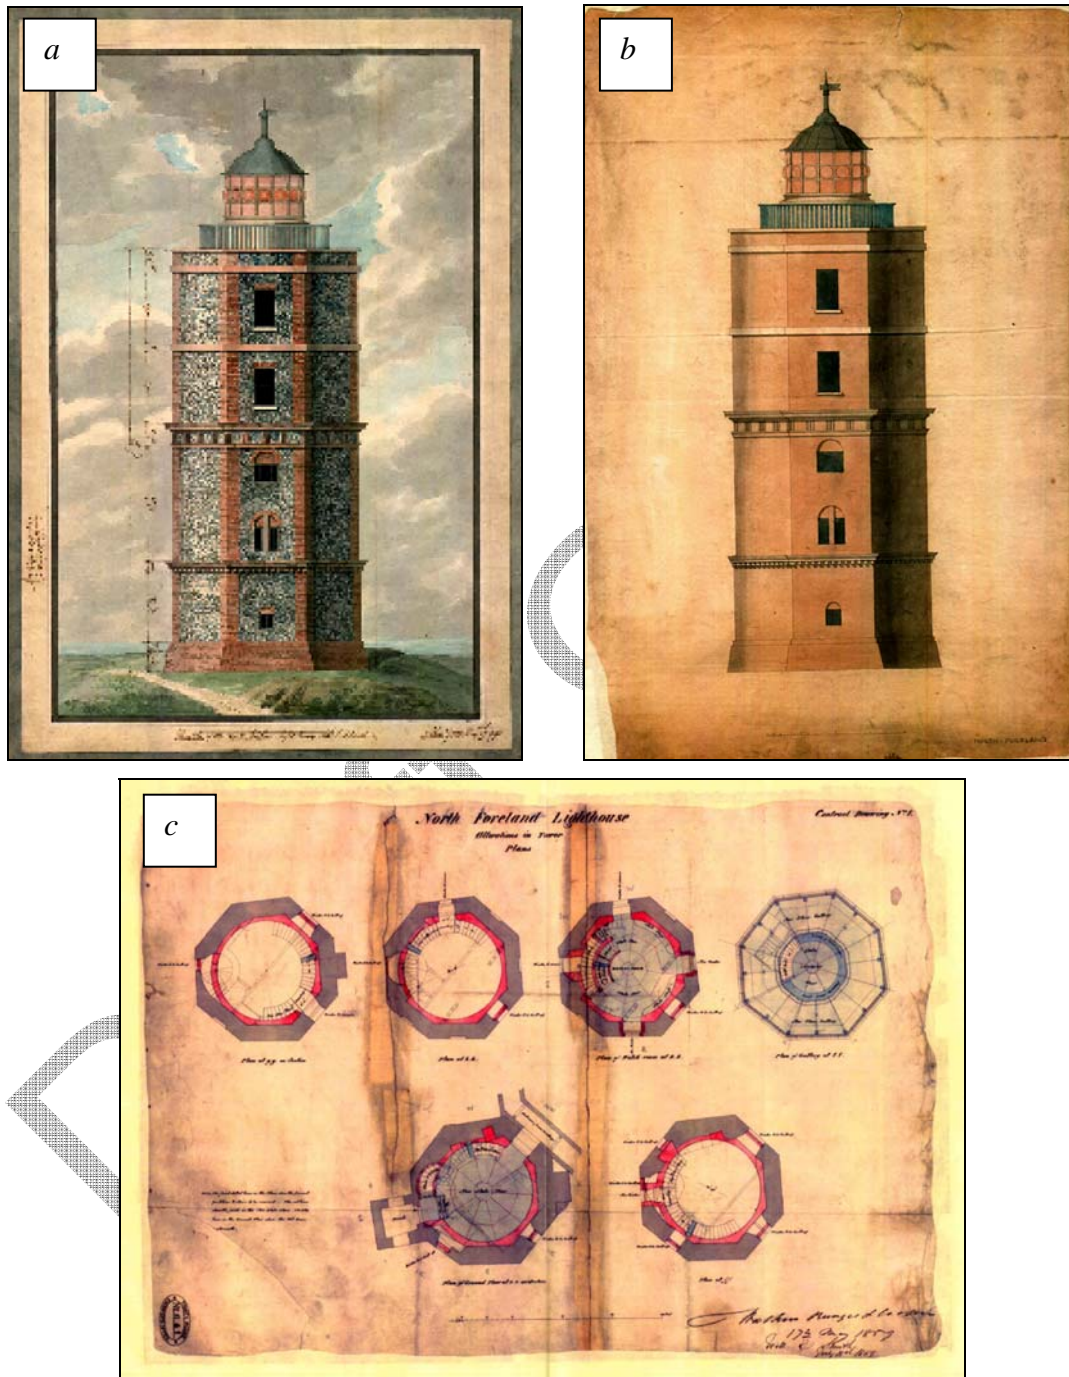
management with referral to archive drawings and plans e.g. North Foreland (Figures 5a–c) (TH site 13 in Figure 7). In addition, poor specification of material used in repairs and/or replacement can be the source of significant problems with the most common example being the replacement or repair of lime mortar with ‘hard’ cement, which lacks the flexibility and breathability of the original lime mortar.

Figure 5: Historic plans and drawings of North Foreland lighthouse provide a valuable record of significant structural changes that have had a major impact on present-day building conditioning. (a) The original flint and brick finish of the tower, (b) subsequent rendering of the exterior of the tower and, (c) construction of a rounded internal structure within the original octagonal tower which has given rise to considerable stresses between different masonry materials and problems related to moisture movement and reduced breathability.

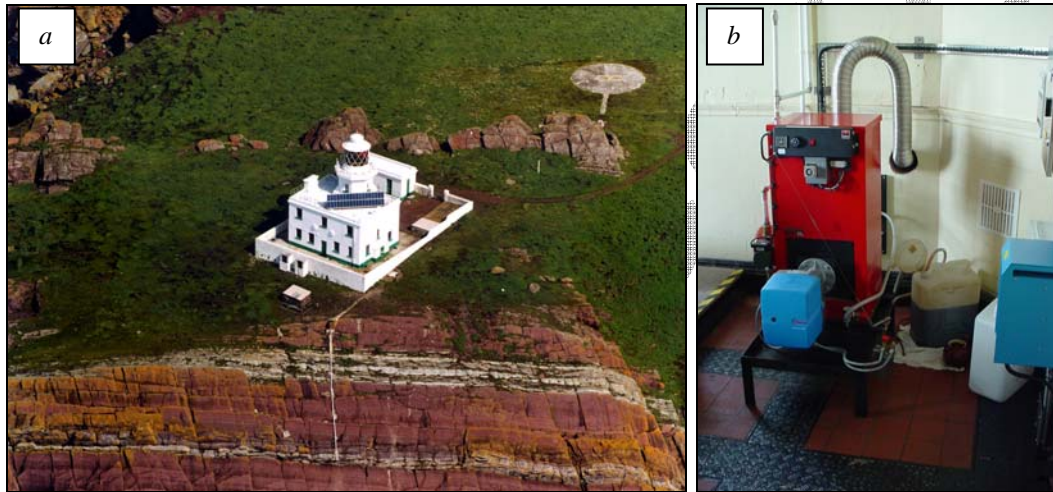
Initially building conditioning was reliant on a passive ventilation system but this proved to be insufficient with the spread of mildew and mould. To address this situation an oil-fired 'Kabola' boiler was installed and this provided two hours of heating per day (Figure 10b). Whilst the standard of building conditioning is not 'ideal', it has improved since the introduction of heating and is now of sufficient quality for personnel required to stay overnight. On-going monitoring of the internal condition of the structure will inform future decisions regarding any modification of the heating regime.

Figures 10: (a) Skokholm lighthouse and, (b) the 'Kabola' boiler providing additional heating for conditioning of accommodation

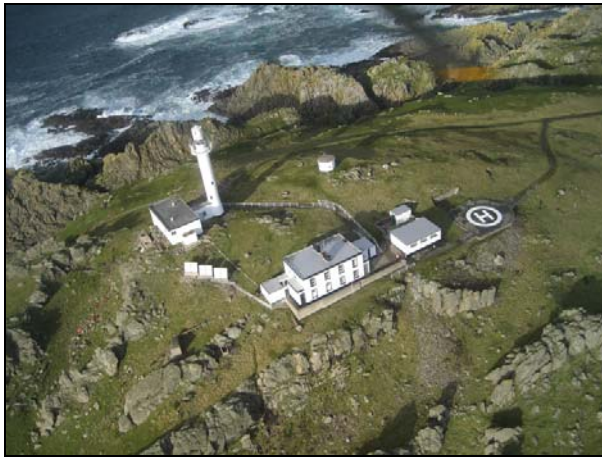
Figure 11: Inishtrahull Lighthouse complex

- Inishtrahull Lighthouse** – An EnviroVent Positive Pressure Ventilation unit was installed at Inishtrahull (Figure 11) with the power needed to operate it generated by a specially installed Air X Marine wind turbine that maintained a charged bank of batteries. As the selected building had a flat roof, the actual positive pressure ventilation unit was installed at ceiling level on the upper floor with an air intake filter fitted to remove salt and moisture in the in-coming air. Unfortunately, the Air X Marine wind turbine failed after a couple of months and was not replaced so the lifespan of the EnviroVent unit which is guaranteed by the manufacturer for 5 years or its success in terms of building conditioning could not be fully determined. During the short time that the EnviroVent Unit was in operation, some visiting personnel reported that the air delivered from the unit was cold and they requested that the unit be switched off when personnel were on station. However, anecdotal evidence indicated that despite the brief period of operation building conditioning did improve with a reduction in mould growth and a perceived reduction in damp.

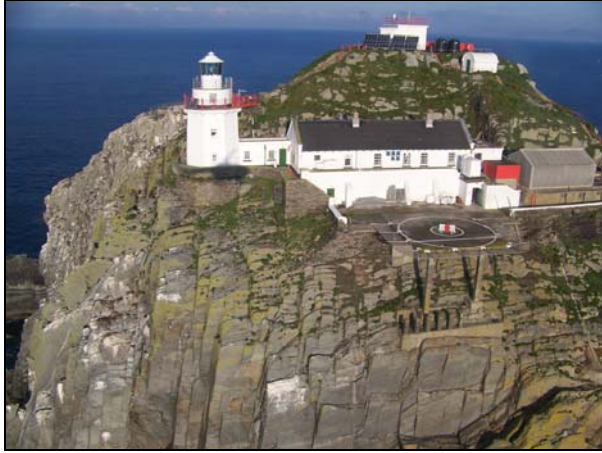
Figure 12: Bull Rock Lighthouse

- Bull Rock Lighthouse** – At Bull Rock (Figure 12) a Wallas 30D Positive Pressure Ventilation and Heating Unit was installed near a window in the accommodation building so that the balanced flue could be mounted within the window itself. A filter was also fitted on this unit to remove salt and moisture from the air intake. Power was supplied to the battery bank by solar panels. The positive pressure/heating unit was modified so that the 3kW heater unit functioned only when the relative humidity (RH) exceeded 80%. The RH figure of 80% was chosen as an analysis of the data from the stations showed that when the RH exceeded 80% the difference between the air temperature and the dew point was less than 5°C, and it is generally accepted that condensation tends to occur when the difference between air temperature and dew point is less than 3–5°C. At Bull Rock because of the location of a blowhole in front of the accommodation buildings and the almost continuous exposure to salt spray, salt accumulation and moisture penetration is a major problem around the front windows internally as well as externally. In addition, damp has always affected the bathroom at the rear of the property. However, installation of the Wallas unit seems to have cured the damp in the bathroom and has greatly improved conditions at the front of the building with initial feedback from attendants and service personnel being very positive with reports that air in the dwellings when

visited after being closed up for over a month was ‘fresh and sweet’. Unfortunately, although the Wallas unit is specified for operation in a marine environment they are not designed for continuous use and its fan failed after about two years but during that time it proved to be highly effective in terms of improved building conditioning.

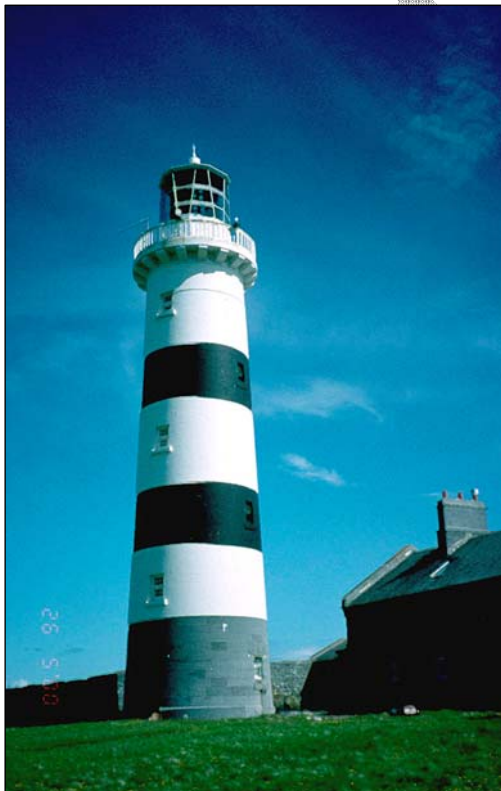
For example, monitoring identified the existence of a clearly defined stratification of humidity within Eeragh lighthouse (CIL site 41 in Figure 8) reflecting a ‘stack’ effect whereby warmer and drier air rises to the upper floors of the tower leaving cooler and more humid air in the lower levels (Figures 16a & 16b).

The design of this tower has created a natural stratification of humidity levels with approximately 10% difference between values in the upper and lower floors. Such differences in micro-environmental conditions will need to be taken into consideration during planning for improvements to the status of building condition.

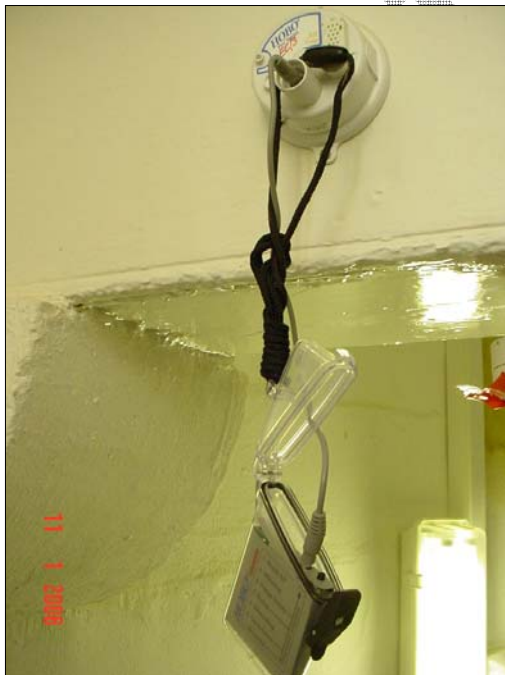
In order to understand the temperature and humidity conditions inside lighthouses, TH deployed HOBO data-loggers recording values every hour (Figure 17a). At North Foreland, for example, these were placed externally and internally in the mezzanine, within the tower itself and in the service room. Data extracted from these loggers gave information about seasonal and daily trends of air temperature, relative humidity and dew point (Figure 17b). The HOBO units are relatively cheap, unobtrusive and generally quite robust often providing many years of continuous service.

Figure 17a: HOBO data-logger in situ at North Foreland Lighthouse

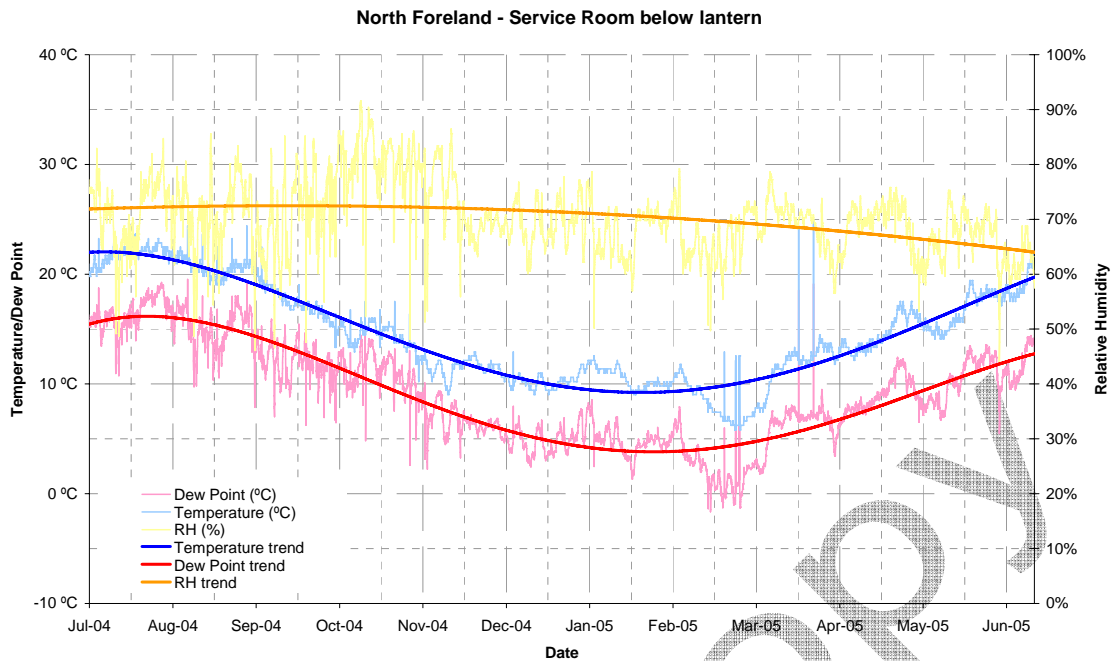
Figure 17b: This graph shows the seasonal trends in temperature, relative humidity and dew point data recorded by a HOBO unit in the service room in North Foreland during 2005 – 2006.

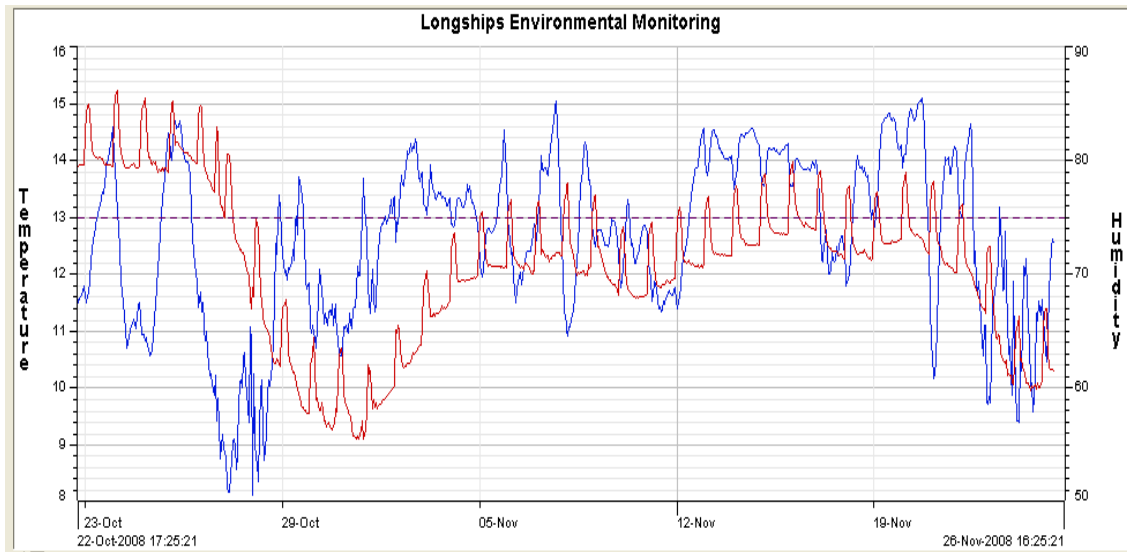
Figure 18 is an extract from the telemetry monitoring system covering a period of about one month from October to November 2008. It can be seen that each night the boiler raises the temperature of the service room with an associated reduction in the relative humidity thus successfully maintaining general humidity levels within a desired range that is conducive to the maintenance of good building conditioning.

Figure 18: Snapshot of air temperature (red line) and relative humidity (blue line) data from the Service Room in Longships Lighthouse showing the regular spikes in temperature resulting from the night-time activation of the heating system and the less regular fluctuations in relative humidity conditions within the tower that reflect both the internal heating regime and the influence of external meteorological conditions.
