# Building Conditioning of Lighthouses, Accommodation, Outbuildings and Associated Structures

IGC5 TASK GROUP REPORT  
2009

# **IGC 5 TASK GROUP REPORT**

## **BUILDING CONDITIONING OF LIGHTHOUSES, ACCOMMODATION, OUTBUILDINGS AND ASSOCIATED STRUCTURES**

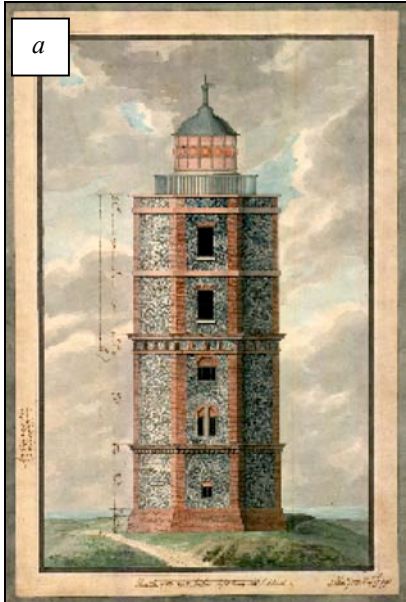
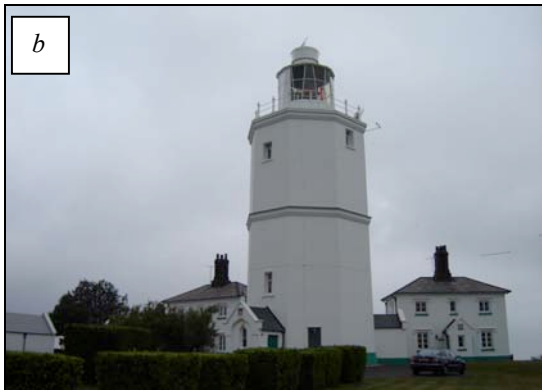
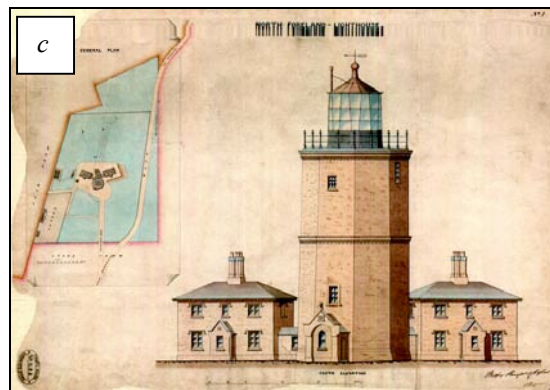
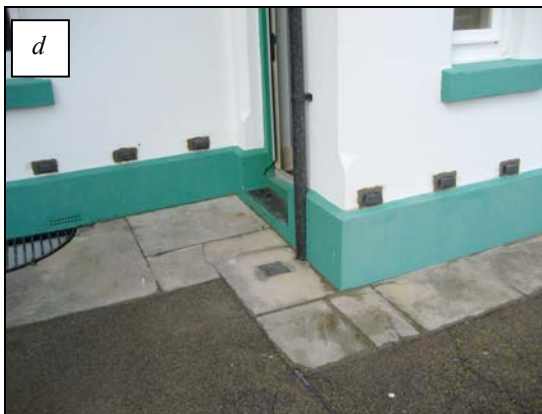
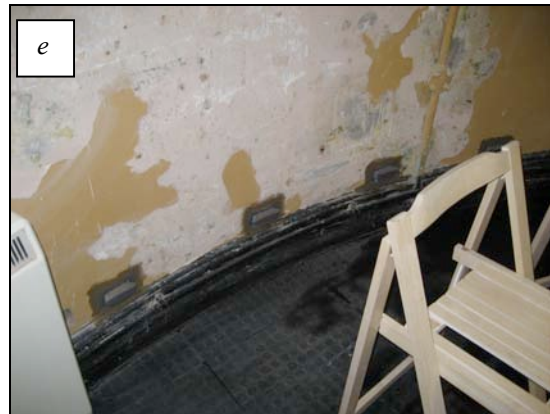
**North Foreland (TH)** – North Foreland is a land-based lighthouse located in east Kent (TH site 13 in Figure 9). This is a structurally complex octagonal tower originally built with a flint and brick finish (Figure 17a). Subsequent historic modifications included external rendering of the tower and construction of a rounded internal ‘skin’ within the original octagonal tower (Figures 17b & 17c). Unfortunately these modifications have given rise to the development of conflicting stresses between different masonry materials resulting in reduced breathability from internal and external surfaces, cracking of external render and moisture ingress.

Figures 17: (a) Historic drawing showing the original brick and flint external finish of North Foreland lighthouse with (b) and (c) showing the appearance of the tower after the application of cement render which has reduced the breathability of the original masonry mass and facilitated moisture retention. (d) regularly spaced external vents of the humidity control system inserted into the external walls approximately 400mm above ground level and (e) also inserted into internal walls to facilitate moisture removal and drying of internal surfaces. When painted these grey vents should not be visually intrusive. (The system used at North Foreland is the Schrijver System: [www.schrijversystem.com](http://www.schrijversystem.com))

In an attempt to reduce and control the moisture trapped within the masonry walls of the tower, a humidity regulating system is being trialled. The system consists of a stone element and a hole drilled into the wall which may be lined with a ceramic tube. A series

of these are inserted into the walls at intervals of 700mm (Figure 17d & 17e). The system operates by drawing dry air in through the surface vent directly into the hole which extends some 600mm into the wall. A cold bridge is created which draws moisture out of the masonry and this is subsequently removed by return airflow to the outside. This system was installed in the early part of 2009 and its effectiveness is still being assessed. It is important to note that if the building in question has listed status then approval will need to be sought from the relevant authorities for use of such a system.

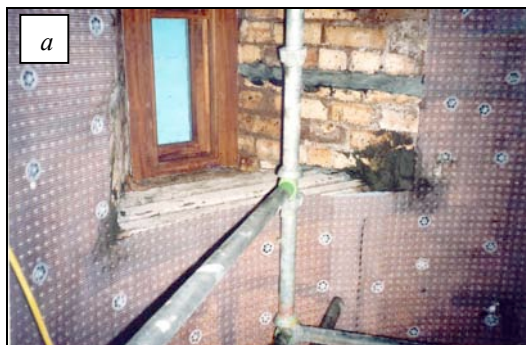
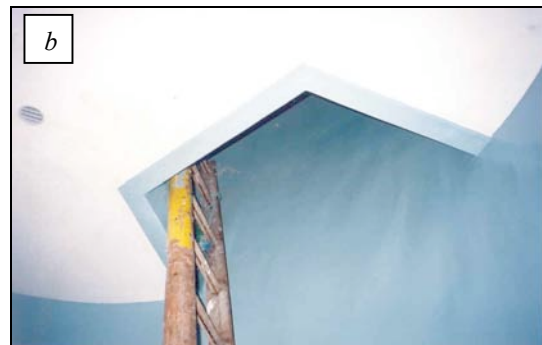
Previously gas powered, the lighthouse was generally ‘cold’ and prone to excessive dampness on interior wall surfaces, which were strapped and lined with a Formica-type material called ‘Wearite’. Although no obvious material deterioration within the tower was initially evident closer inspection behind the ‘Wearite’ lining revealed a very different situation with severely corroded steel beam ends and rotting timber floor joists and door/window frames (Figures 19a & 19b).

Figure 20: (a) Installation of ‘Delta Membrane System’ to stripped walls before plastering; (b) view of floor hatch after plastering and painting and before installation of new stairs.

Major refurbishment works were necessary to secure the long-term future of the tower. These works involved converting the lighthouse to mains electricity, replacement of compromised steel beams and floor joists and removal of the ‘Wearite’ dry-lining. In order to improve the internal conditioning of the tower the Wearite dry-lining was

replaced with a ‘Delta Membrane System’ which provided a sound over-paintable plastered surface that still allowed external walls to ‘breathe’ (Figures 20a & 20b). Storage heaters were also installed along with permanent ventilation, which promoted circulation of warm air within the tower.

Refurbishment appears to have been reasonably successful with sound painted internal surfaces and no evidence, to-date, of excessive dampness.

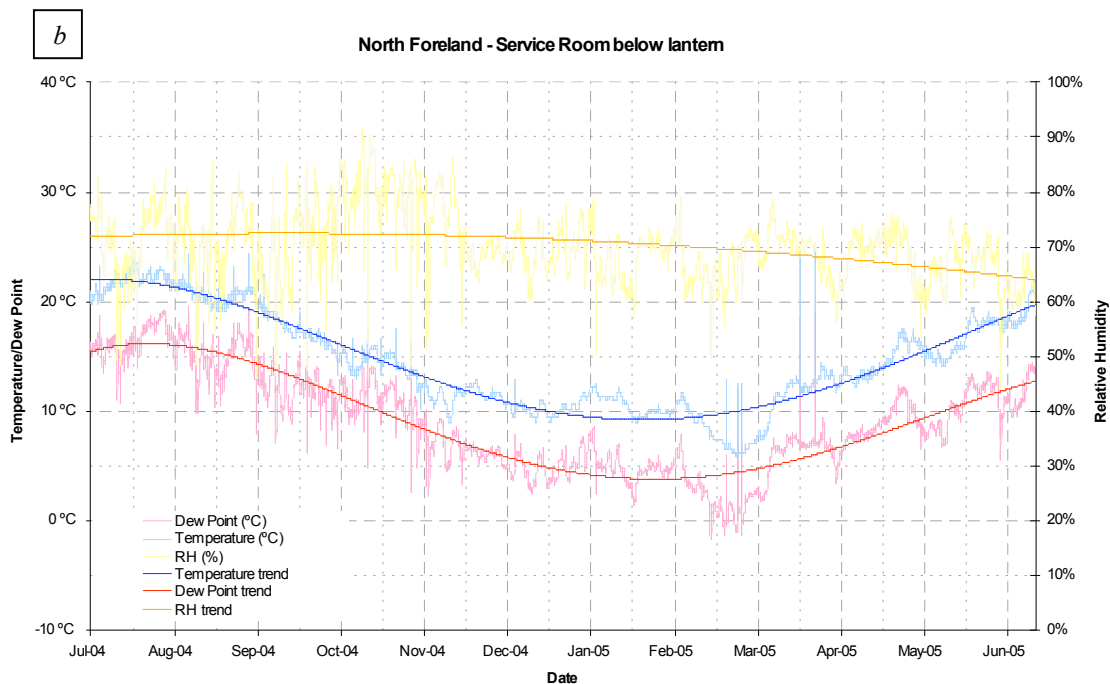
Figure 23: (a) HOBO data-logger in situ at North Foreland Lighthouse positioned on the wall above the doorway and, (b) graph showing the seasonal trends in temperature, relative humidity and dew point data recorded by a HOBO unit in the service room in North Foreland during 2005–2006.

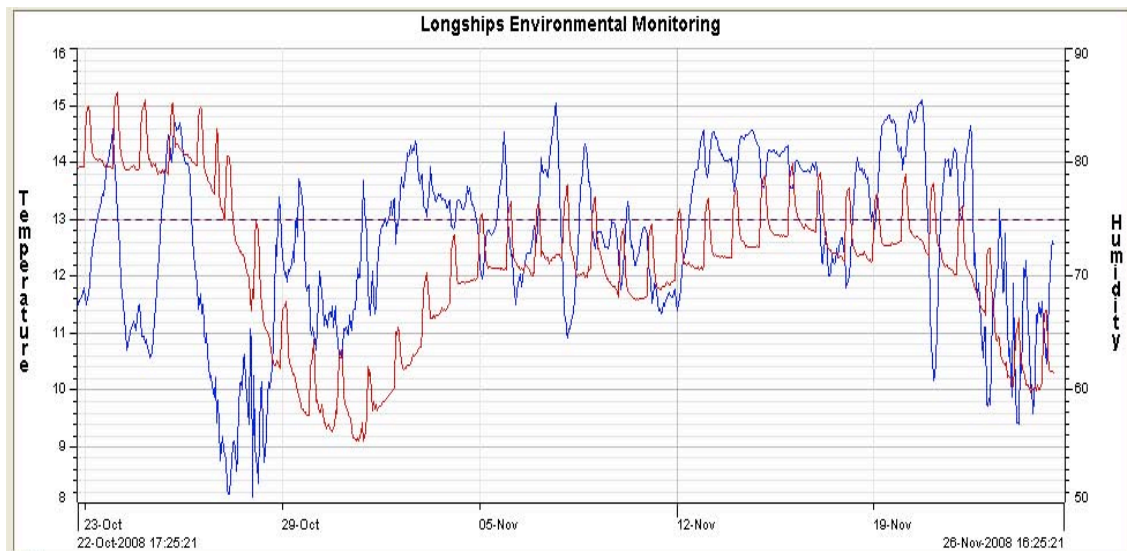
Figure 24: Snapshot of air temperature (red line) and relative humidity (blue line) data from the Service Room in Longships Lighthouse showing the regular spikes in temperature resulting from the night-time activation of the heating system and the less regular fluctuations in relative humidity conditions within the tower that reflect both the internal heating regime and the influence of external meteorological conditions.

An extract from the telemetry monitoring system covering a period of about one month from October to November 2008 is shown in Figure 24. Data shows that each night the boiler raises the temperature of the service room with an associated reduction in the relative humidity thus successfully maintaining general humidity levels within a desired range that is conducive to the maintenance of good building conditioning.

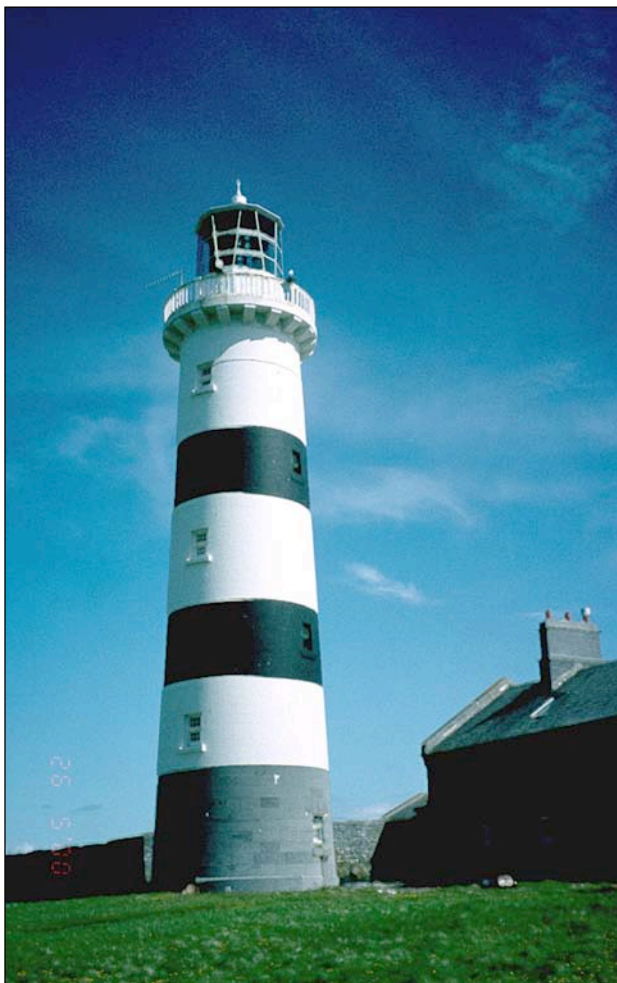
Following automation the granite stonework that forms the ceilings, floors and steps of Eeragh Lighthouse (CIL site 41 in Figure 9) started to show evidence of surface deterioration and breakdown. The deterioration was most severe in the lower floor levels with the condition of the granite improving significantly with increasing height within the tower. SQUIRREL data-loggers were used to monitor conditions at ceiling level on the 1<sup>st</sup>, 2<sup>nd</sup> and 6<sup>th</sup> floors by recording air temperature and relative humidity every 15 minutes for one year.

*Figure 25a: Eeragh lighthouse, which comprises a total of seven floor levels excluding the lantern/optic.*

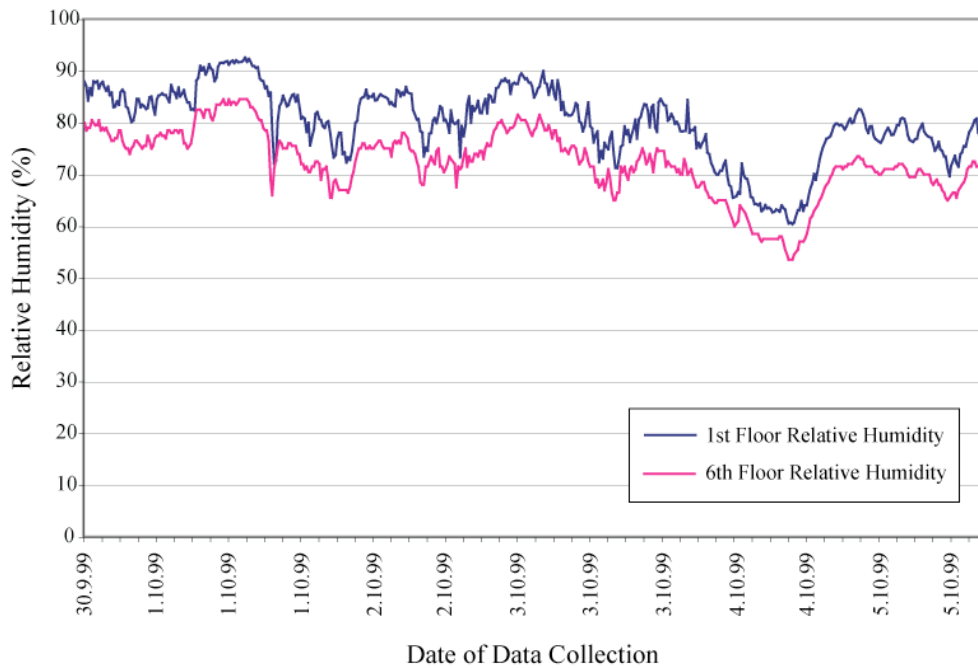
Monitoring identified the existence of a clearly defined stratification of humidity within the tower reflecting a 'stack' effect whereby warmer and drier air rose to the upper floors of the tower leaving cooler and more humid air in the lower levels. Data show that, on average, there was approximately 10% difference between humidity values in the upper and lower floors (Figures 25a & 25b).

Figure 25b: Variation in relative humidity values between the 1<sup>st</sup> and 6<sup>th</sup> floor levels within Eeragh lighthouse over a six-day period.

Such differences in micro-environmental conditions help to explain the pattern of granite deterioration. Since automation ‘still air’ conditions have prevailed within the tower because it was effectively sealed between maintenance visits with the lower doors shut and the upper venting slats closed. RH data indicate that the lack of ventilation within the tower created conditions conducive to the development of condensation through the combination of high RH and stone surface temperatures that were consistently lower than the ambient air temperature. This was particularly relevant in the lower tower levels where dense moist cool air tended to collect. High RH levels when combined with conditions of reduced airflow overlying cold stone surfaces for prolonged periods of time will facilitate the development of condensation with the stone cooling the overlying air reducing its ability to hold moisture. This moisture then condenses out onto the surface of the stone providing a mechanism for the wet-deposition, surface accumulation and gradual penetration of salts into the fabric of the stone.

Monitoring allowed identification of the zonation within the tower of environmental conditions and salt loading which helped to inform management intervention with the introduction of improved ventilation.

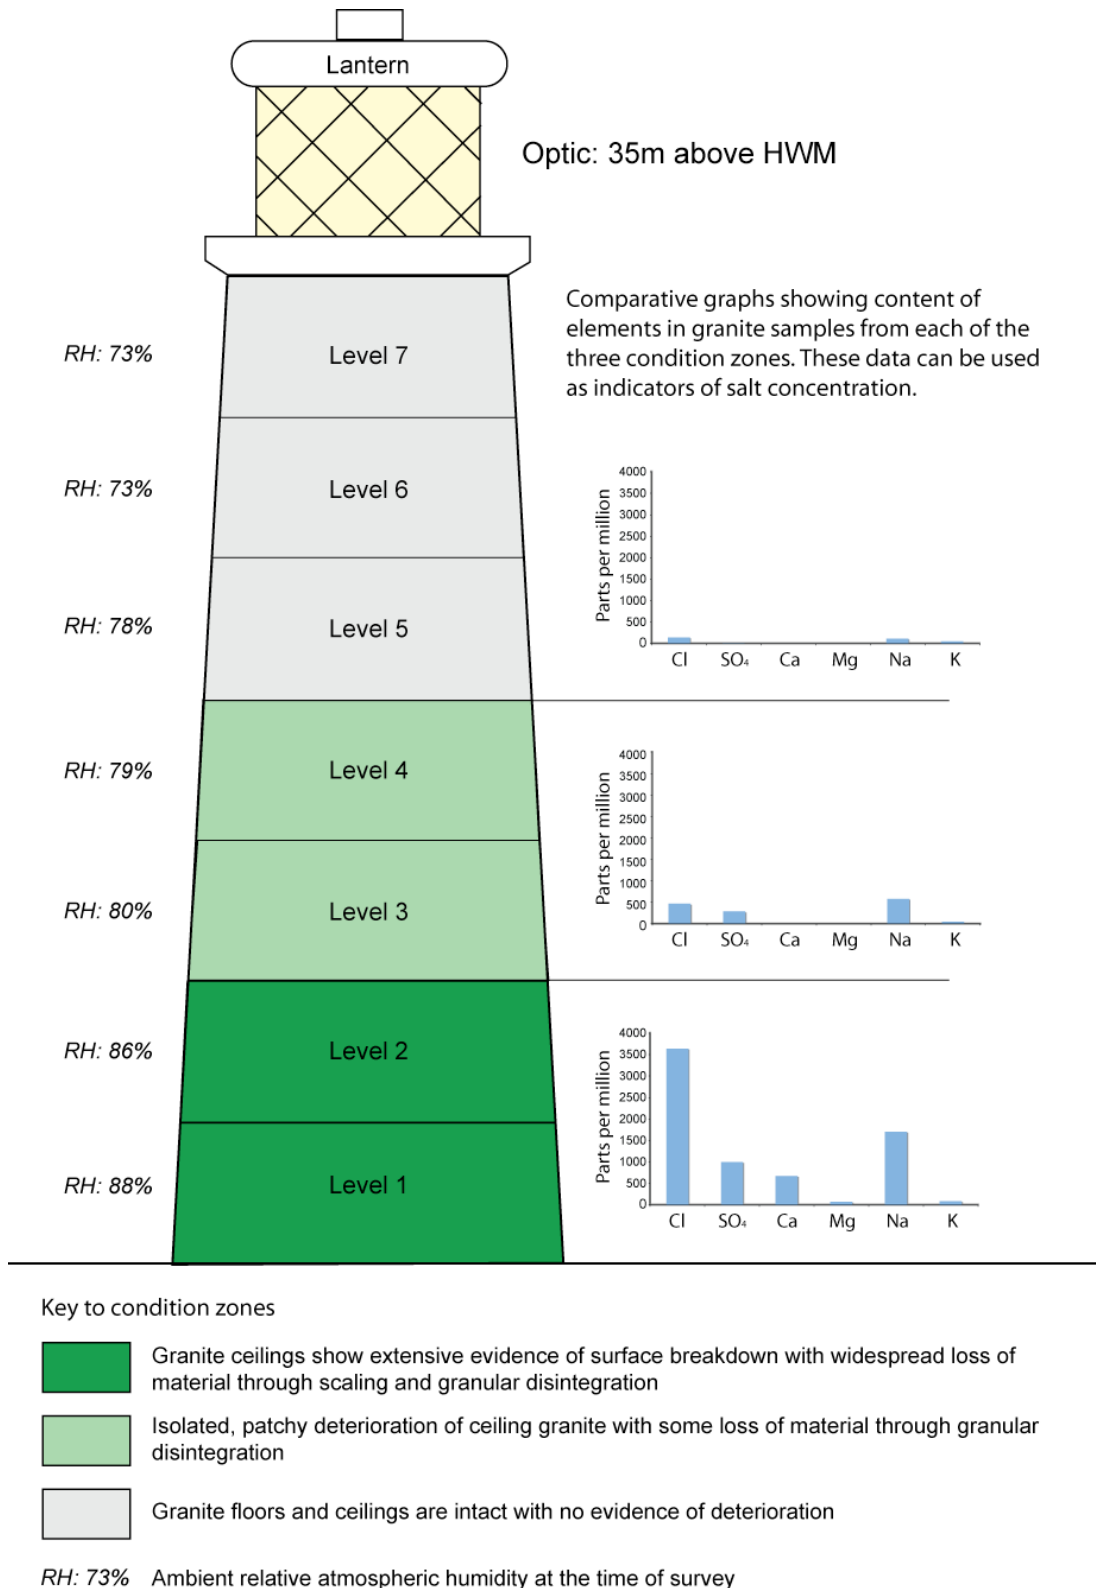
Significantly, the areas of most extensive granite weathering and disintegration correspond with zones of highest relative atmospheric humidity (RH) and the zones of greatest salt accumulation (Figure 26). One of the most commonly occurring salts in this tower is halite (NaCl), which is a strongly hygroscopic salt that attracts moisture from the atmosphere – it is therefore said to be deliquescent. Deliquescence forms part of a complex process whereby condensation nuclei in the salt absorb water molecules and grow in size becoming first deliquescent, then a very concentrated hygroscopic salt solution and later a dilute solution. Where ventilation is minimal or absent and RH values remain consistently high, walls and ceiling can remain continuously damp through this process of deliquescence and this can have serious long-term implications for masonry.

Figure 26: Monitoring of ambient relative humidity at Eeragh (North Aran) lighthouse identified a gradient with values in the lower floor levels being consistently greater than those at higher levels within the tower. Analysis of stone surface samples within the tower also identified a gradient with higher concentrations in the lower levels of the tower as shown by the graphs.

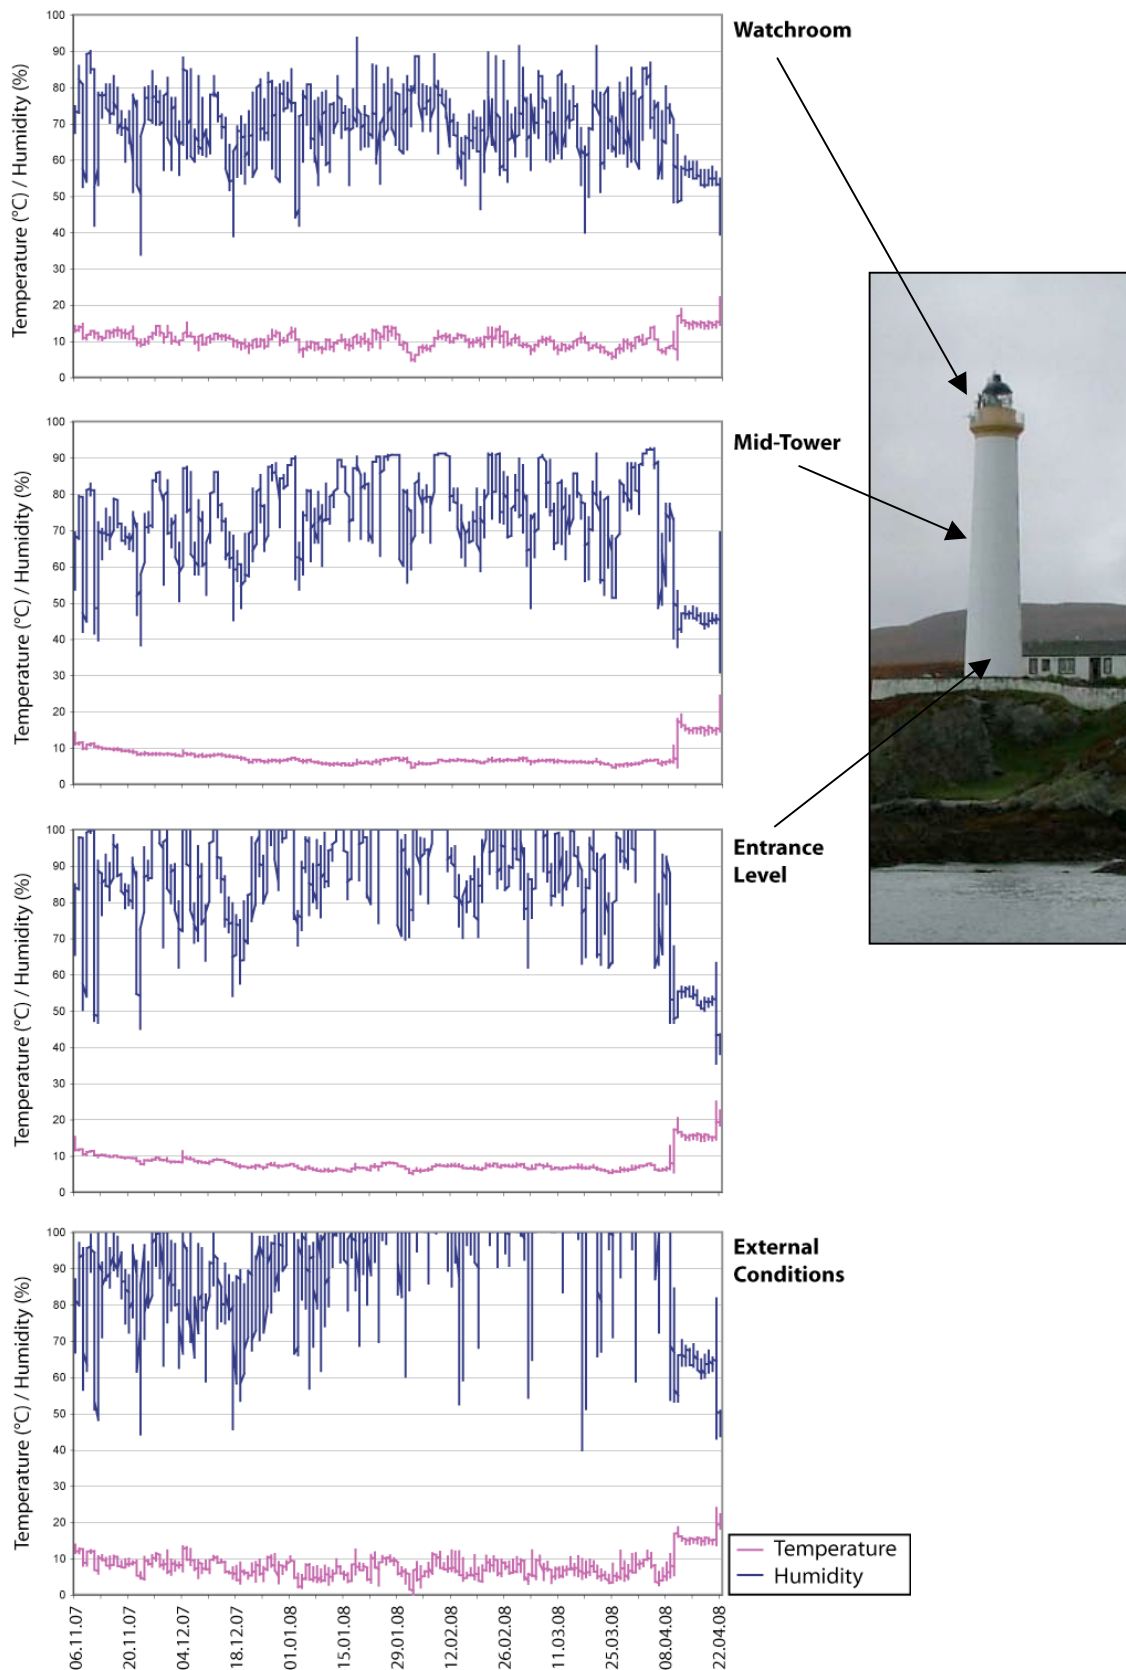
Refurbishment works were completed in Winter 2008/2009 and therefore it is too early to assess the success of the new conditioning regime. However, installation of four ‘Gemini TinyTag’ data-loggers placed externally at the entrance level of the tower and within the tower at the entrance, mid-tower and watchroom levels give an indication of conditions prevailing within the tower during the refurbishment period (Figure 29). It is important to remember that this region of Scotland is regularly subject to extreme storm conditions with high wind speeds and driven rain, a factor that is clearly demonstrated by data from the external logger which shows relative humidity conditions to be near or at vapour saturation for considerable proportions of the recording period.

Figure 29: Data-logger results showing air temperature and relative humidity conditions at different levels within Ruvaal Lighthouse and externally at the entrance level. These data show a clear vertical stratification within the tower with humidity levels decreasing with increasing height with often around a 10–20% difference between conditions at the entrance and watchroom levels.

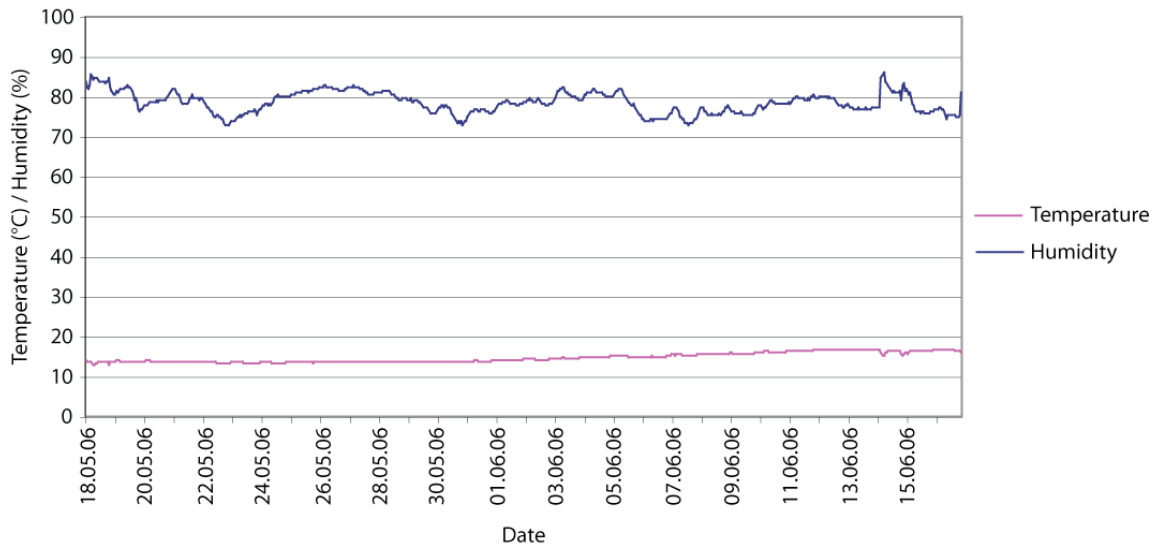
HOBO data-loggers were used on Casquets to collect long-term environmental information from within St. Peter's Tower and the accommodation building. Air temperature and relative humidity data were recorded at hourly intervals giving a clear indication of conditions before the start of refurbishment works (Figure 33).

Figure 33: Air temperature and relative humidity values collected by HOB0 data-logger from St. Peter's Tower on Casquets. Note the consistently high humidity values despite relatively 'warm' air temperatures.

Continued monitoring of condition during and after refurbishment will hopefully show a decrease in ambient humidity with an associated improvement of overall condition within the tower.

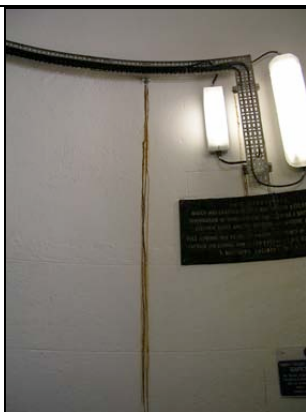
Repair defective lantern glazing. If the soffit plate is badly affected it may be removed if the building does not have listed status. However, if it is listed then the soffit plate may need to be replaced.
Corrosion of fixings behind a new stainless steel tray with associated staining of adjacent painted surface

Where possible corrosion resistant stainless steel fixings should be used when attaching components to solid masonry walls, especially external walls that may contain moisture. Ideally, a gap should be left between the equipment and wall to facilitate airflow as this should help to prevent corrosion and the problems associated with surface staining. When such corrosion staining does occur, all ferrous fixings such as old electrical fixings, nails, screws and exhaust manifolds should be removed and replaced, where necessary with corrosion-resistant equivalents.

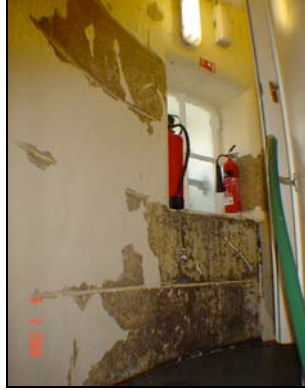
Staining of stonework associated with corrosion of embedded ironwork is the first sign of deterioration of ironwork which will eventually result in fracturing of adjacent stonework due to corrosion-related expansion of ironwork.
<b>Moisture Ingress &amp; Deterioration of Internal Surfaces</b>		
Flaking, peeling and loss of paint associated with moisture in masonry materials and excess surface condensation

If the building is not used for accommodation paint removal should be considered. This will allow affected masonry to 'breathe' and facilitate drying. Checks of the building exterior should be made for any defects that might facilitate moisture penetration. The situation may also be improved by increasing ventilation. If the building is required for accommodation then thought must be given to introducing or increasing the duration and extent of heating along with improved ventilation.

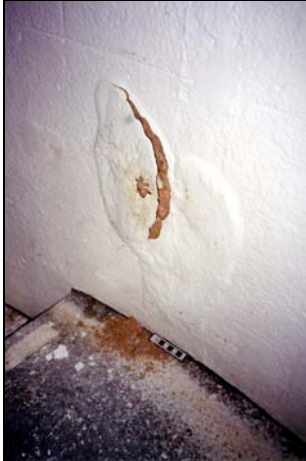
In severe cases render/plaster should be removed to allow underlying masonry to 'breathe' and aid drying. External wall surfaces should be checked for defects that may have facilitated moisture penetration.
Blistering and loss of internal surface paint as a result of moisture and salt

Check external wall surface for evidence of defects that may have aided moisture ingress and repair if present (e.g. defective external paint, structural cracking or degraded mortar). If the problem is widespread, paint should be removed to allow masonry to 'breathe' and release moisture. When removing historic paint protective measures should be taken as some of the older paint may be lead-based.
Salt efflorescence on a granite floor

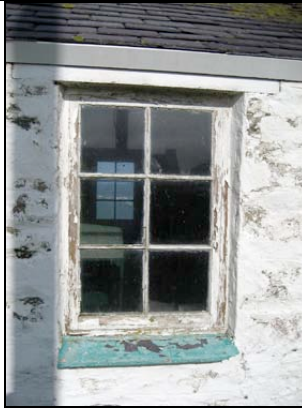
Rotting of window joinery due to breakdown of protective paint cover

Regular application of paint will prevent initiation of wood rot and eventual penetration of moisture.
Weathered external paintwork on joinery elements

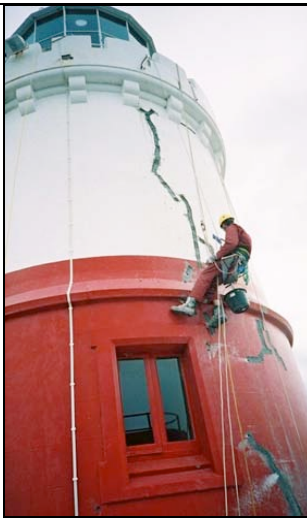
In some cases re-rendering may be required to maintain building condition when 'old' render cannot prevent moisture ingress because it has become so cracked and degraded.
Cracking of external tower surface

Render repairs should be carried out as a matter of urgency to prevent moisture ingress and initiation of internal moisture related problems or exacerbation of pre-existing ones.
Peeling external paint film resulting from defective adhesion with underlying surface

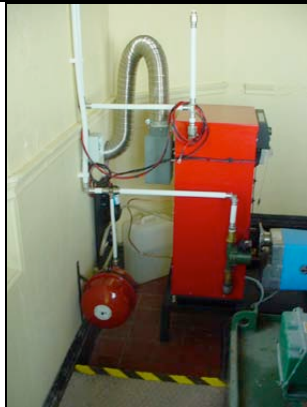
Insufficient energy from renewable sources for building conditioning

Installation of oil-fired boiler (Kabola) for wet central heating system.
