Evaluation of  
Extreme Ice Forces  
on a Lighthouse  
in the Bothnian Bay

A study of the Björnklack  
overloading event in April 1985

VBB Project M7334

Final Report Jan. 15th, 1987

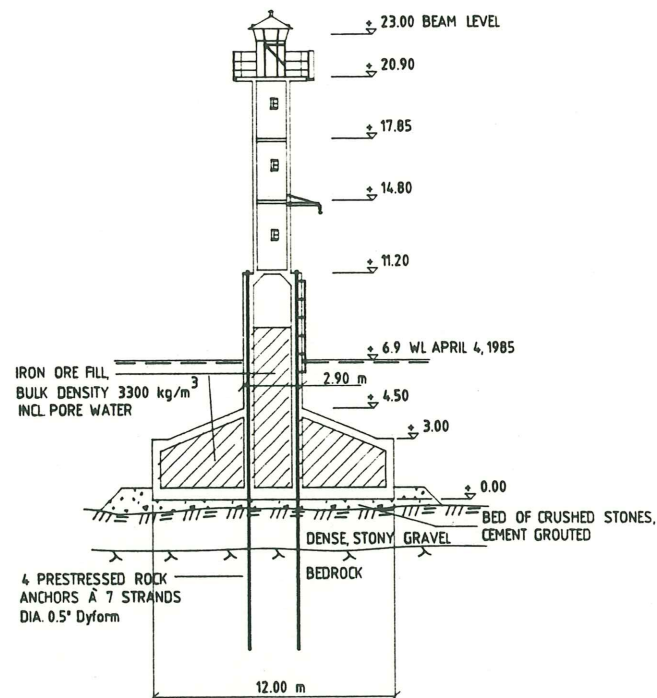
Figure 2.1 Section through the BJÖRNKLACK lighthouse

Four VSL tendons, each with seven 0,5" strands, were provided as rock anchors. The tendons were placed in bore holes, drilled vertically from the entrance platform, through the concrete structure and the underlying soil and into the rock (see Figure 2.1). Above the anchorage zone the greased strands were coated with plastic sheaths, preventing bond between the steel wires and the cement grout, which was injected into the bore holes immediately after the mounting of the tendons. The grouting could thus be performed in one single operation and the tendons could be subsequently tensioned.

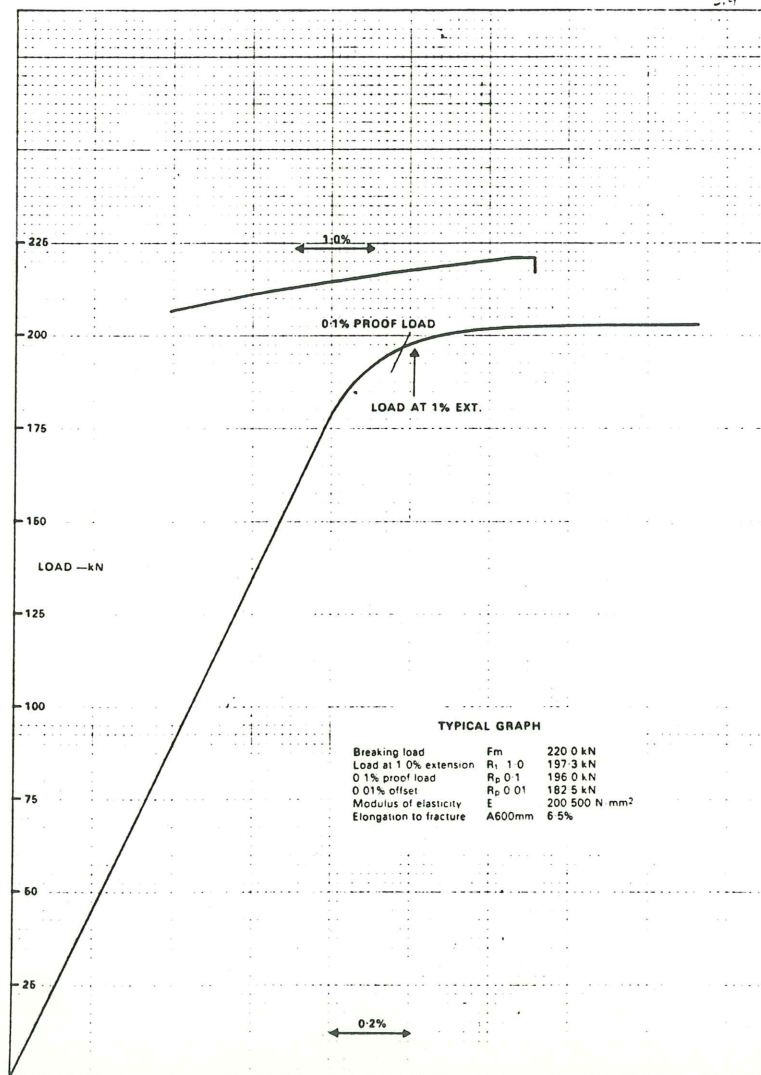
Figure 5.4 Typical stress-strain relation for a rock anchor strand

- Each one of the 4 rock anchors consisted of 7 Dyform dia. 0.5" strands, manufactured by Bridon Wire Ltd, Great Britain. A typical stress-strain relation diagram for such a strand is shown in Figure 5.4. The ultimate tensile strength of a single strand is 220 kN. Since the strands were affected by bending the ultimate tensile load was reduced.

Since the prestrain was about 0.005 the corresponding load must have been about 200 kN (see Figure 5.4). The estimated actual ultimate force of all the rock anchors together is  $4 \times 7 \times 0.20 = 5.6$  MN  $\pm 3$  per cent.

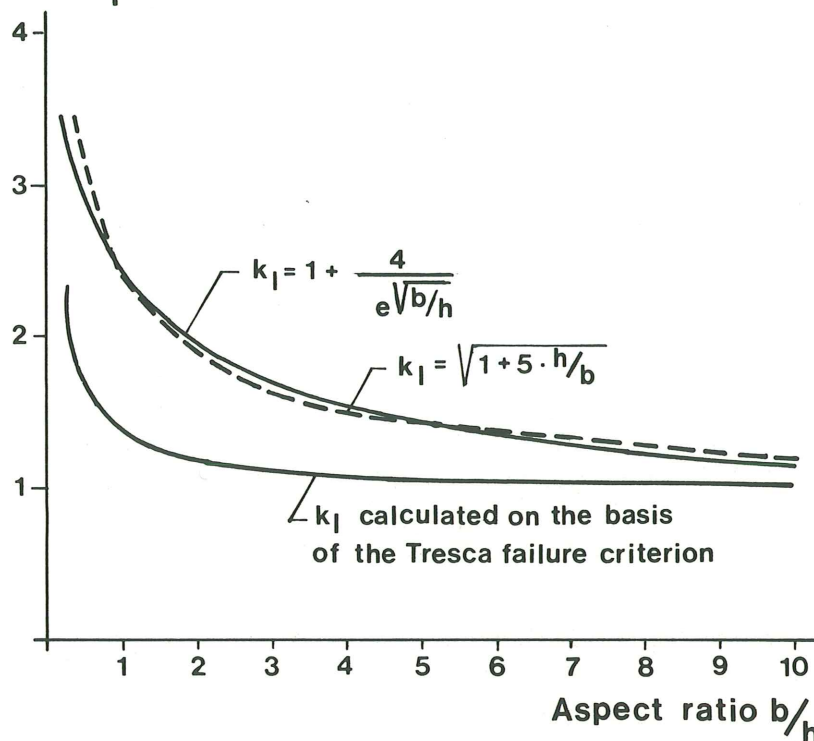
Figure 6.2 Graphs illustrating various relations between the indentation factor and the aspect ratio

The two curves in Figure 6.2 have been chosen to represent the upper and lower boundaries of various suggested relations, when some extremes have been omitted. The two curves have been reproduced from ref. 7, where the background is also commented. The upper curve (from Korzhavin 1962) also approximately represents the equation

It is therefore probable that the real influence of the aspect ratio is less than that indicated by the factor  $k_I = 1.9$  in the first combination. Another fact also points in that direction, namely that the ice failure mode in the actual case, as in other similar observed cases, was obviously of a type, which is reasonably well explained theoretically on the basis of the Tresca failure criterion as described in Ref. 5 and 7. This implies that the failure zone is located close to the indenter and the aspect ratio effect is minor except for very small values of  $b/h$  as shown in Figure 6.2. If that was the case the large scale multiaxial stress conditions did not increase the ice pressure very much and a contact factor of the order of unity seems to be explicable. It is quite possible that the strain rate varied during the sequence of overloading and that the ice at the contact surface became momentarily more ductile, particularly when the rock anchors began to yield and the structure moved in the direction of the ice drift.

ing to a range of  $k_I$  values from 1.15-1.9, which means that the corresponding ice pressure on a very large structure would have been between  $2.6/1.9 = 1.4$  and  $2.6/1.15 = 2.3$  MPa in case of complete indentation.
