## Development of Auto Releasing New Danger Mark Buoy

**Prof. Dr. Seung-Gi GUG,**

Korea Maritime and Ocean University

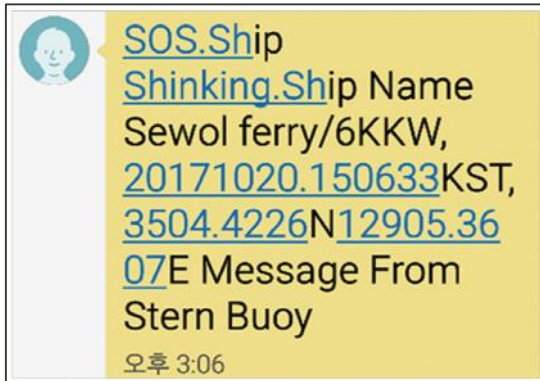
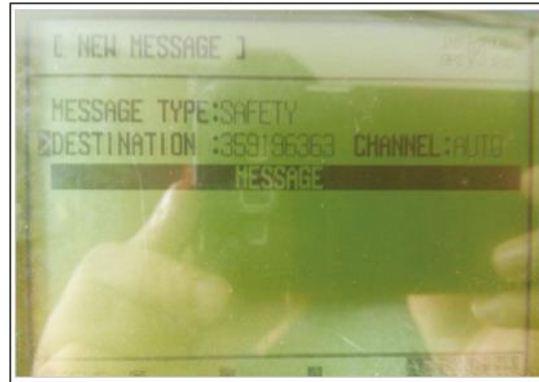
《 Location of sinkage shown on cell phone, AIS receiver and ECDIS 》

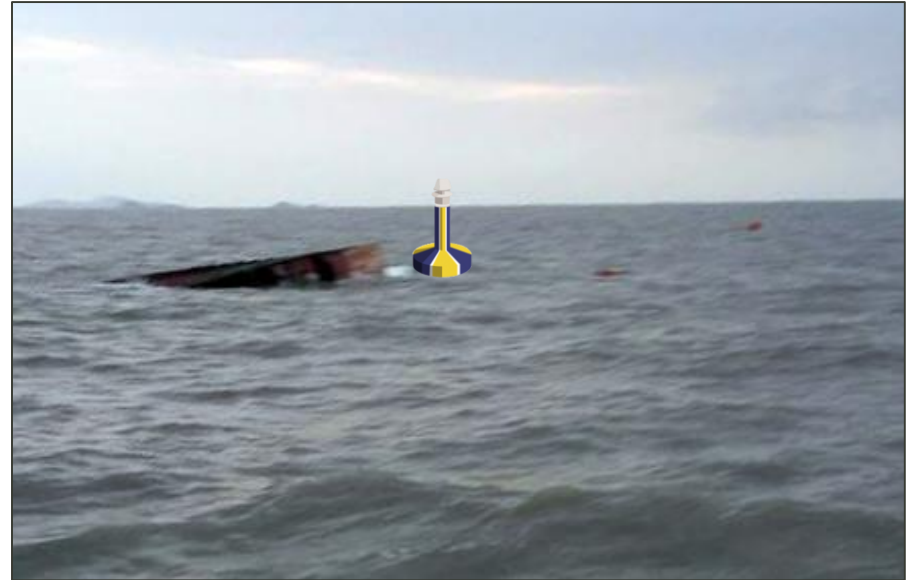
<The buoy will be used to reduce the risk of navigation and to prevent secondary collisions>

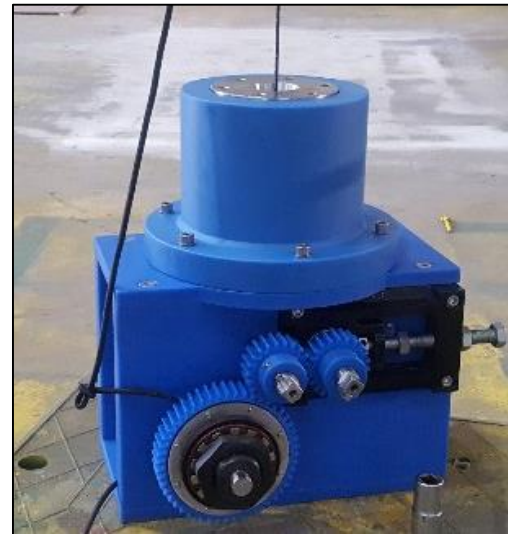
Auto reel adjust the length of mooring rope. After a vessel is sunk a wrapped mooring rope is released by the gravity applied on weight furnished in the unit. By reaching under the sea surface, the force is made upward when the gravity and buoyancy on a weight becomes equivalent. Then an axis hanged on a pulley has fastened the mooring rope

《 Auto Reel Mooring Rope 》

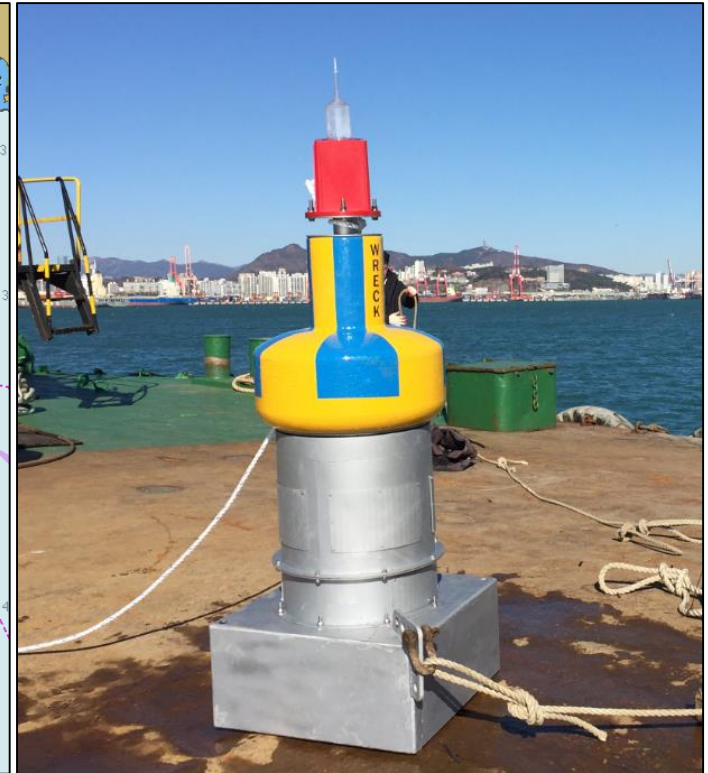
《 Auto Releasing New Danger Mark Buoy 》

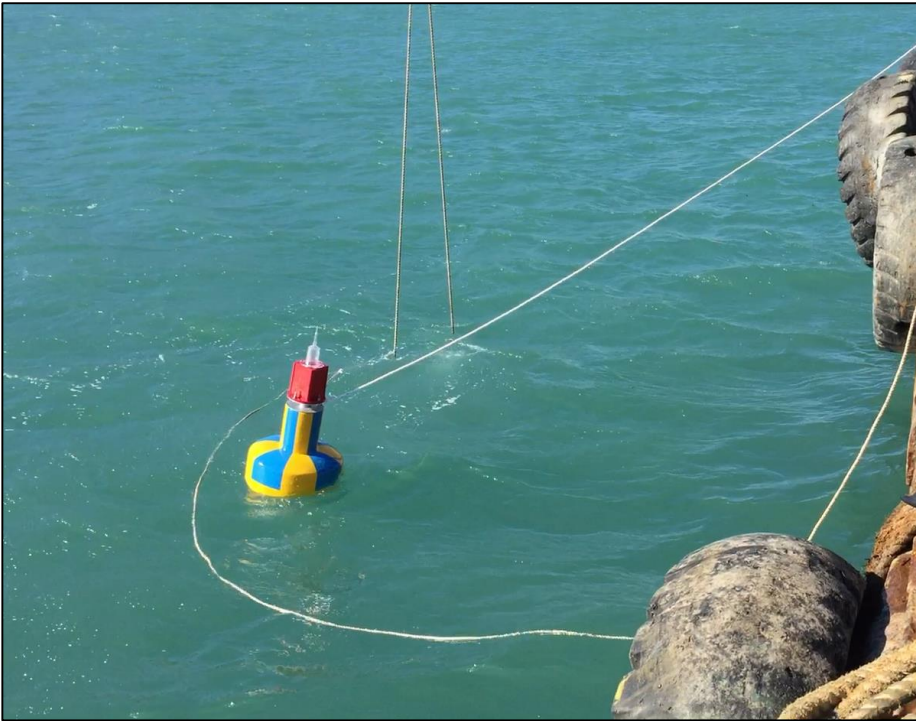
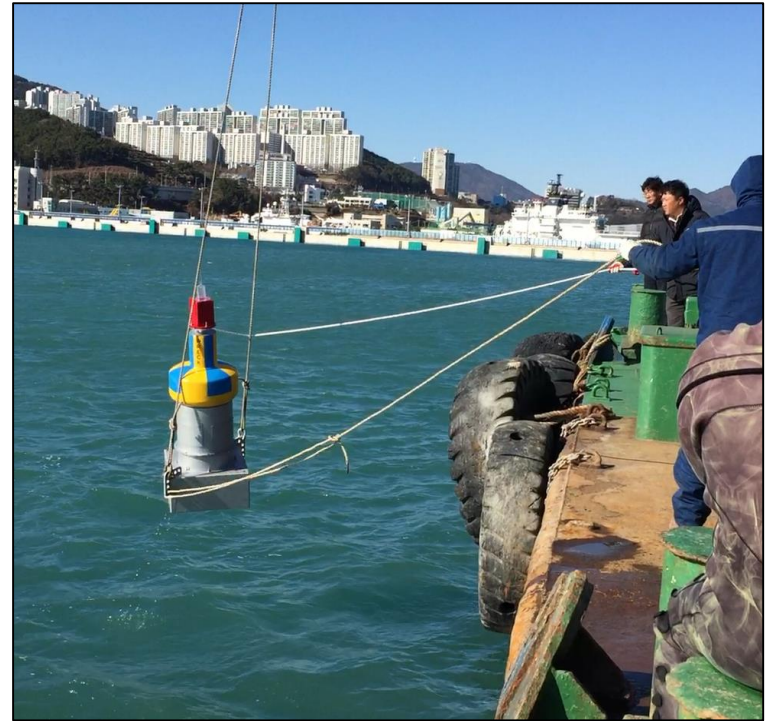
Upon entering the water, buoy and mooring rope was automatically released. After the auto reel mooring rope box touched the sea floor, the mooring rope was fixed. Field test was successful.

《 Field Test 》

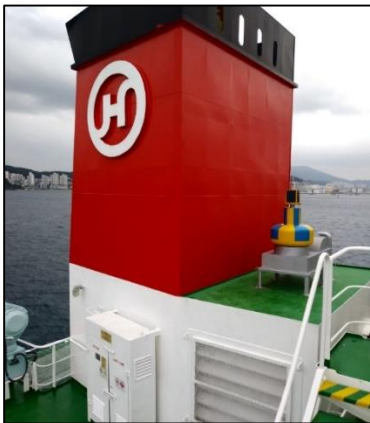
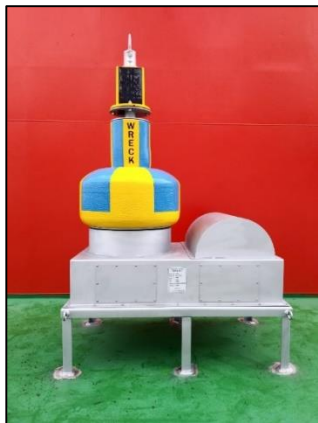
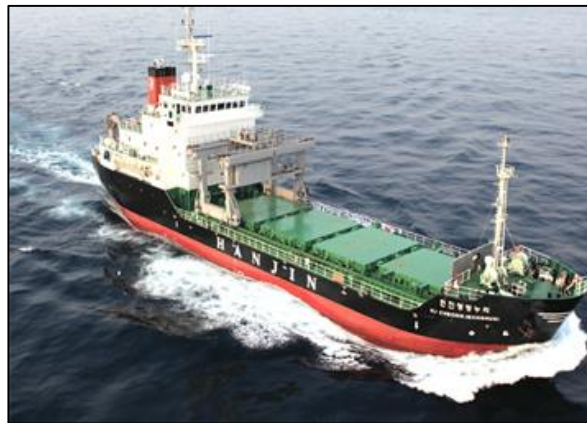
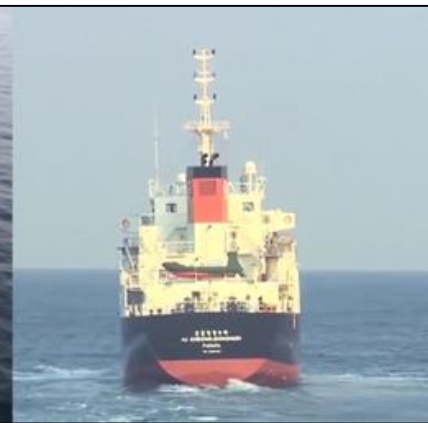
- Vessel Type : Radioactive Waste Carrier
- Specification : LOA 78.6m, Beam 15.8m, Draft 4.0m, GT 2,600, Nav. Full Spd. 12.0kts.
- Purpose of Installation : Rapid recovery of nuclear waste and search & rescue,  
Prevent secondary collision

《 Case of Installation on Cheongjeong-Nuri 》
