Report on AIS data used as evidence in court cases

The Working Group on AIS data used in court cases (Jan Gabrielsen, Christina Schneider and Maarten Berrevoets)

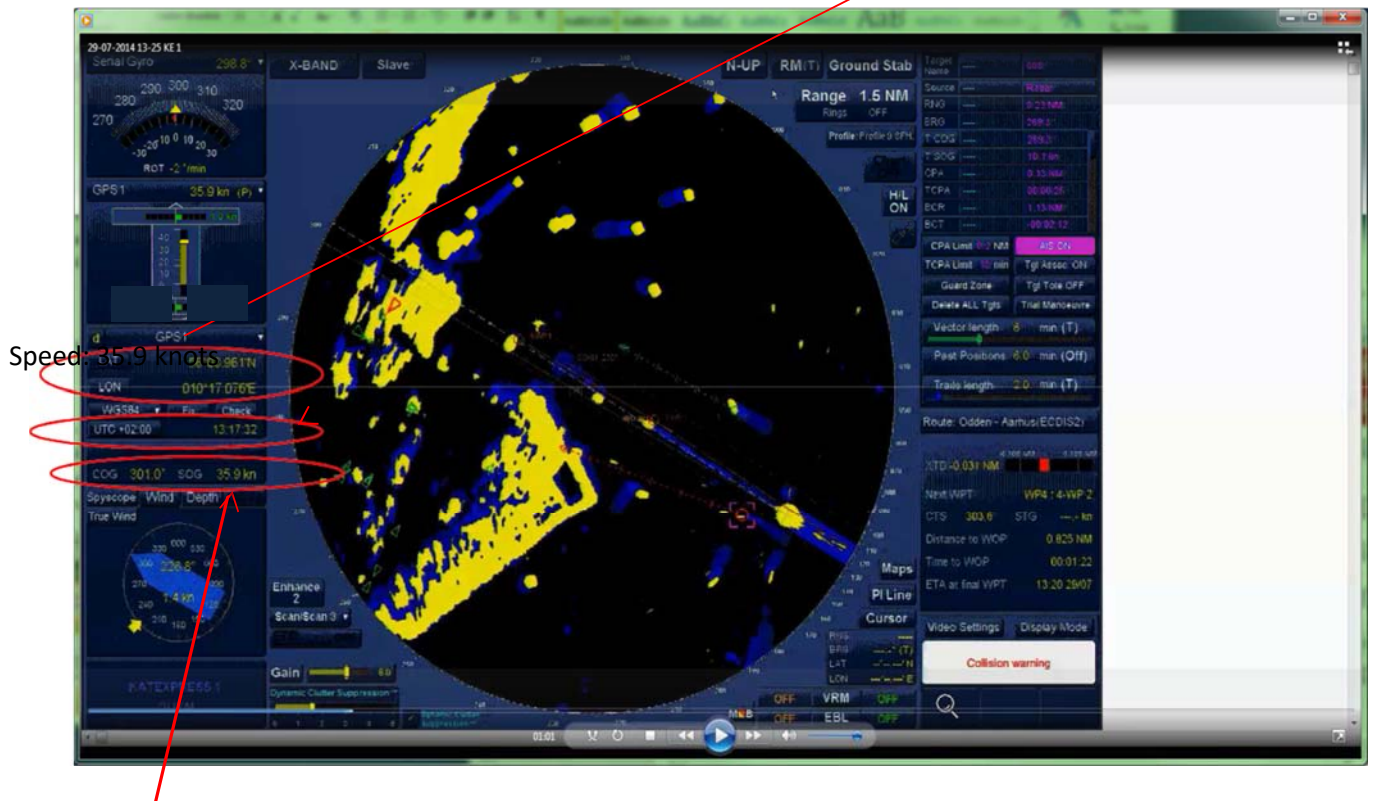
The picture below shows the radar picture displayed on the ship at 13:17:32 Danish summertime (UTC + 02:00). The picture is a "screen dump" and originates from the ship's VDR (Voyage Data Recorder – "the black box"), which takes such screen dumps at intervals of approx. 15 seconds. This is how the instrument of the master of the vessel looked during the voyage

By means of the AIS (Automatic Identification System) system, the ship's navigational instruments transmit information over the VHF radio at intervals of a few seconds, thus enabling ships to see the identity, course and speed of nearby vessels. AIS signals are also picked up by the Danish Maritime Authority's nationwide network of base stations. Around 11:17:32 UTC (i.e. Danish summertime 13:17:32 UTC + 02:00), an AIS signal from the ship shows a position, course and speed corresponding to simultaneous data from the ship's radar.

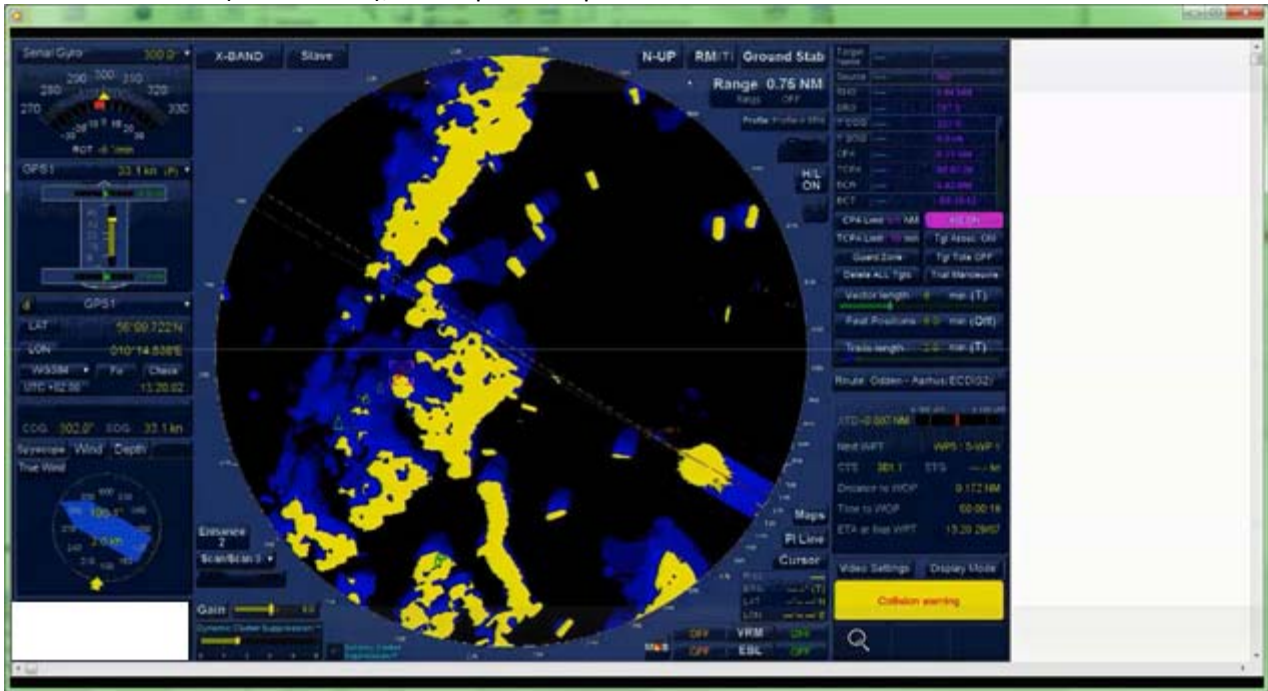
At 13:20:02 hours (UTC + 02:00), the ship's radar picture shows this:

Speed: 33.1 knots

Speed 33.5-32.7 knots. It should be noticed that, as regards both position and speed, the AIS measurement at 11:20:02 is somewhat to the one side and the measurement at 11:20:02 (2 seconds later) somewhat to the other side of the information from the radar picture. This is due to the fact that the sampling of radar pictures and AIS data is not synchronic and that the data displayed in the radar picture and transmitted via AIS have, consequently, not necessarily been recorded at exactly the same millisecond. It can be seen that the data in the radar picture correspond to the AIS data.

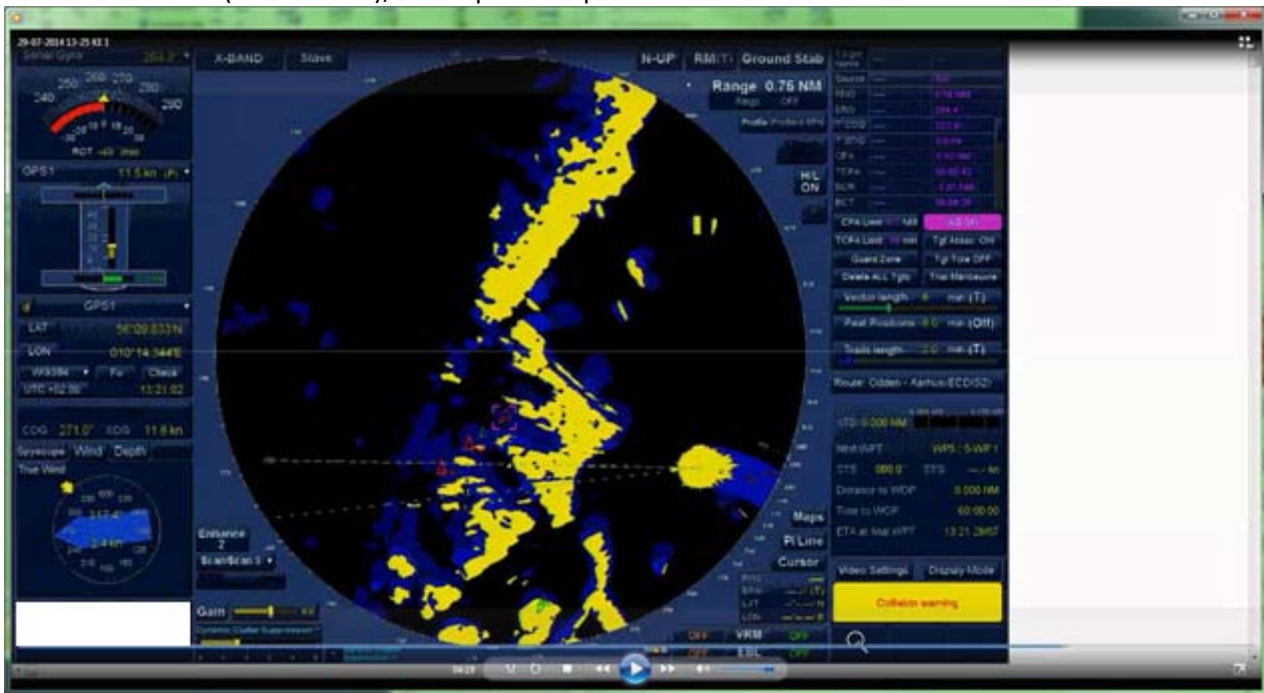
At 13:21:02 hours (UTC + 02:00), the ship's radar picture shows this:

Speed: 11.6 knots

Thus, it is found in several comparisons that the AIS data correspond to the instrument data that have been shown to the navigating officer on the radar.

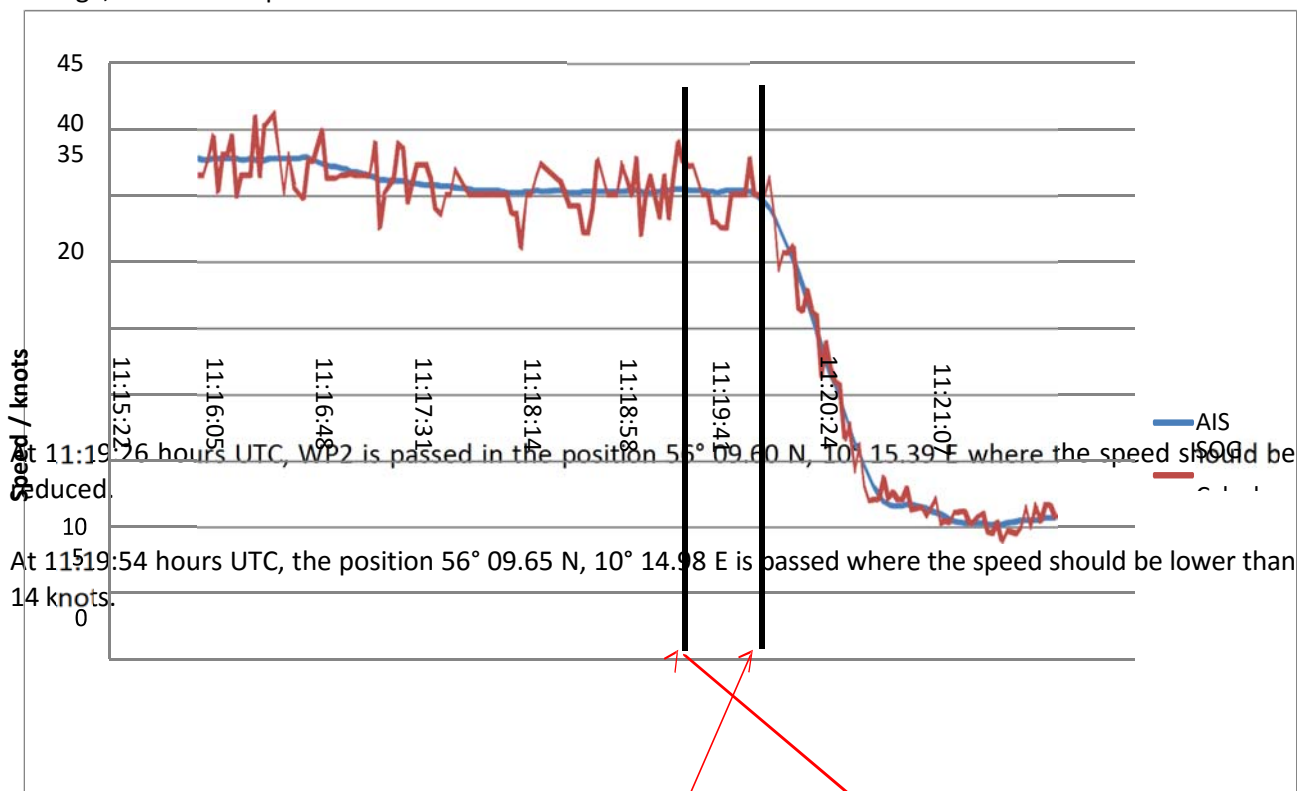
A control of the ship's position fixing has been made by means of a visual inspection of the accordance between the position given and the ship's radar picture. The SOG (Speed Over Ground) measurement has been checked by measuring the distance travelled (on the basis of the ship's own GPS position reports received via AIS – which is identical to the positions displayed on the radar) over time (measured by the AIS base station network with high precision). In a comparison with the SOG displayed on the ship's radar and transmitted via AIS, our control measurement (which consists of much fewer measurement points than the ship's own SOG measurement and is thus subject to larger uncertainty) concludes that there is no reason to doubt the correctness of the ship's recorded navigation information and that the speed measurement is, on average, within the 2 per cent tolerance established in relevant test standards for SOG measurements.
