Report on AIS data used as evidence in court cases

The Working Group on AIS data used in court cases (Jan Gabrielsen, Christina Schneider and Maarten Berrevoets)

1 Background

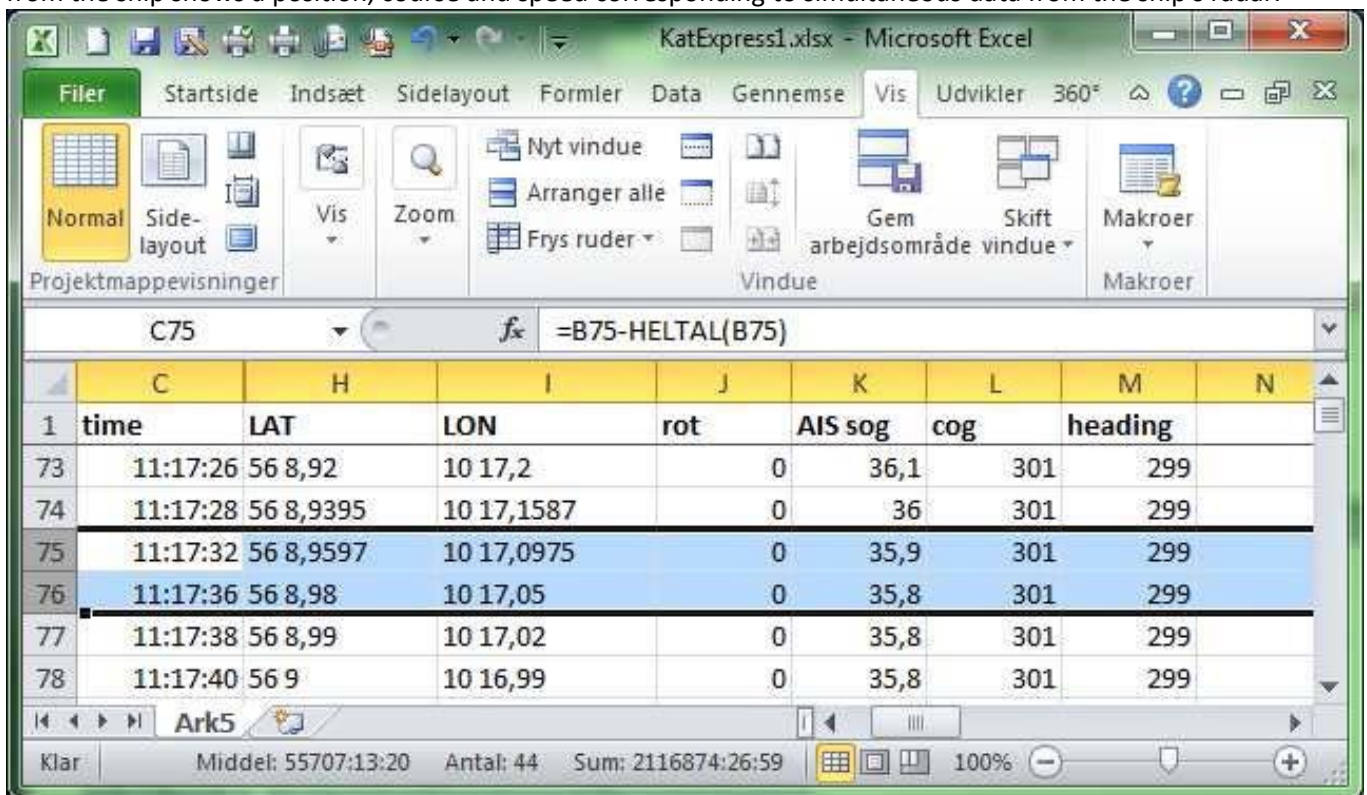
By means of the AIS (Automatic Identification System) system, the ship's navigational instruments transmit information over the VHF radio at intervals of a few seconds, thus enabling ships to see the identity, course and speed of nearby vessels. AIS signals are also picked up by the Danish Maritime Authority's nationwide network of base stations. Around 11:17:32 UTC (i.e. Danish summertime 13:17:32 UTC + 02:00), an AIS signal from the ship shows a position, course and speed corresponding to simultaneous data from the ship's radar.
