EEP15

WP – Bird Deterrents

EEP16/8/6
Formerly EEP15/WG1/WP7

1. Scope;

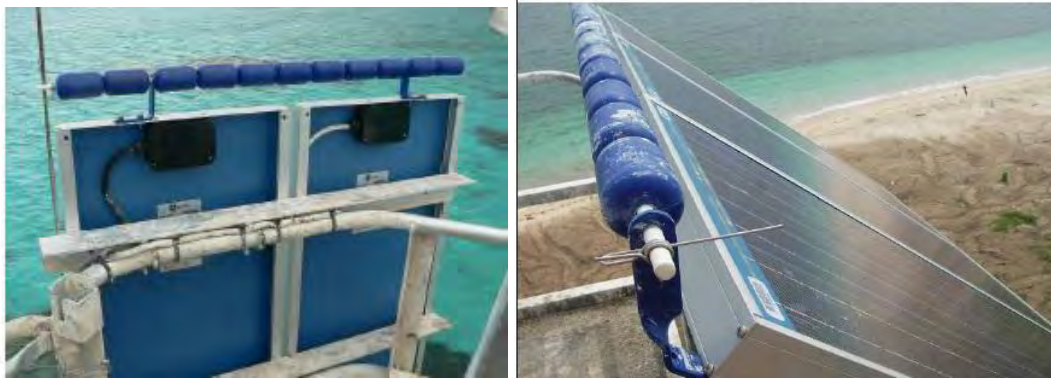
Figure 1. Bird Rollers installed in Australia

- A variety of different methods have been used by AMSA.
 - Bird rollers – mounted on solar panels and structural components on a variety of different structure. Bird rollers have proven reasonably successful.
 - Vertical mounting of solar panels – successful but requires additional solar components to address power loss.
 - Installing cones on top of flat lantern services, to remove areas for bird purchase

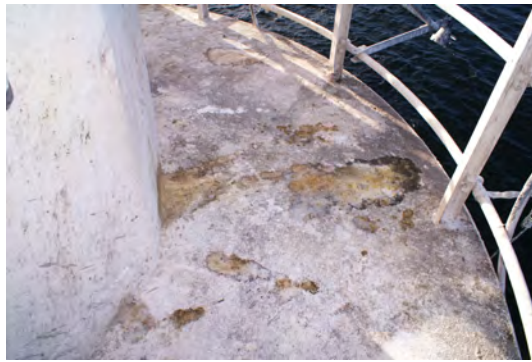
Figure 1: Cormorant droppings on lighthouse

An obvious side effect of the visiting cormorants are the abundant amounts of bird droppings on the lighthouses. Cormorant droppings leave an unpleasant odour and are considered to be an inconvenience by Swedish Maritime Administration personnel. Droppings also cause increased cleaning and repainting needs of lighthouses.

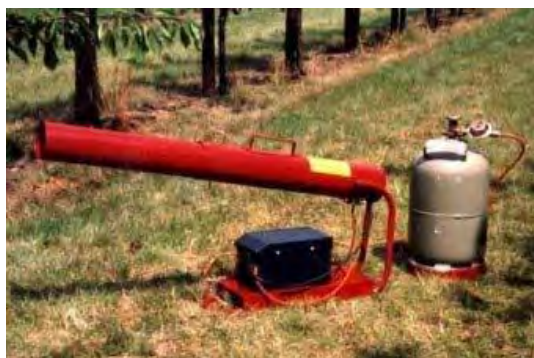
Figure 5: A gas cannon from Nordanvik

A gas cannon ignites liquified petroleum gas to create a sound effect that scares off birds. It can also be programmed to ignite gas at random intervals to make it more efficient. Figure 5 illustrates a gas cannon from Nordanvik AB.

An evaluation done by Viltskadecenter (a service center that aims at investigating and preventing damages caused by wildlife) revealed that gas cannons are an effective way to disperse birds. Viltskadecenter tested gas cannons on

a field, frequently used by crane birds, outside the town of Örebro in central Sweden. The test outcome showed an 84% reduction of number of visiting crane birds. Unfortunately a potential habituation effect was not thoroughly examined since the experiment only lasted for 30 days.

The Swedish Maritime Administration installed one gas cannon at the lighthouse Svinbådan outside the city of Helsingborg. The Svinbådan lighthouse is very popular among cormorant birds all the year round. The initial effect of the gas cannon was very good, according to Martin Samuelsson captain of the service ship Scandica. After some time the promising initial effect diminished and the gas cannon was later decommissioned. The cormorant birds displayed a clear and indisputable habituation effect.

A gas cannon initially showed promising results but it soon became obvious that this solution was not time constant. The cormorants were habituated to the gas cannon quite rapidly and the cannon was dismantled.

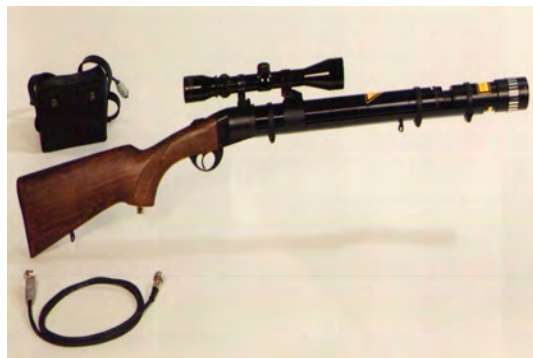
Figure 6: A Desman laser

The French company Desman markets and manufactures lasers designed specifically for bird control. An example of a Desman bird control laser is shown in figure 4.

Inquiries was sent to Desman reference customers listed on their web page asking about their experience of the Desman laser. Two answers was received, one from the U.S. Department of Agriculture (UDA) and one from Bayerische

Doctor Manfred Klein at BLL reveals that the experiment with the Desman laser has been aborted and that BLL classifies this technique to be ineffective. BLL used the Desman laser on breeding cormorants and was unable to make them abandon their nests.

Andy Radomski, field biologist at UDA, has had a slightly different experience of the Desman laser. According to Andy Radomski the laser was indeed successful at scaring of cormorants, at least temporarily. But despite this initial success UDA does not consider the Desman laser to be an effective solution since the effect is not long lasting and too local for their intended use.

Finally the use of laser scarecrows was examined to some extent. The result of that examination was discouraging.

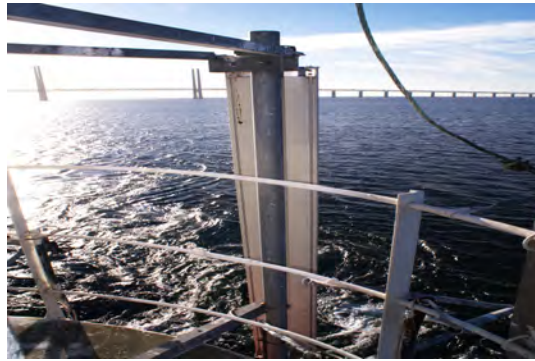
Figure 7: A mobile phone base station at Flintrännen 6

The Flintrännen 6 lighthouse is one of several lighthouses that constitute the Flintrännen international channel in Öresund. This particular lighthouse should according to information received have far less visiting cormorants than its nearby neighbors. Presumably due to the presence of a mobile phone base station.

An attempt to compare the number of visiting cormorants at Flintrännen 6 with the lighthouse Flintrännen NO (only 2,3 nautical miles from Flintrännen 6) was performed. A distinct difference in amount of faeces between these two lighthouses was noticeable, Flintrännen 6 being the one having significantly less faeces.

Further, cormorant birds on Flintrännen 6 was monitored with a surveillance camera connected to the Internet via wireless 3G technology. During several months of surveillance the camera only caught a handful of birds visiting the lighthouse, far less than expected in this by cormorants densely populated area.

Whether or not electromagnetism from mobile phone base stations actually deter birds is not fully understood. Observations from Flintrännen 6 and the fact that birds are capable of perceiving at least some magnetic fields seem to support this assumption. Although cormorants do not seem to be too disturbed by electromagnetism since cormorants have been spotted at the Svinbådan lighthouse.

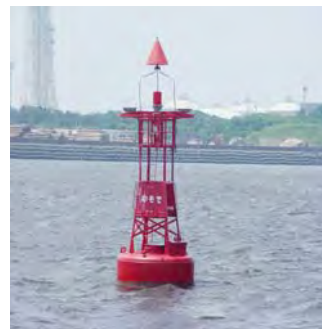
Lighted buoy

The countermeasures described in Material 1. were tested for 239 aids to navigation (mainly buoys and Resident buoys), which were heavily smeared by seabird droppings.

And the comparison of the smear before and after the tests is as follows:

Lighted buoys are exposed to a large amount of rotational motion and pitching/rolling, which causes variability of the necessary insolation to generate sufficient electricity. Perpendicular installation of PV panels is not a choice in this case. The countermeasure of (1) or (2) will be implemented to prevent smear.
