# **A HISTORY OF FLOATING AIDS TO NAVIGATION**

Adrian Wilkins

Copyright © 2013 Adrian H. Wilkins

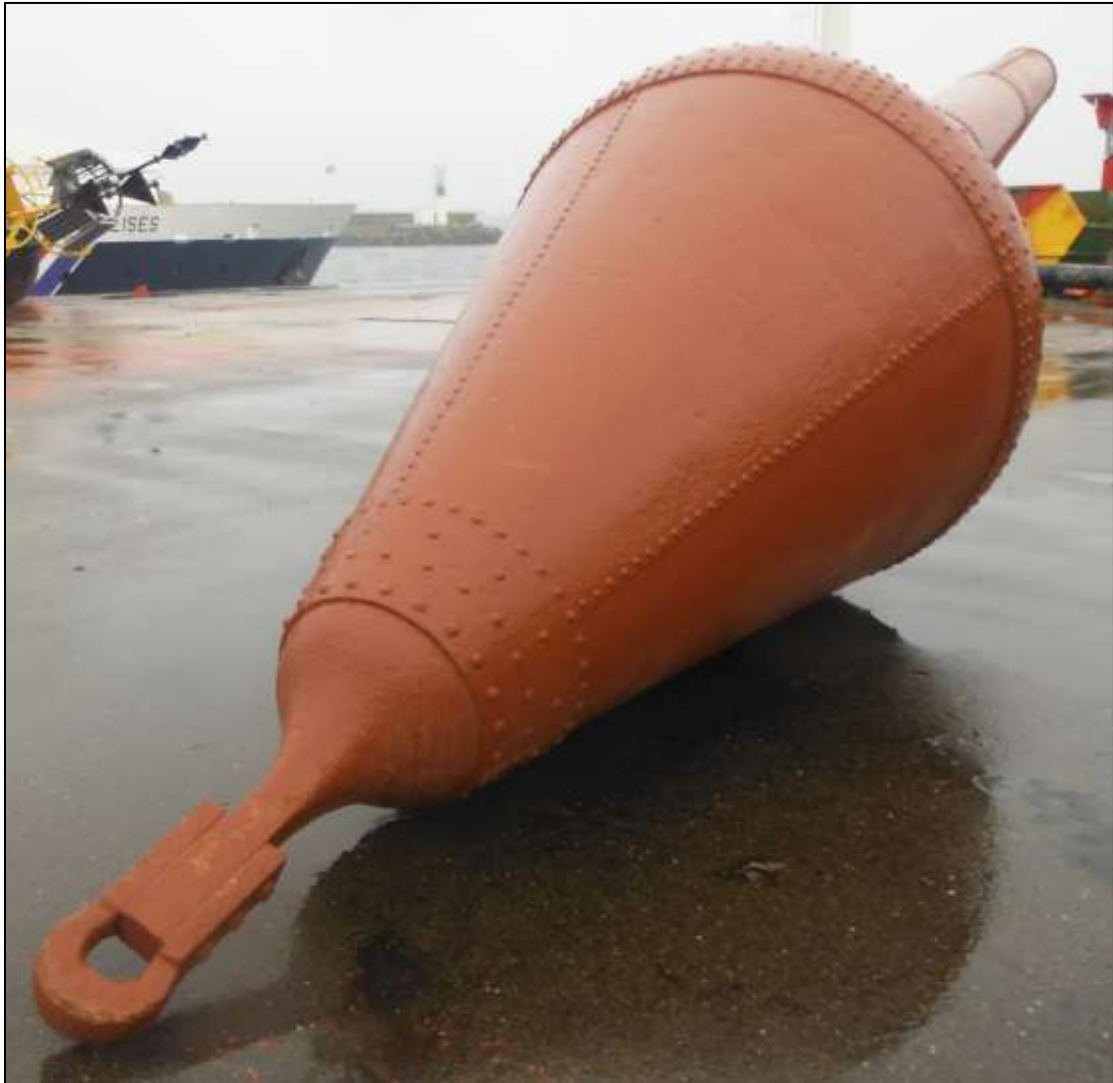
*Fig.33* French riveted iron buoy, 1880s design.

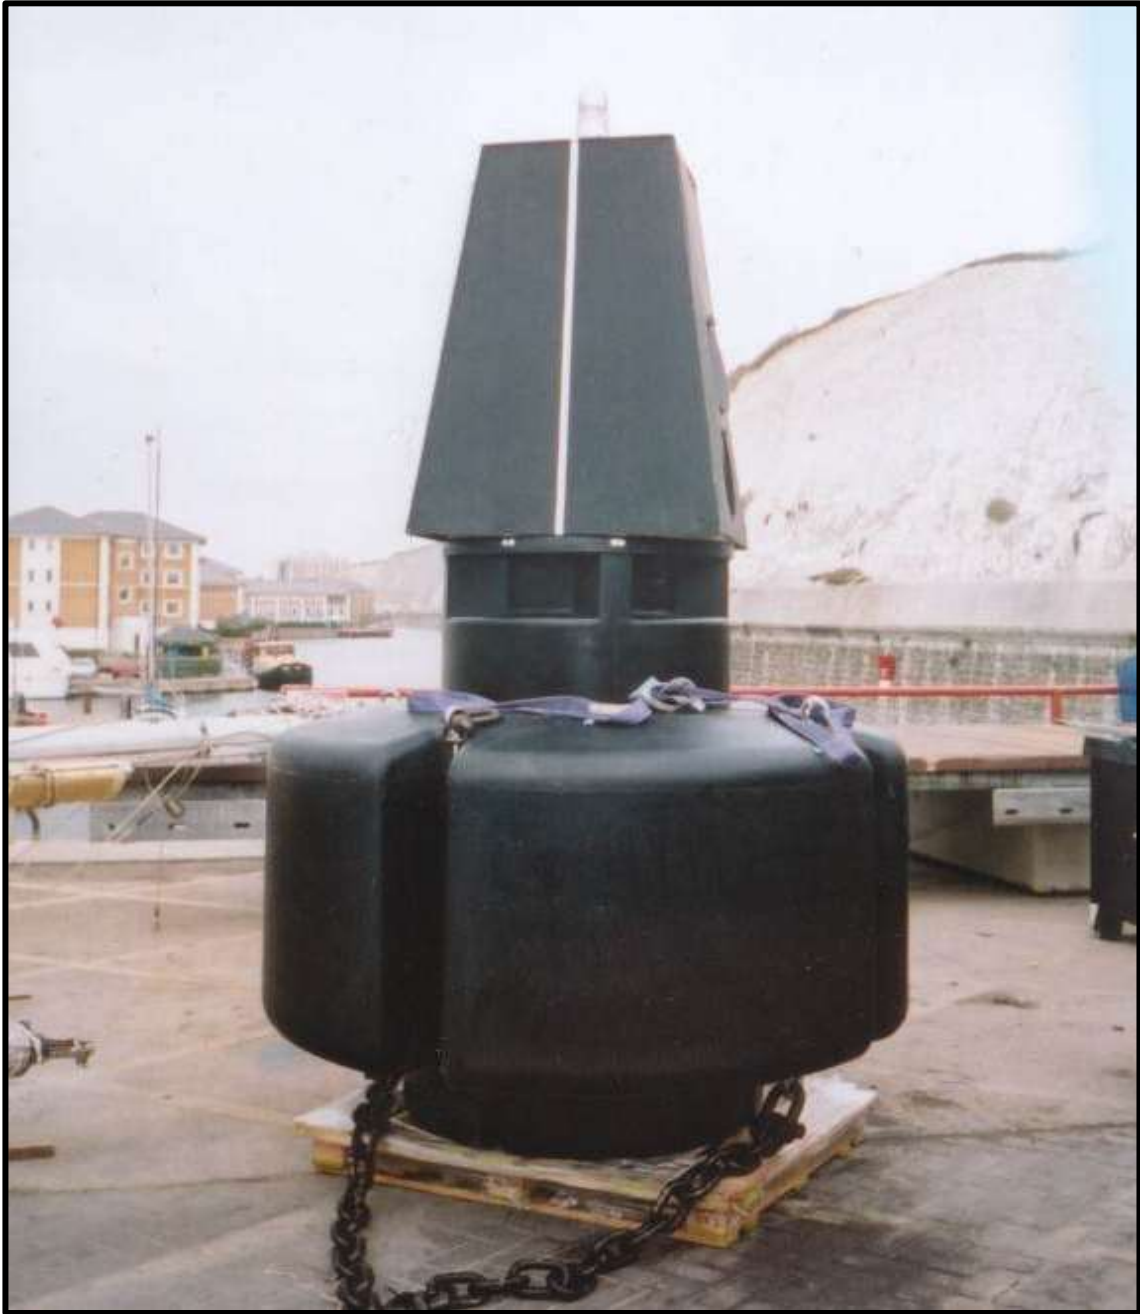
*Fig.38* Small  
rotomoulded buoy  
with rotomoulded  
superstructure

The rotomoulding process was originally developed for the manufacture of robust polyethylene containers. By this process complex hollow shapes can be produced in sheet metal moulds. The early moulding materials suffered problems such as brittleness at low temperatures and poor colour stability. Trials with rotomoulded daymarks on three metre gas buoys in the early 1980s were abandoned when a number of these daymarks shattered during cold winter weather. The moulding process and the plastics have progressed and rotomoulded polyethylene buoys now make up a large proportion of buoys manufactured worldwide. Some small buoys are entirely moulded, including the mooring attachment. Medium and large buoys usually have a steel core structure carrying the mooring eyes, ballast and superstructure attachment.

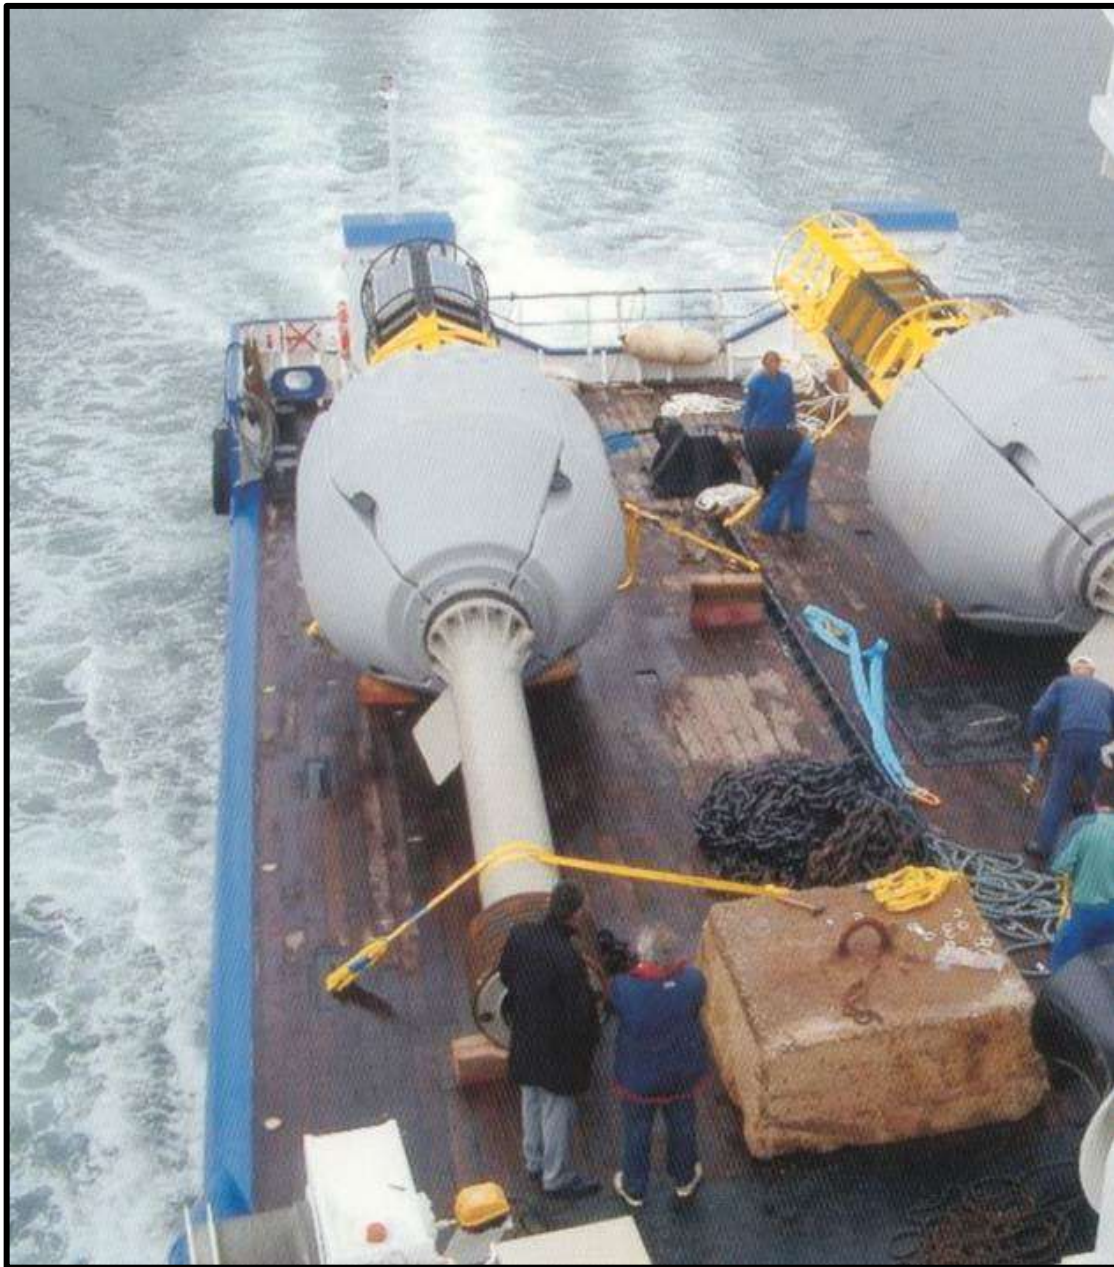
*Fig.39* Large rotomoulded buoys  
with steel core structure and  
aluminium superstructure.  
(Note concrete sinker)

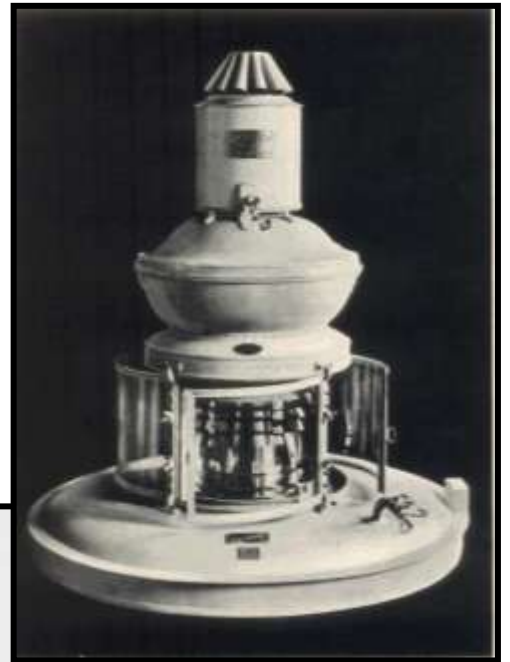
Fig.40 Wigham  
lantern

This drawing and photograph (Figure 40) show the Wigham lantern that had a mechanism to constantly move the wick so that the area of the wick at which the oil was burnt was continually renewed. References suggest that these lanterns would burn for 10 days without attention. The lantern burnt continuously and provided a fixed white light that in practice was probably orange in colour.

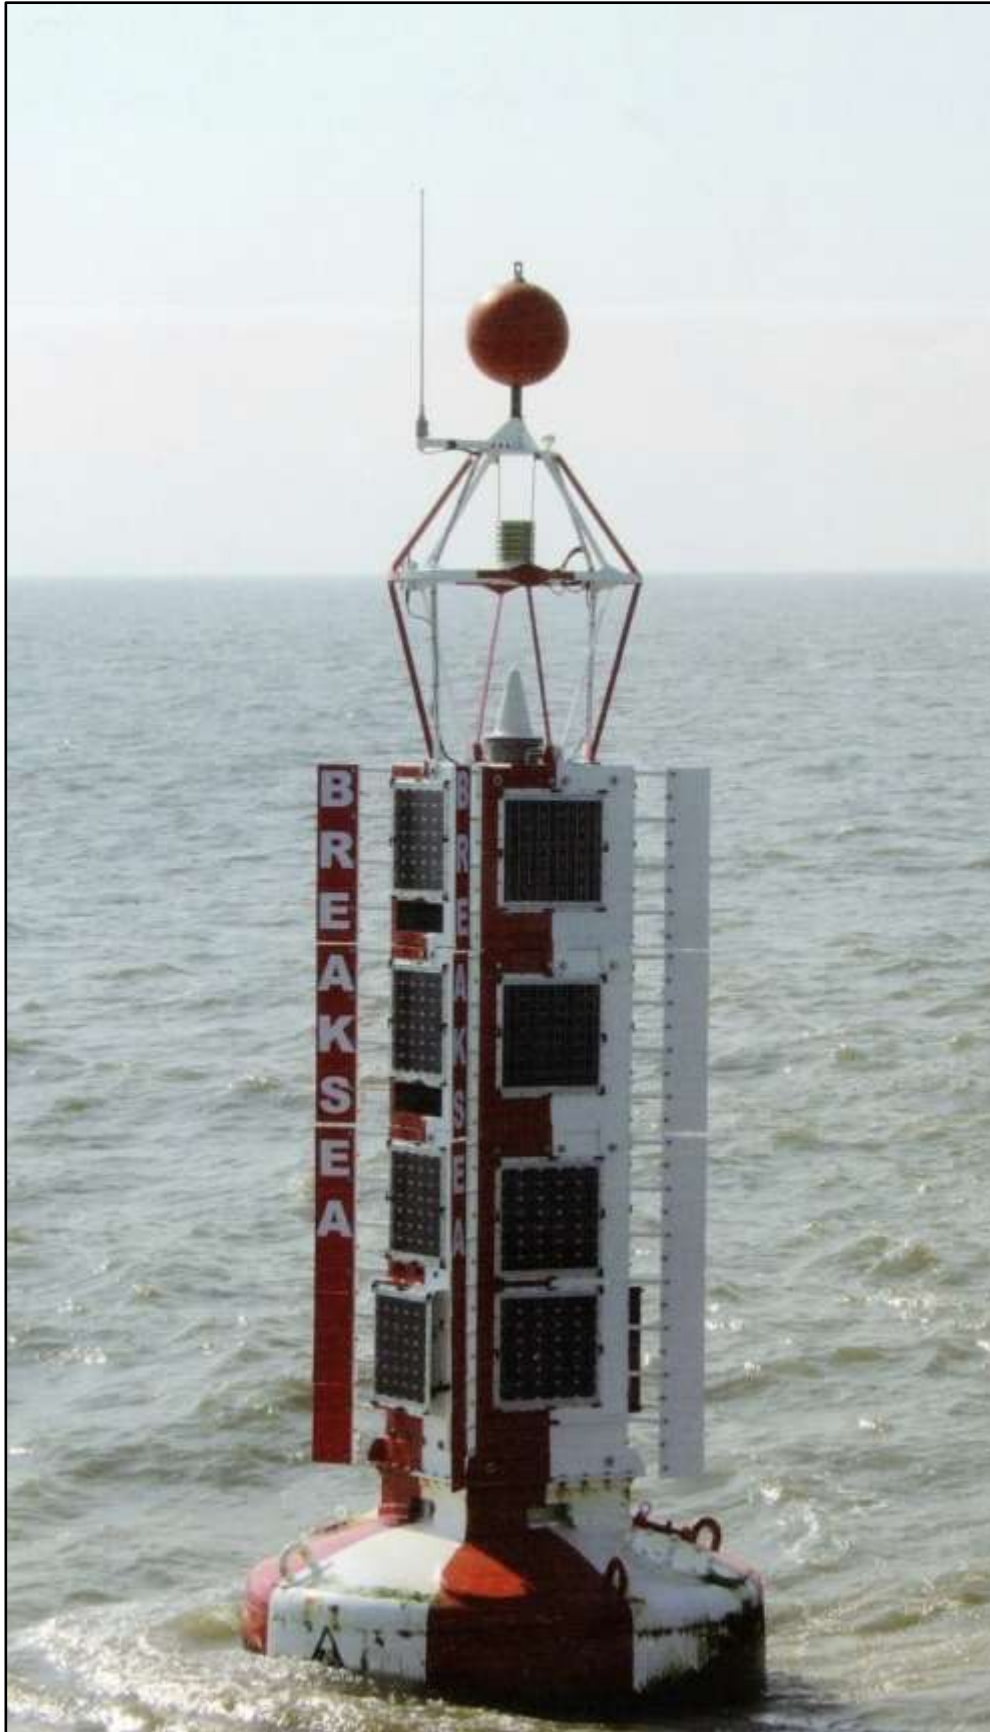
*Fig.86* Large solar powered buoy with Racon, LED lantern and AIS installation.

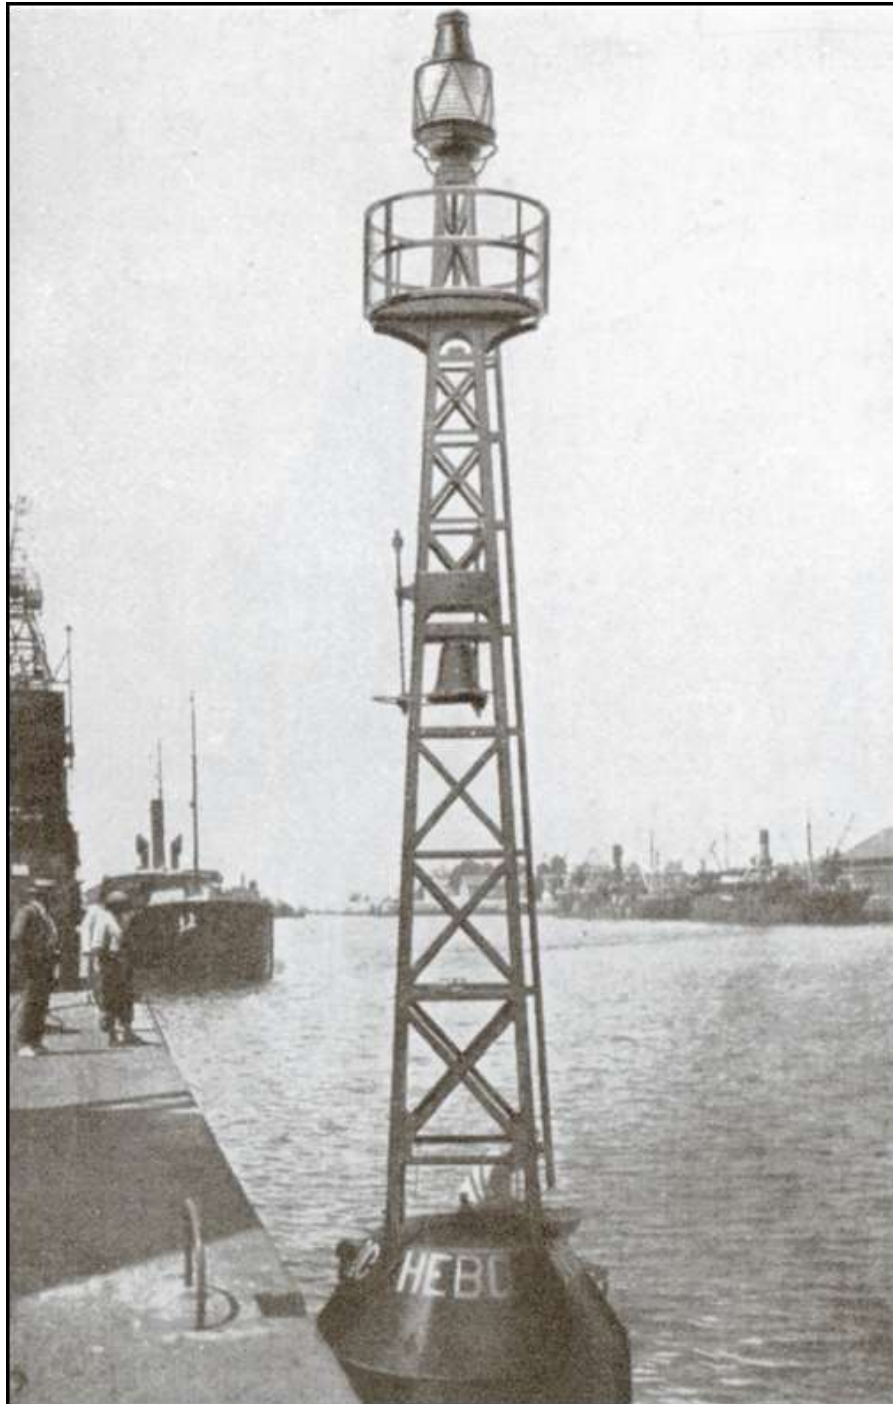
*Fig.87* French BBT high focal plane buoy early 1900s
